# COUNTY OF LOUDOUN

### **March 2, 2016 BUDGET WORK SESSION SUPPLEMENTAL PACKET**

- Board Questions Response Supplemental Packet #1 – LCPS Questions
- Budget Question Database as of 03/02/2016

Questions from Chair Randall..... 1  
Questions from Supervisor Volpe.....1  
Questions from Supervisor Letourneau.....25  
Questions from Chair Randall.....27  
Questions from Supervisor Higgins.....29  
Attachment to Question 8 (Volpe), *Loudoun County Public Schools Facility Assessment Study*.....46

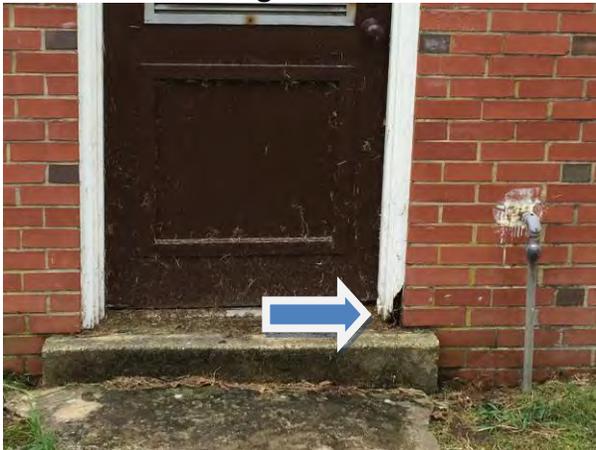
**Rotting door frame**

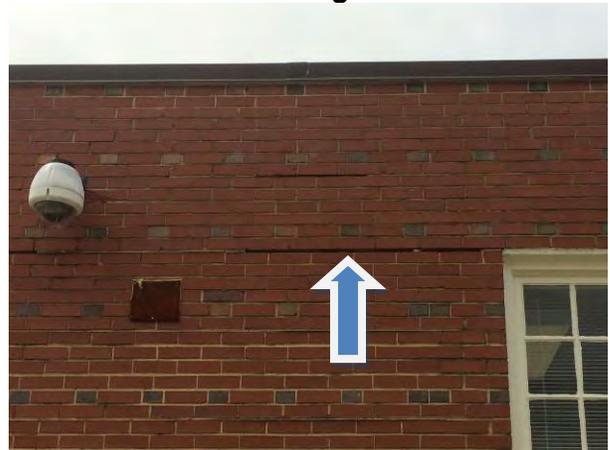
**Deteriorating mortar**

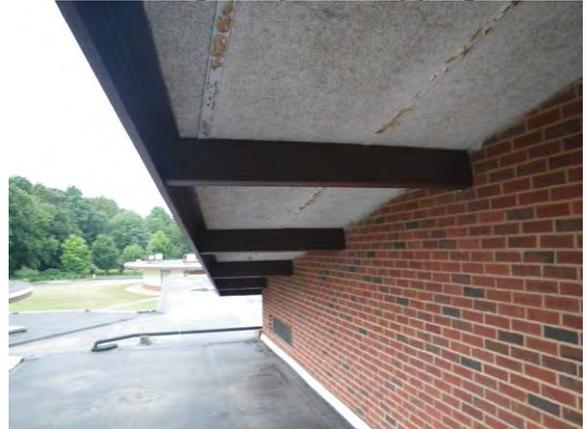
**Multi-purpose room eaves rusting and paint chipping**

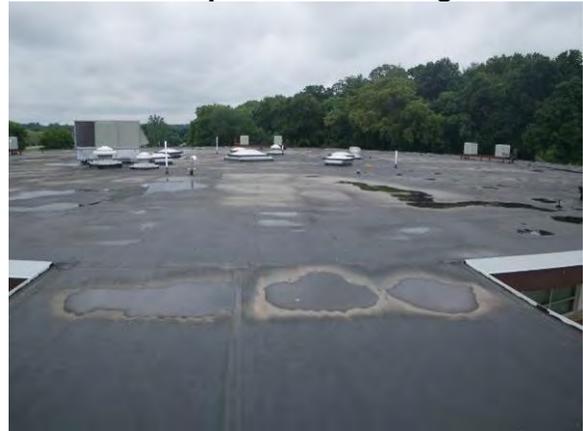
**Inadequate roof drainage**

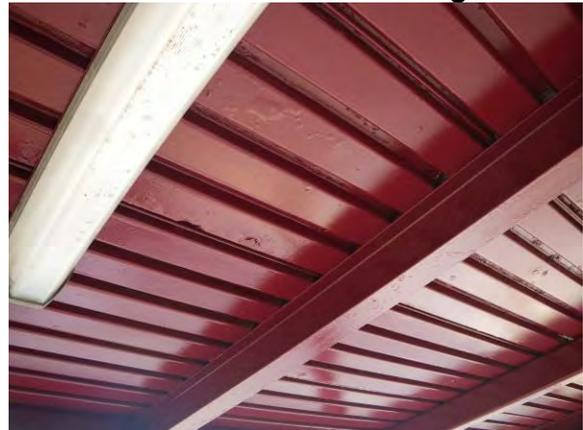
**Front canopy deck  
rusted and deteriorating**

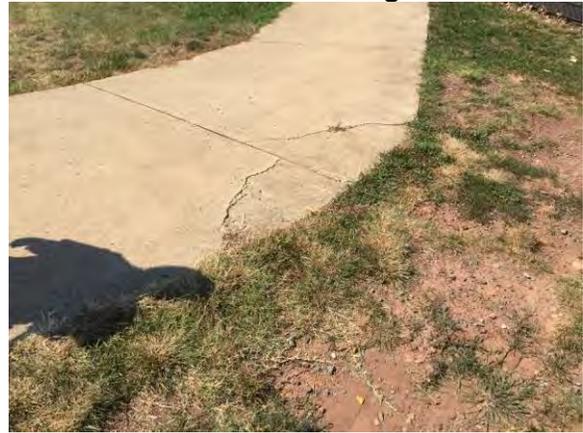
**Poor drainage/stabilization causing erosion near modular learning center**

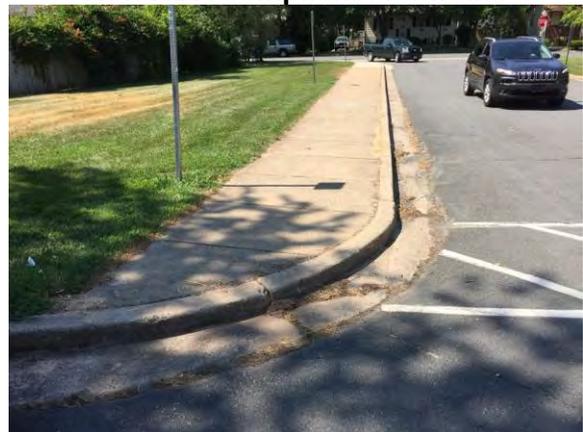
**Non-ADA compliant sidewalks**

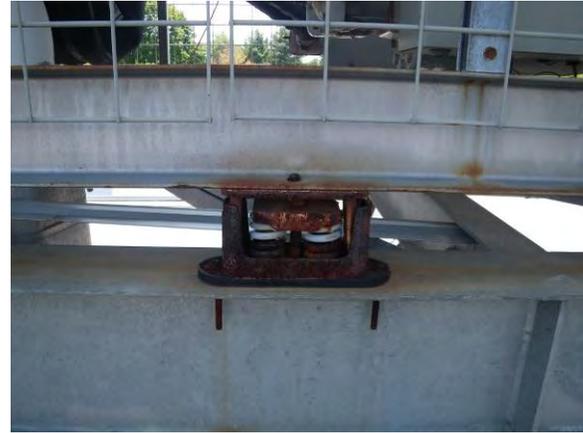
**Old and worn vibration isolators**

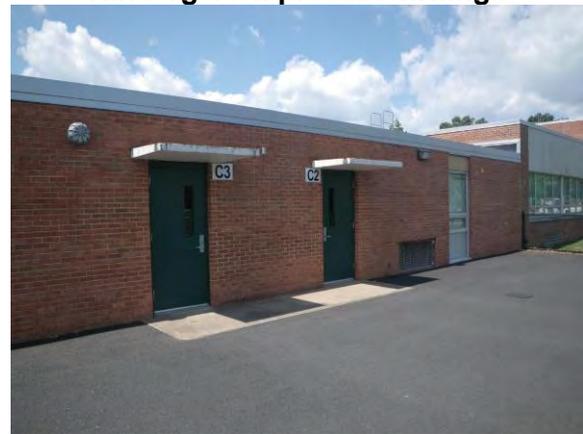
**Kindergarten precast awnings**

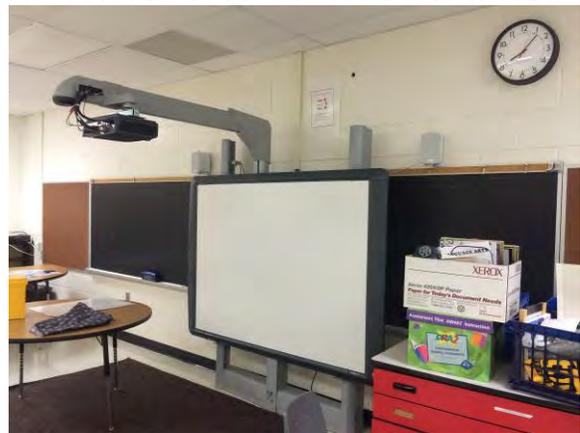
**Chalkboards not converted to marker boards**

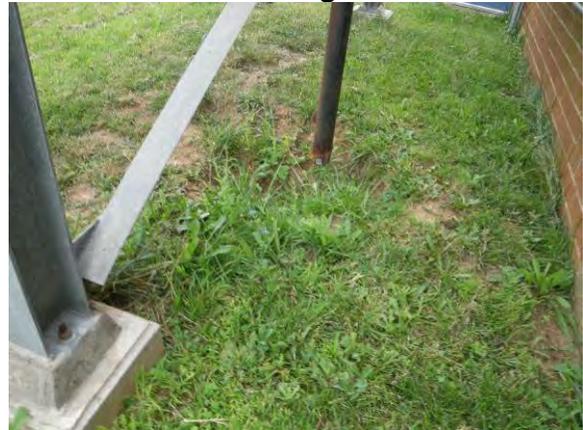
**Cooling tower- condensation drip line has created a depression in the ground. If allowed to continue, this may undermine adjacent footings**

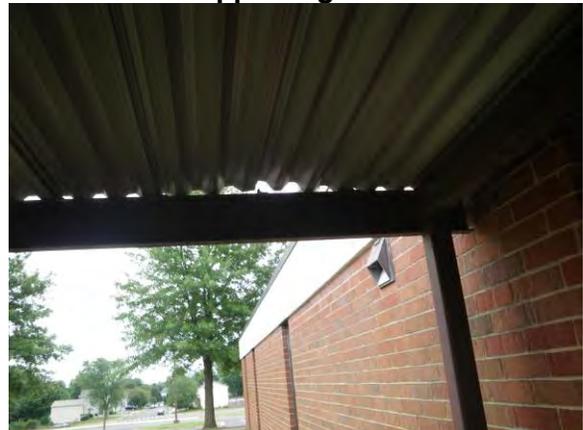
**Breezeway roof deck not attached to supporting steel**

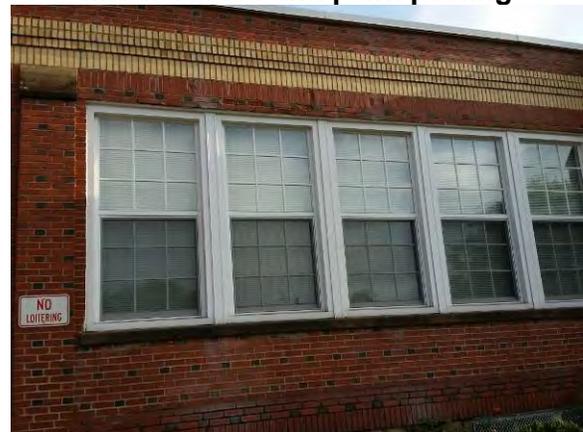
**Spalling brick façade; lintels rusted and paint peeling**

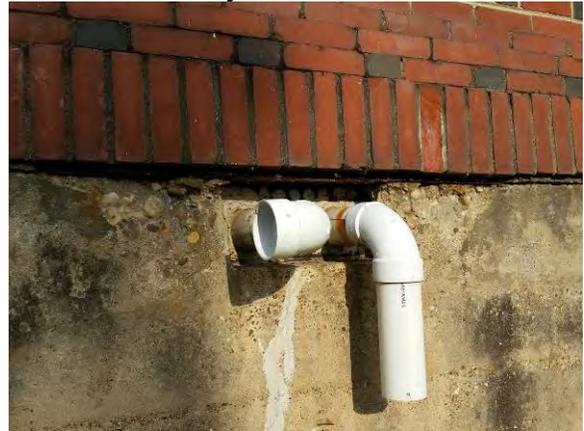
**Severely corroded lintel**

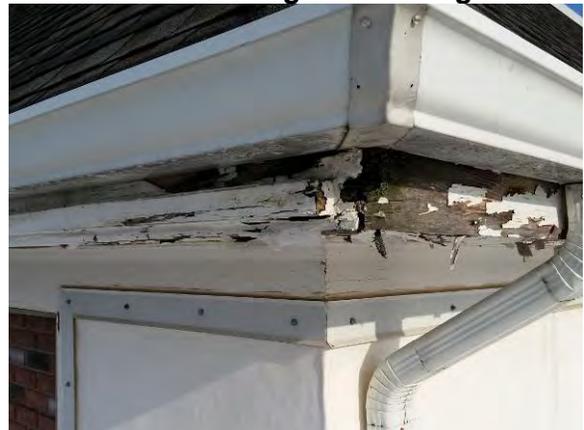
**Deteriorating eave framing**

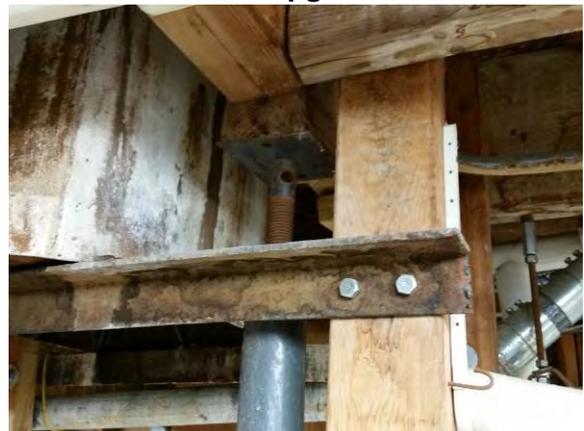
**Pieced together wood framing due to MEP upgrades**

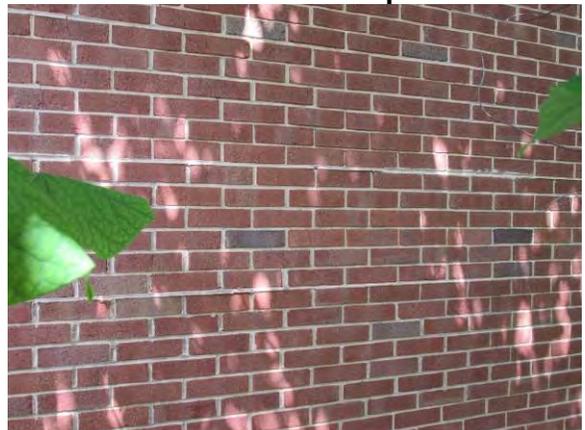
**Mortar corrosion and exposed wire**

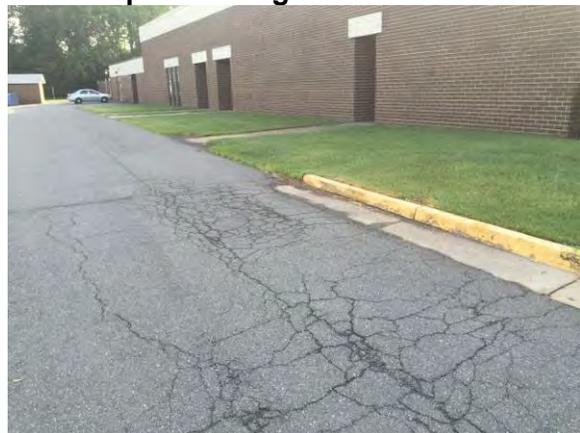
**Asphalt failing at service area**

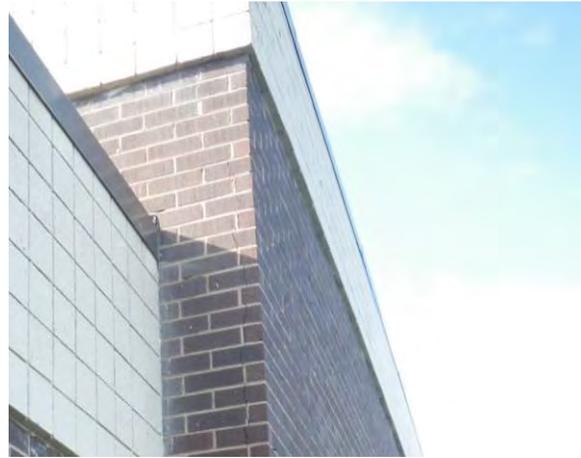
**Façade cracks due to lack of control joints and thermal movement**

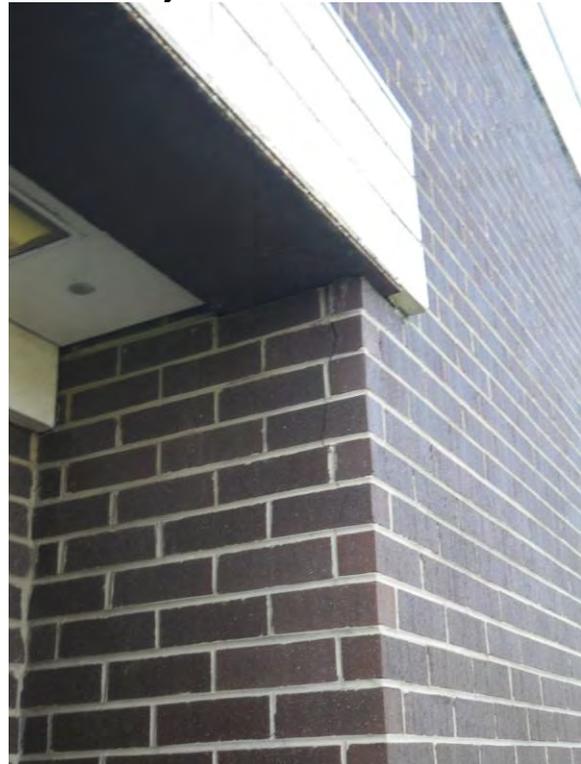
**Façade at lintel bearing cracking due to lack of control joints and thermal movement**

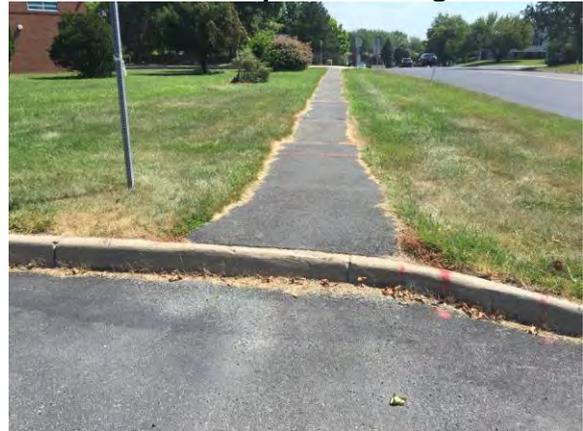
**Non-ADA compliant frontage trail**

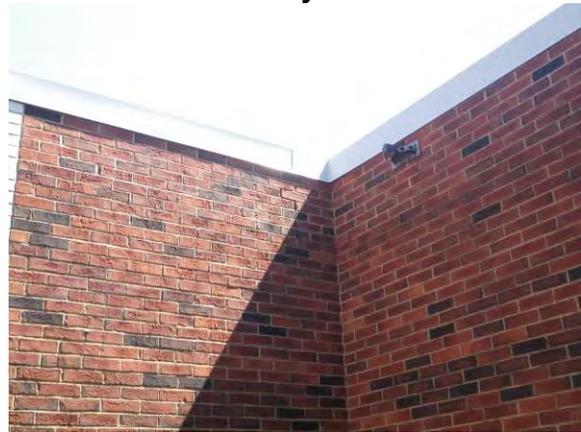
**Façade crack in north east corner of courtyard**

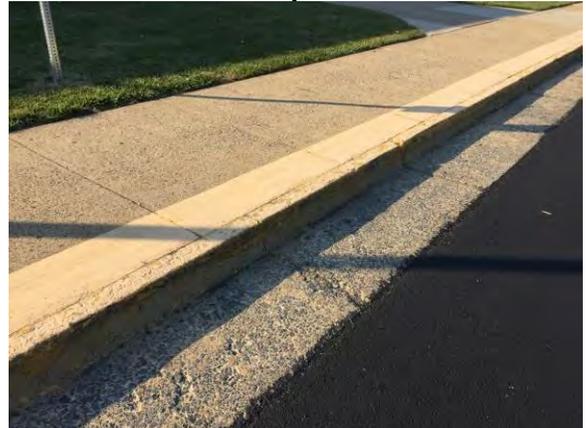
**Concrete curbs deteriorating at  
front drop off area**

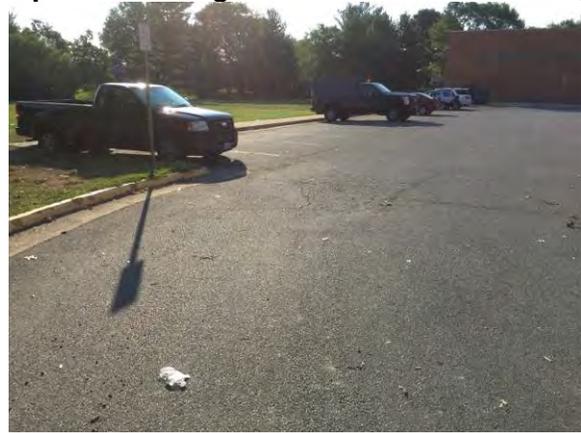
**Asphalt cracking at service side of building**

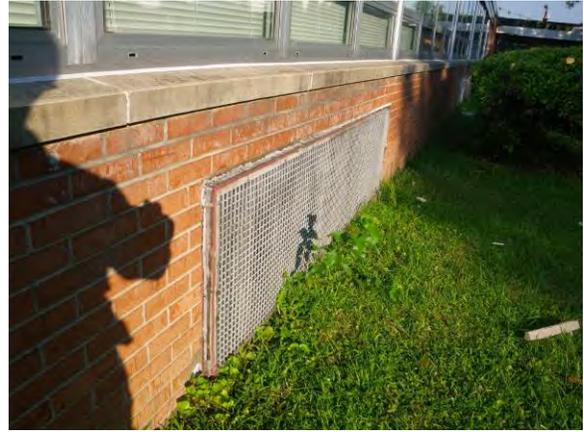
**Courtyard through-wall A/C units allow moisture in**

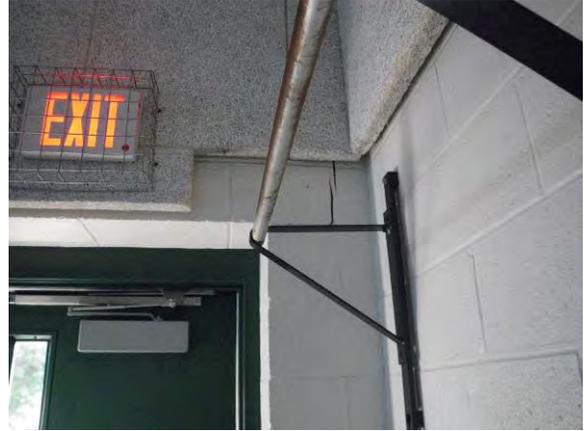
**Crack at end of lintel caused by settlement in corner of gym**

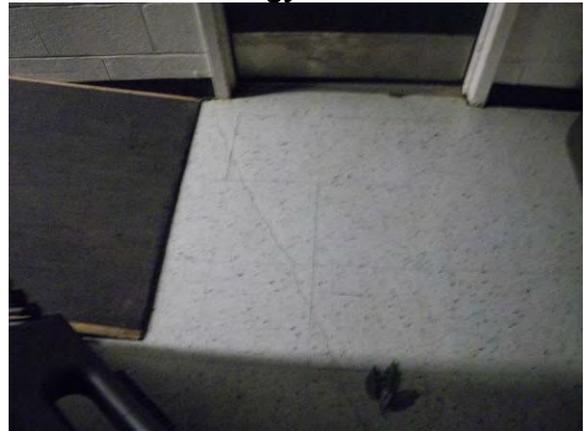
**Floor crack caused by settlement in corner of gym**

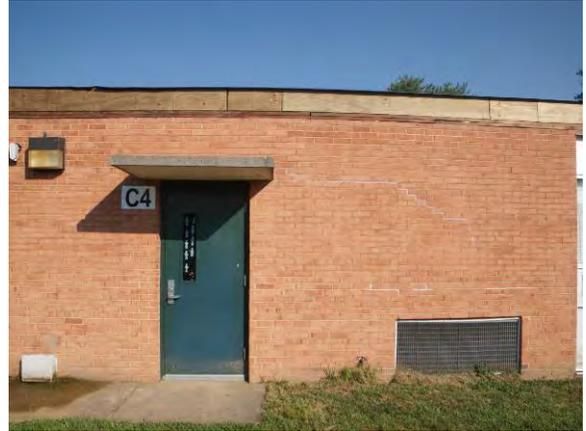
**Precast awning rotation causing façade cracks**

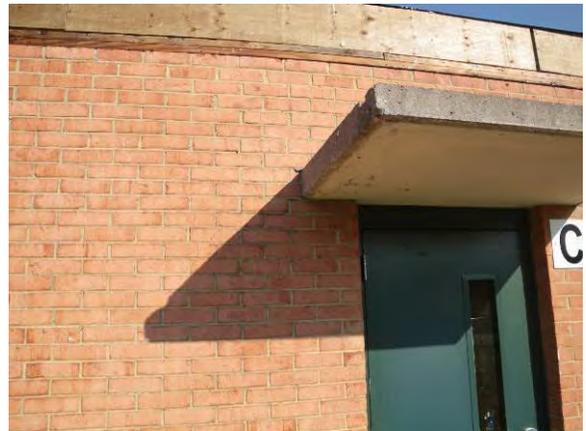
**Precast awning rotation causing façade cracks**

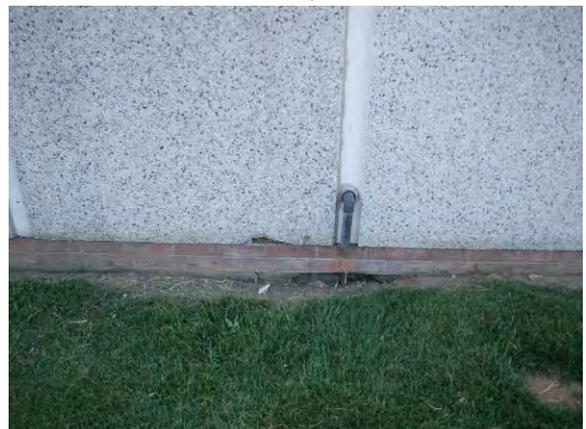
**Façade damage due to leaking condensation line**

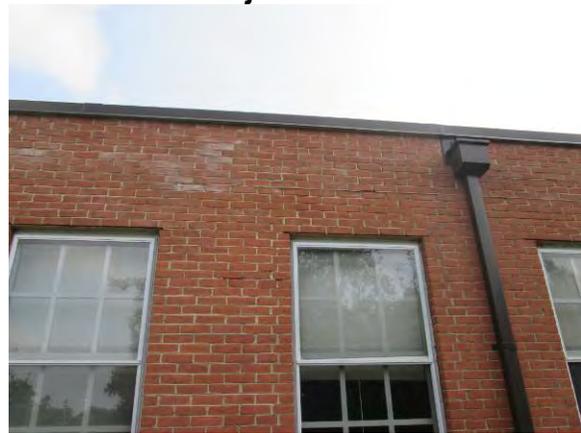
**Mortar joint condition**

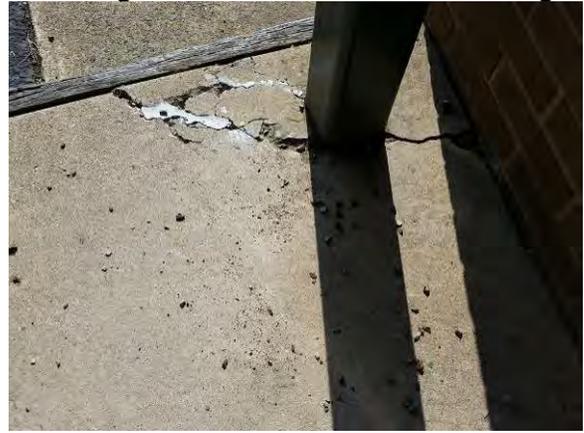
**Loading dock column moisture damage**

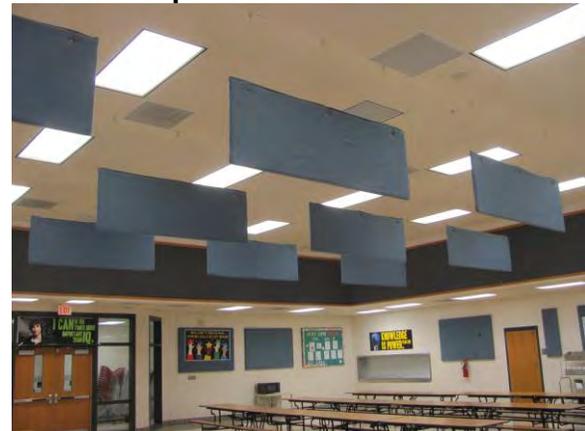
**Hanging and wall mounted sound deadening panels in cafeteria**

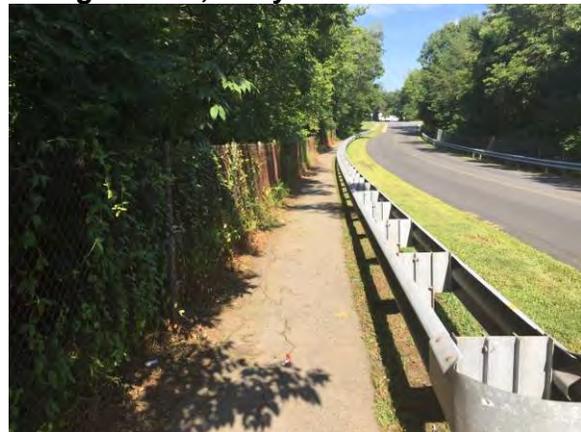
**Trail leading to school narrow and bound by guardrail, rusty chain link fence**

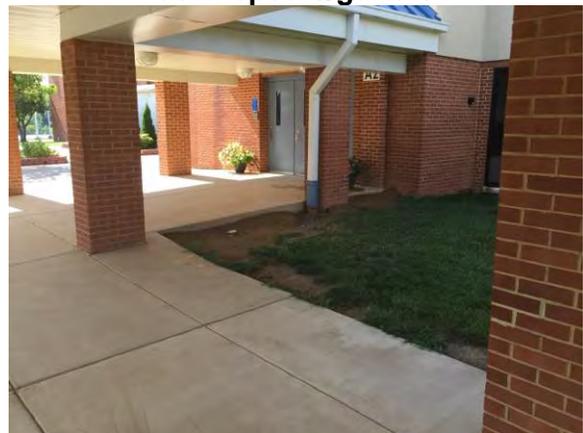
**Front entrance drainage caused by grading problems and poorly functioning downspouts/gutters**

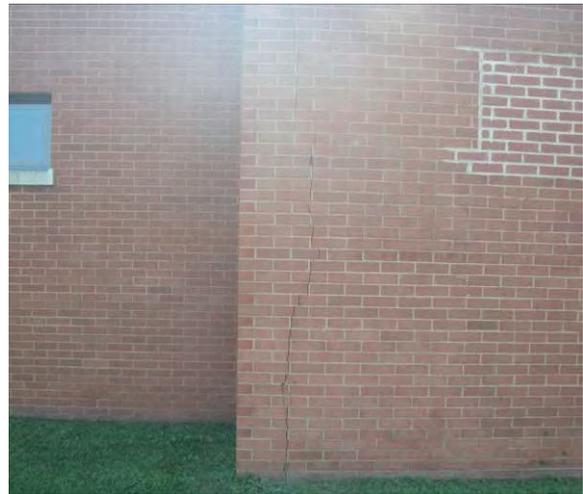
**Façade cracks due to lack of control joints and thermal movement**

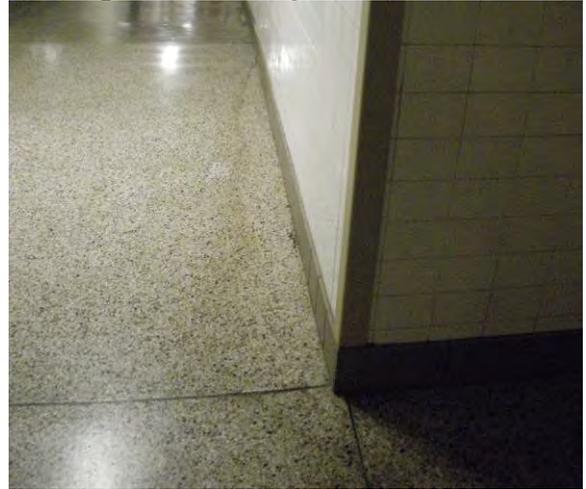
**Cracking floor in computer and tech ed labs**

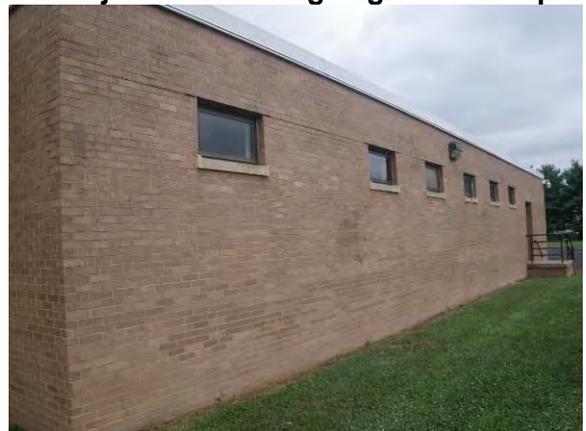
**Façade lacks control joints - mortar joint at relieving angle needs repair**

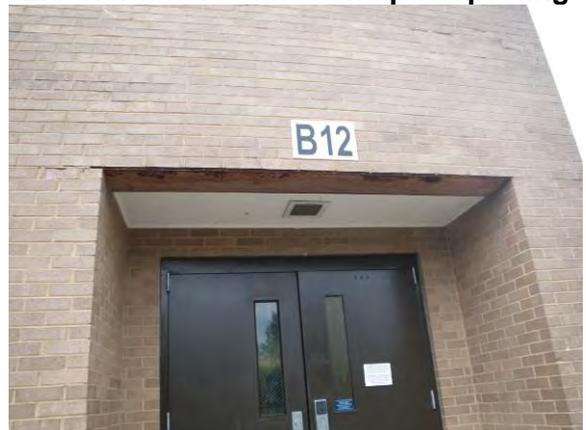
**Exterior lintels rusted and paint peeling**

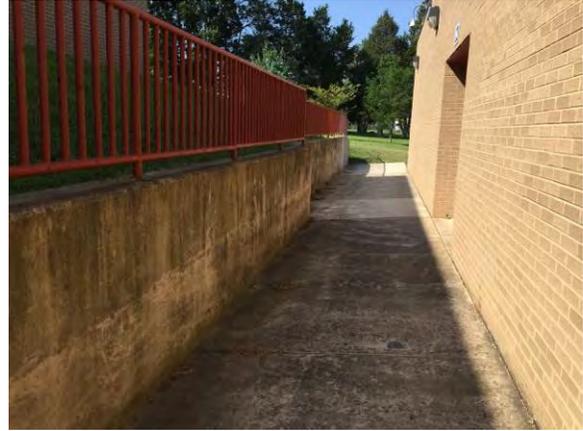
**Poor drainage at sidewalk may result in settlement**

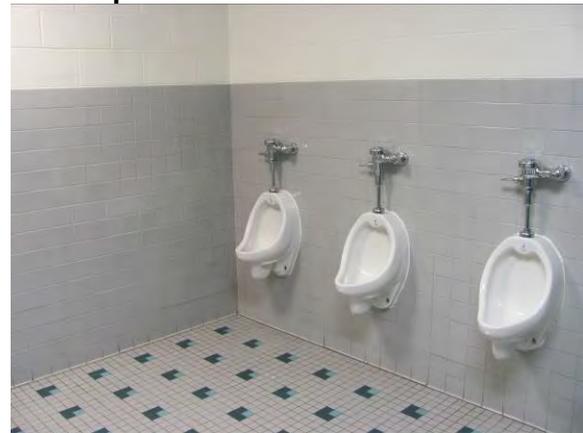
**Group restrooms lack urinal screens**

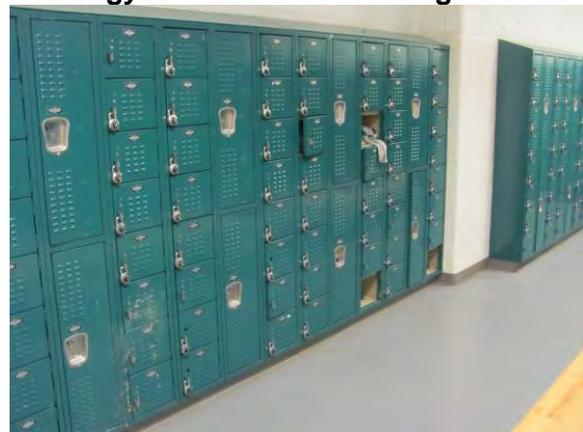
**A few gym lockers have damaged doors**
