# COUNTY OF LOUDOUN

### **March 2, 2016 BUDGET WORK SESSION SUPPLEMENTAL PACKET**

- Board Questions Response Supplemental Packet #1 – LCPS Questions
- Budget Question Database as of 03/02/2016

Questions from Chair Randall..... 1  
Questions from Supervisor Volpe.....1  
Questions from Supervisor Letourneau.....25  
Questions from Chair Randall.....27  
Questions from Supervisor Higgins.....29  
Attachment to Question 8 (Volpe), *Loudoun County Public Schools Facility Assessment Study*.....46

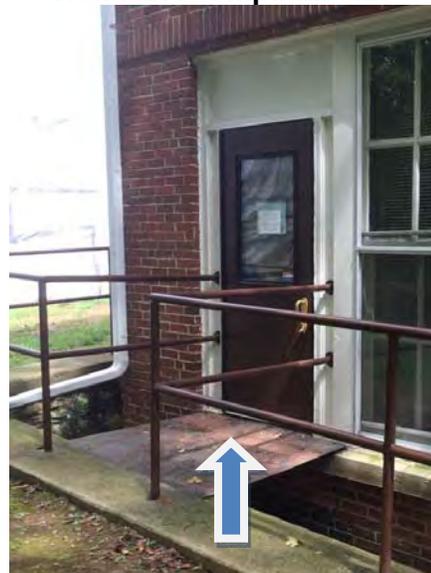
**Non-ADA compliant exit**

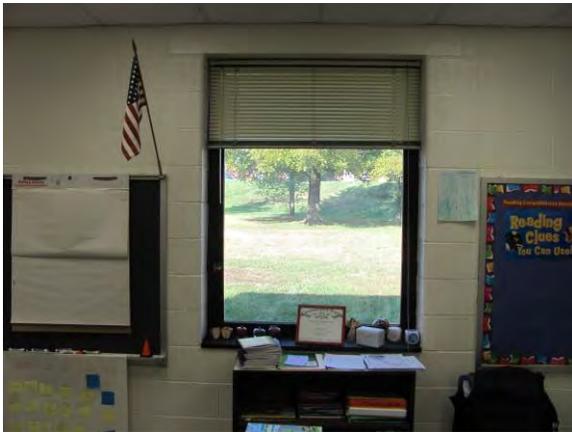
**Double-pane window glass fogging at many locations**

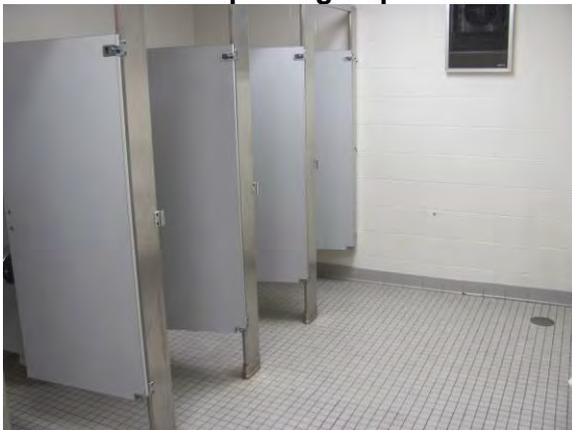
**Non-ADA compliant group restrooms**

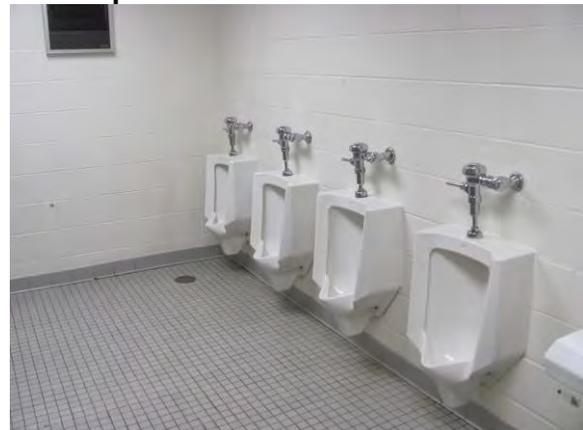
**Group restrooms lack urinal screens**

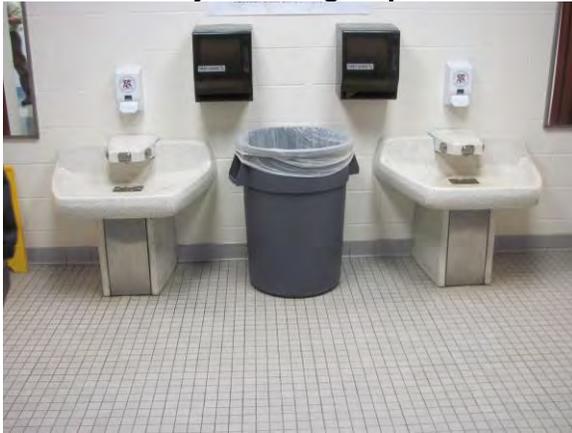
**ADA compliant lavatories located in corridors adjacent to group restrooms**

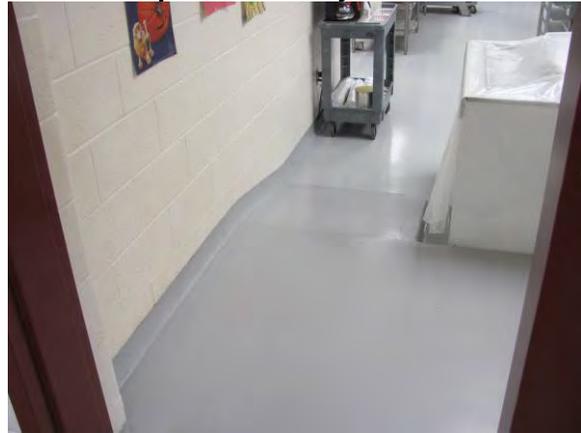
**Ramp from serving line to kitchen lacks painted safety color**

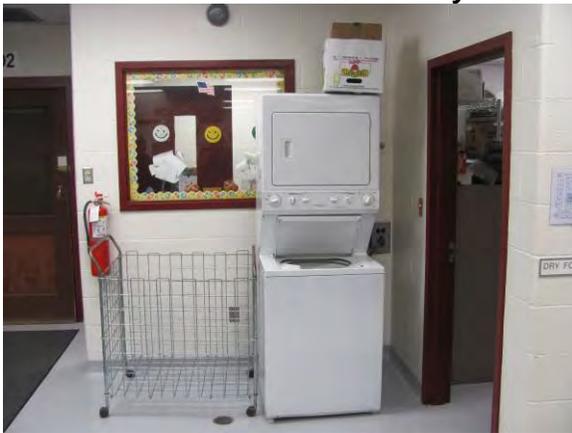
**Kitchen lacks a locker / laundry room**

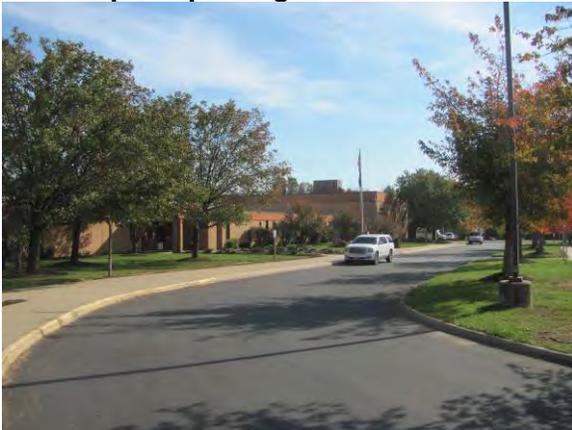
**Curb paint peeling in some locations**

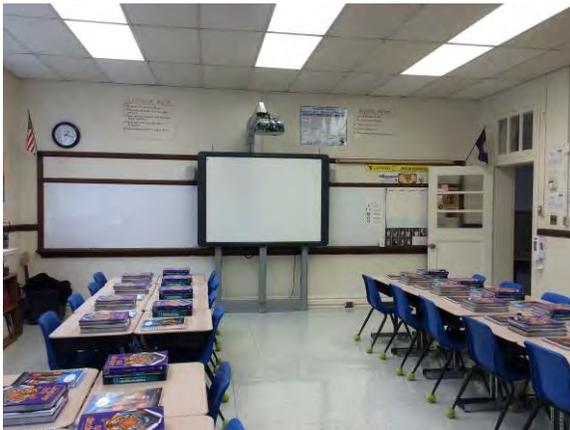
**Chalkboards converted to marker boards**

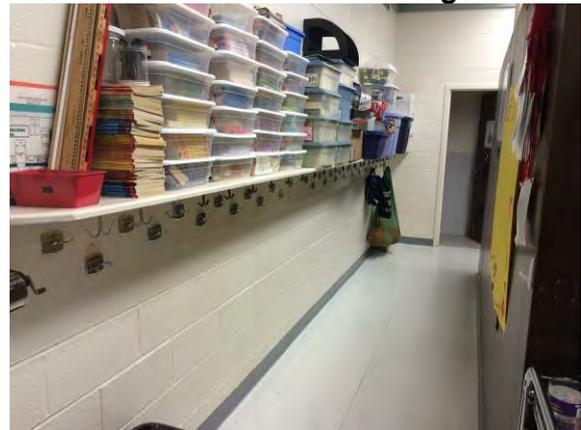
**Classrooms need storage**

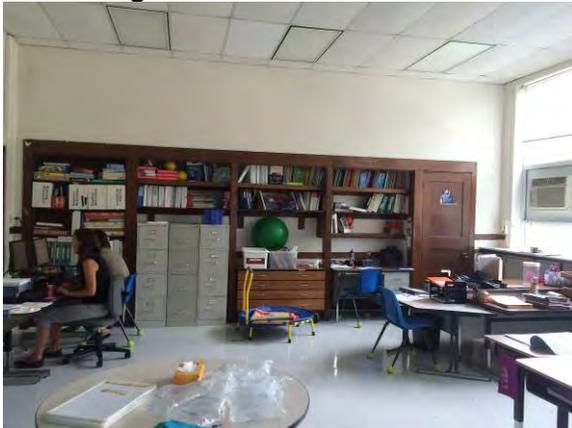
**Original classroom casework**

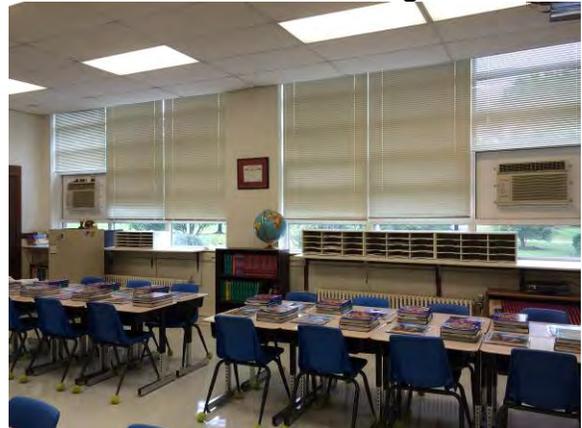
**Makeshift classroom shelving at windows**

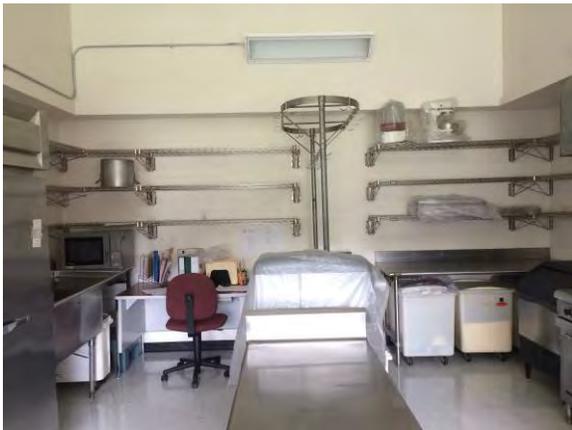
**Kitchen office**

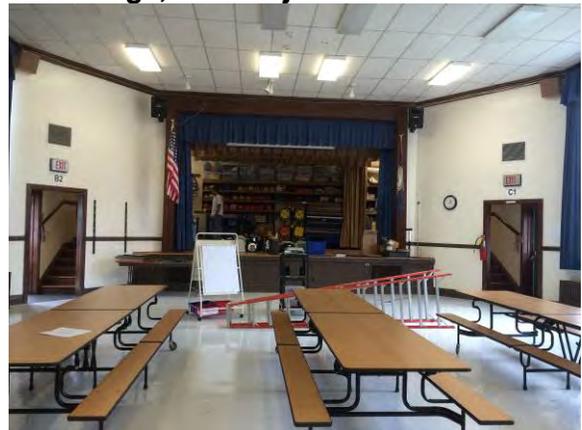
**Multi-purpose room hosts gym, cafeteria, stage, PE and janitorial offices**

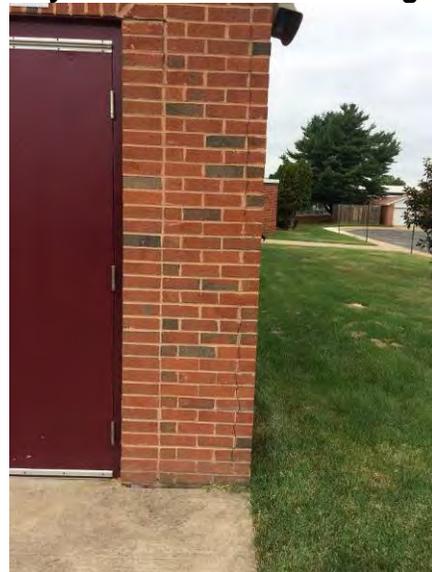
**Gym addition brick cracking**

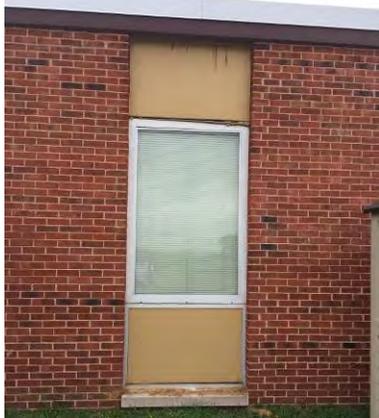
Window and panel aged and poorly insulated

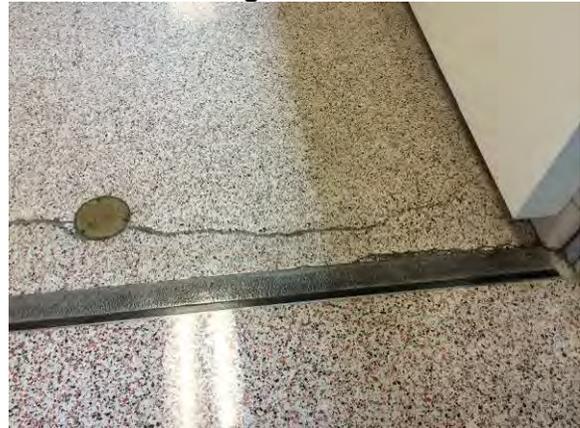
Cracking terrazzo floor

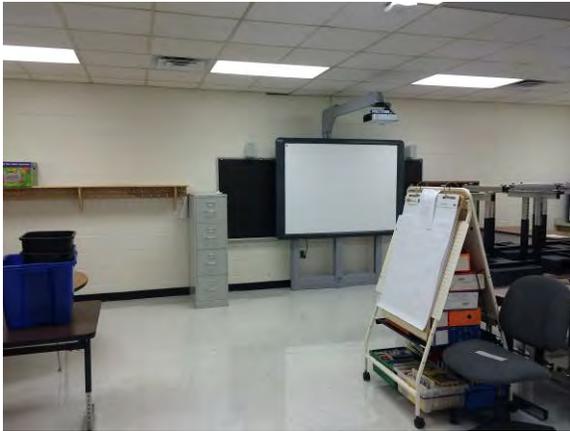
Chalkboards not converted to marker boards

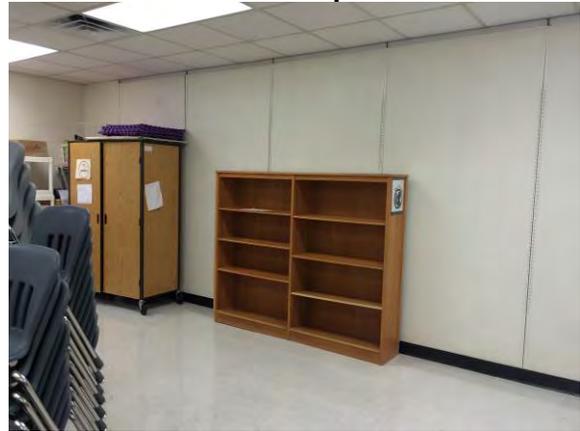
Non-acoustic partition

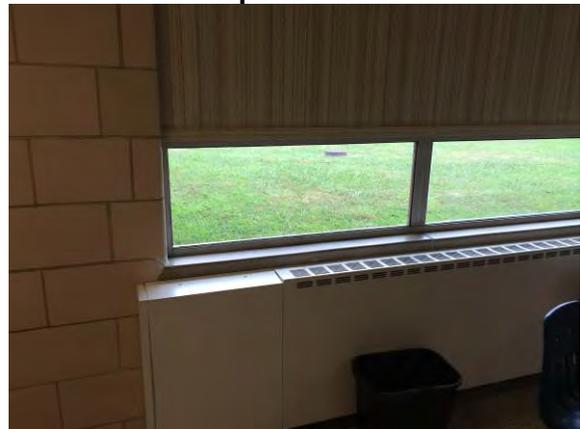
Significant heat gain in corridors to pods 1 & 2

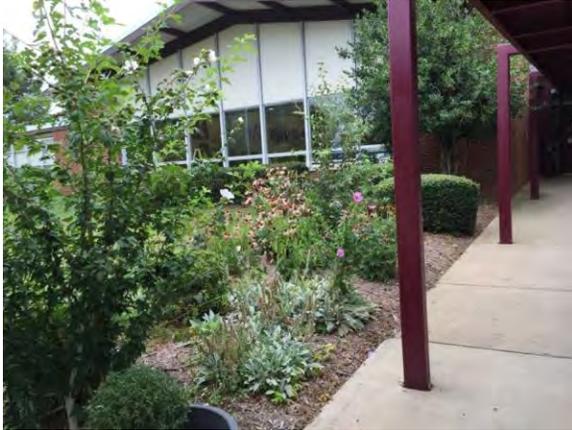
**Front entry landscaping**

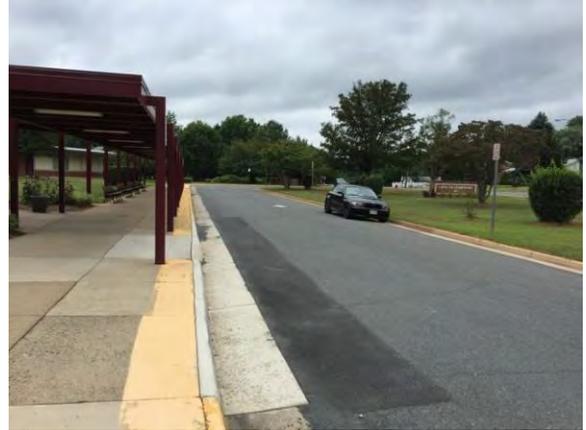
**Bus loop**

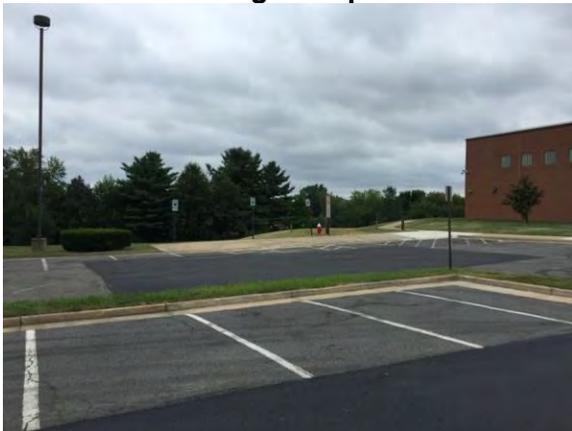
**Parking lot repairs**

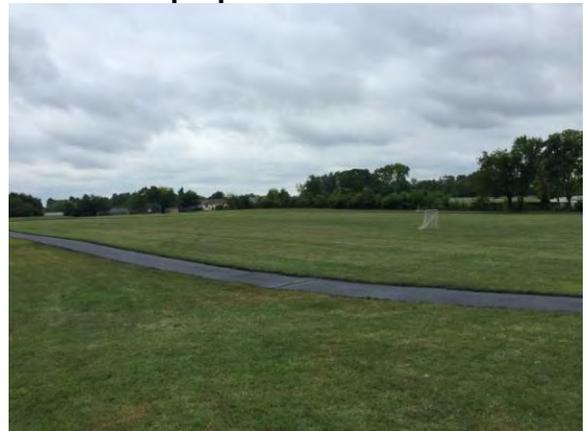
**Multi-purpose field with track**

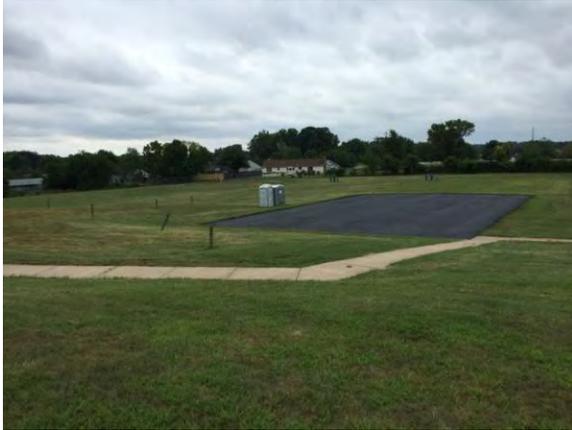
**Softball field / multi-purpose courts**

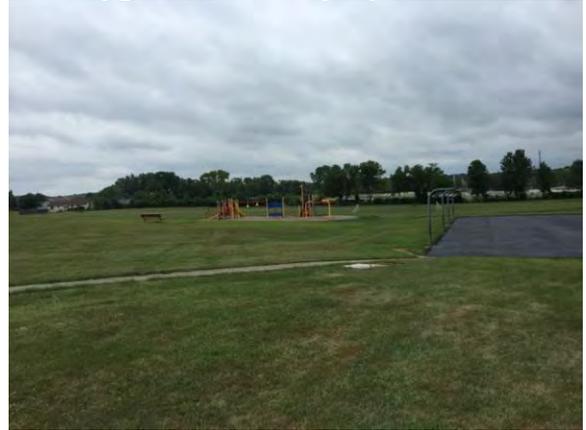
**Playground / multi-purpose courts**

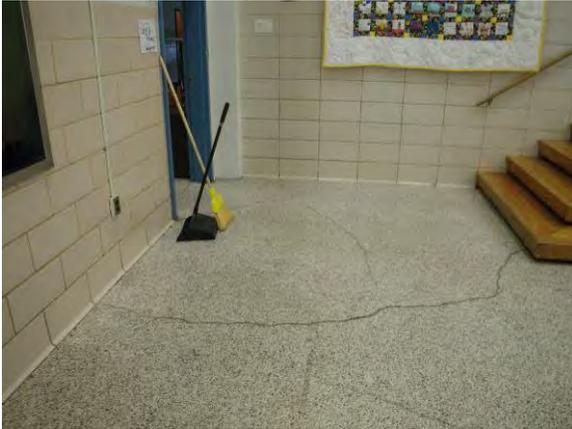
**Cracking terrazzo floor**

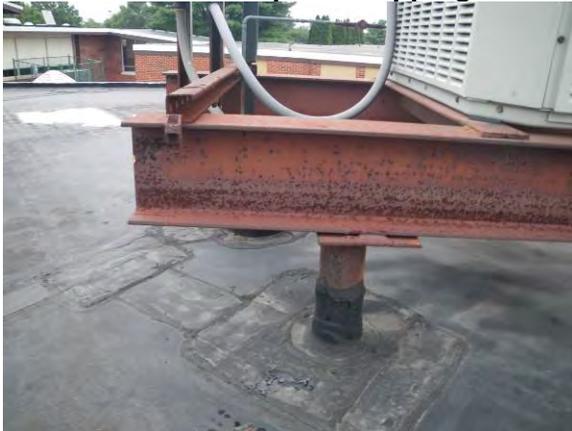
**Roof dunnage  
rusted and paint chipping**

- Roof dunnage steel – clean and paint
- Roof drainage – too few drains; further investigation needed
- Canopy roof deck – replacement needed
- Exposed steel at eaves – clean and paint

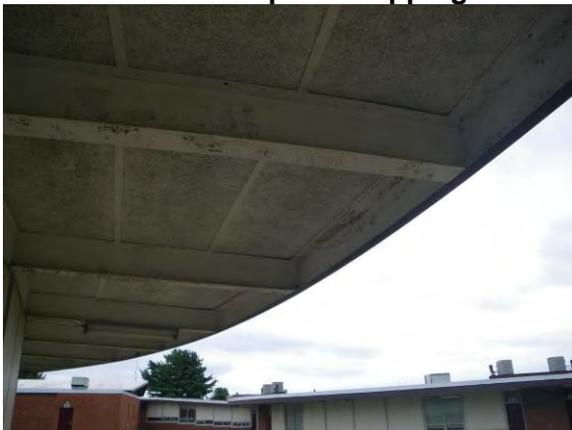
**Classroom pod eaves  
rusted and paint chipping**

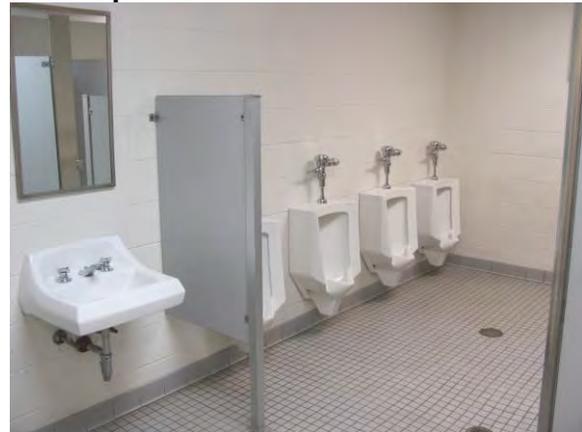
**Group restrooms lack urinal screens**

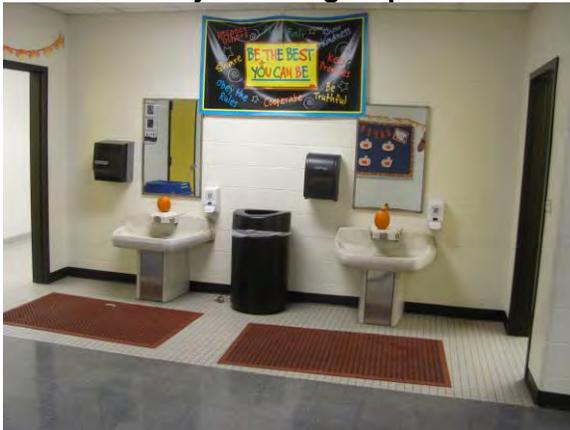
**ADA compliant lavatories are located in corridors adjacent to group restrooms**

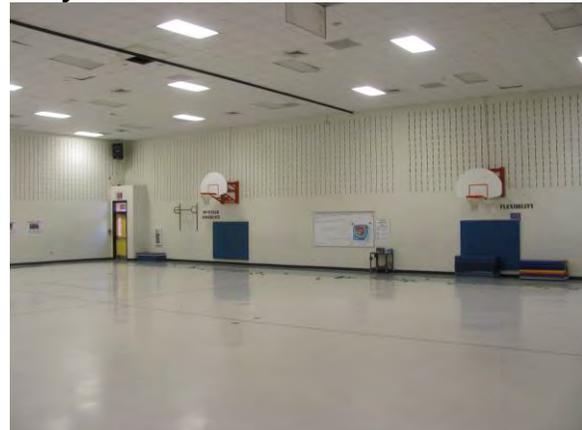
**Gym lacks bleachers and scoreboard**

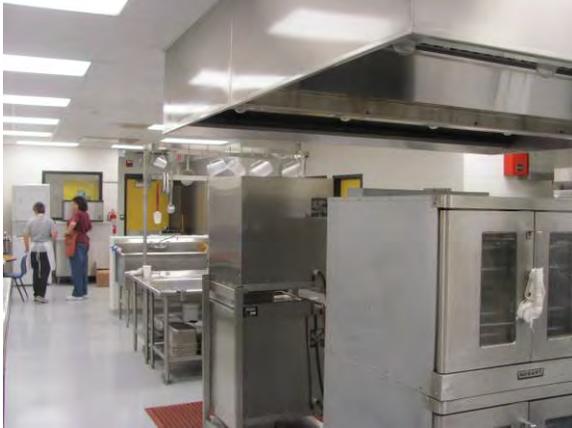
**Kitchen lacks locker / laundry room**

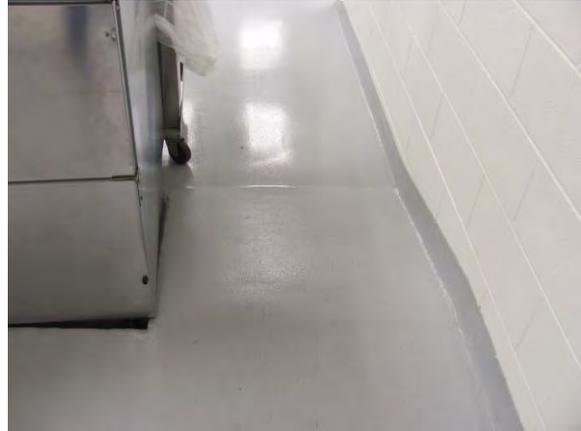
**Ramp from serving line to kitchen lacks painted safety color**

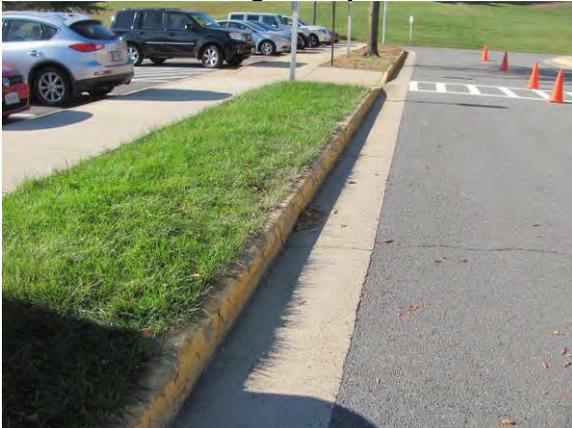
**Peeling curb paint**

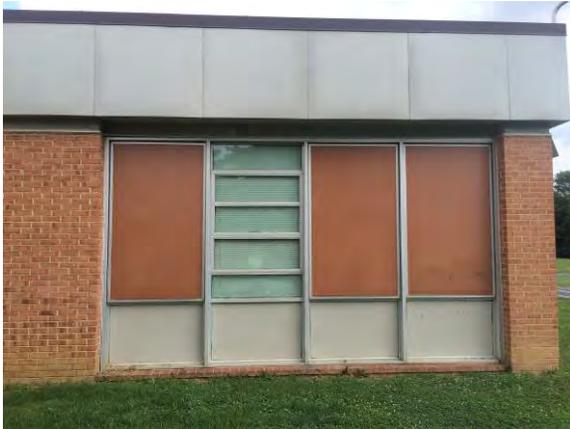
**Panels cover functioning windows in classroom**

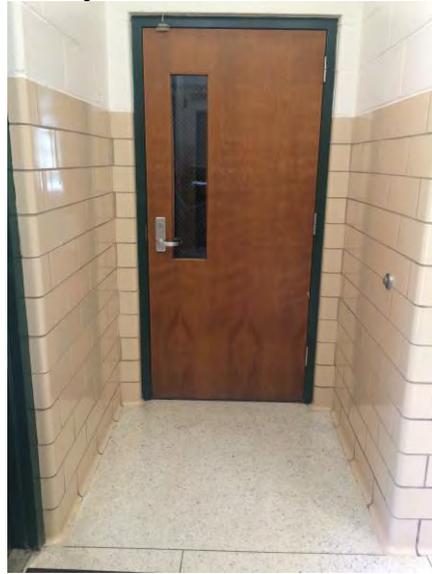
**Non-ADA compliant classroom entry doors in 1972 addition**

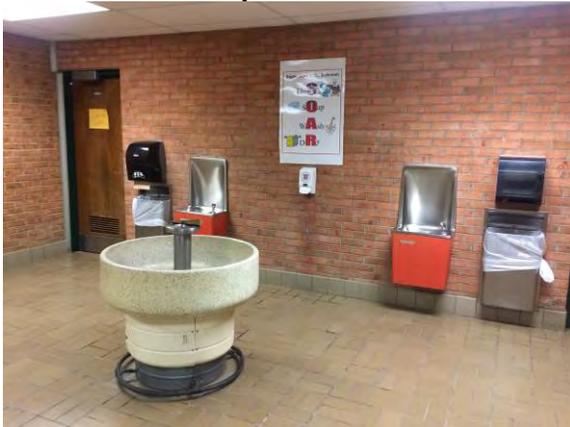
**Non-ADA compliant restroom sinks**

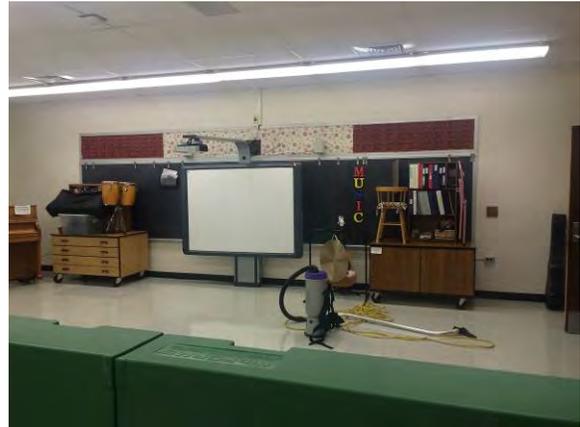
**Chalkboards not converted to marker boards**

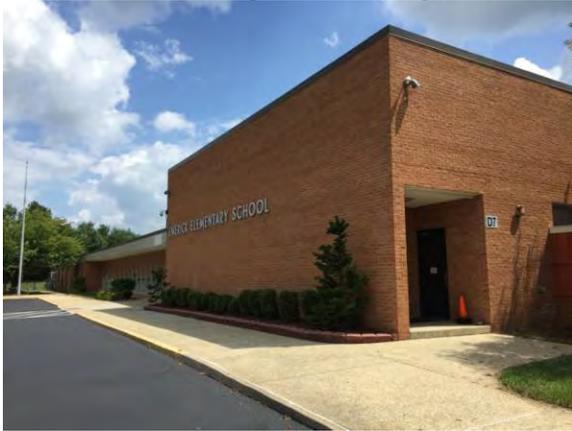
**Bus loop / front entry**

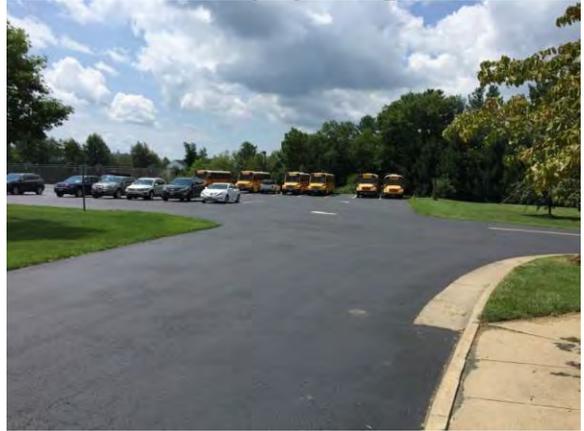
**Bus loop / parking lot**

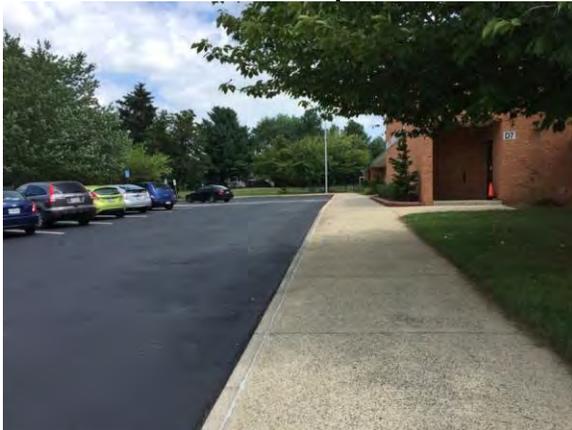
**Bus loop**

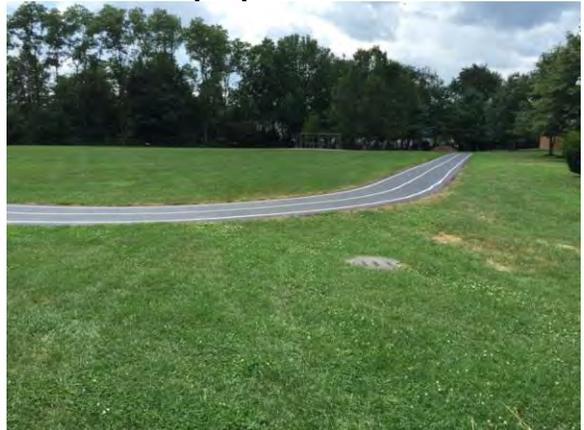
**Multi-purpose field / track**

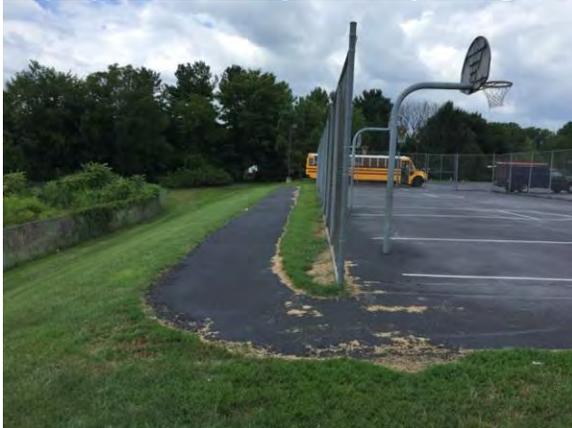
**Multi-purpose court adjacent to parking lot**

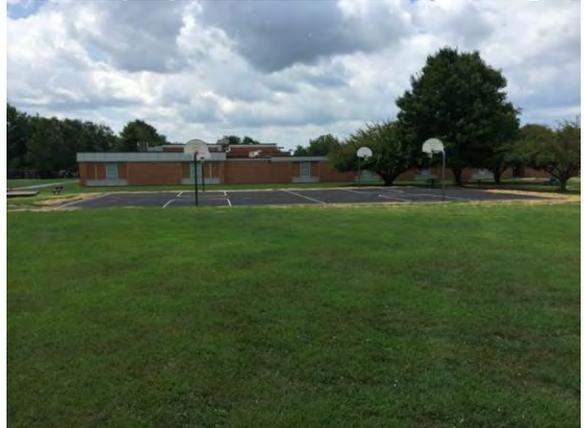
**Multi-purpose court behind building**

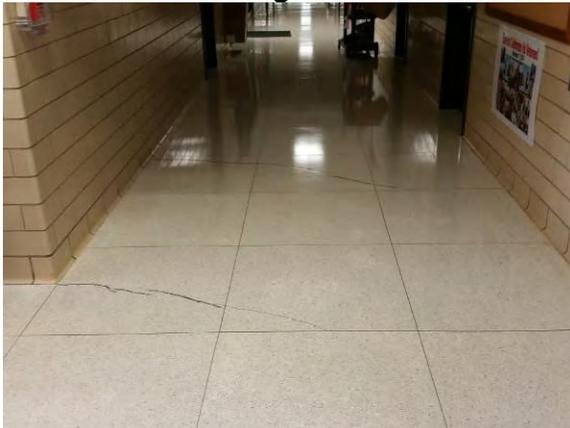
The interior bearing walls are in good condition. There is cracking in the floors throughout the building, however, there is no apparent differential settlement, nor they do not appear to have changed in years.

**Cracking floor tile**

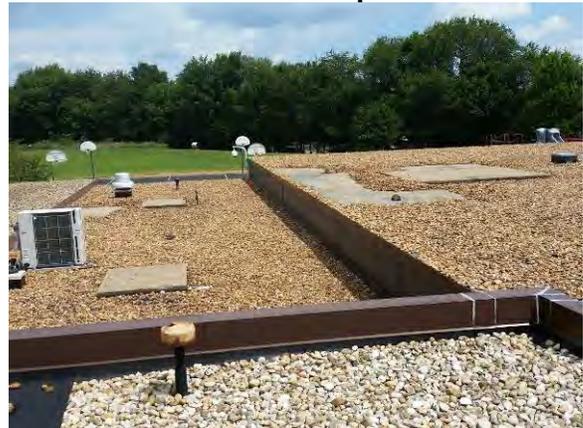
**Abandoned concrete pads on roof**

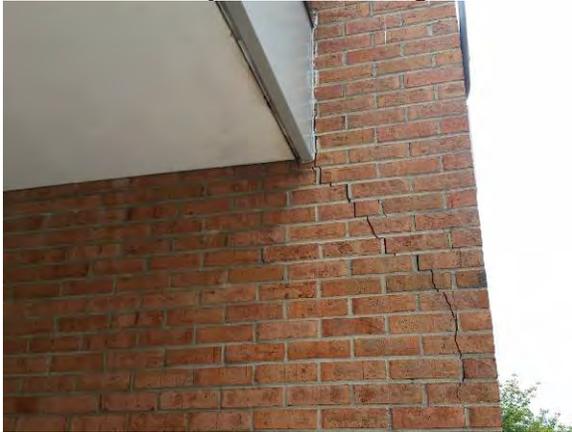
**Entry brick cracking**

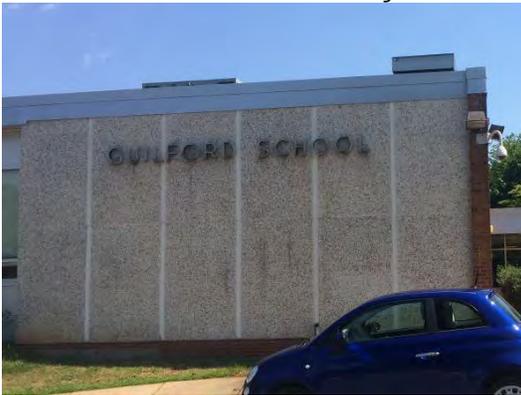
**Aggregate staining and cracked sealant on façade**

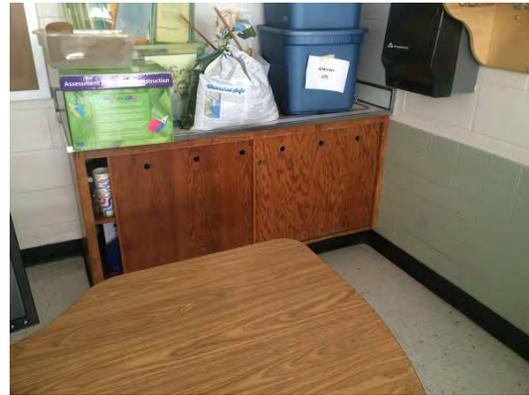
**Worn classroom casework**

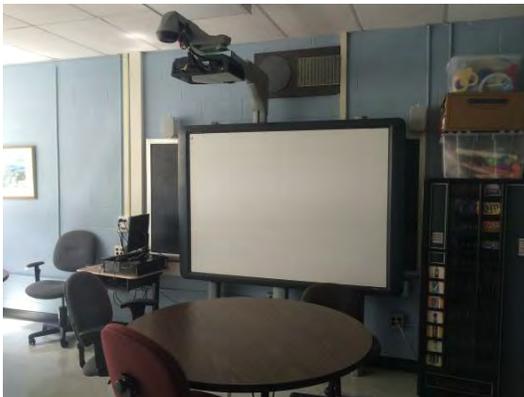
**Chalkboards not converted to marker boards**

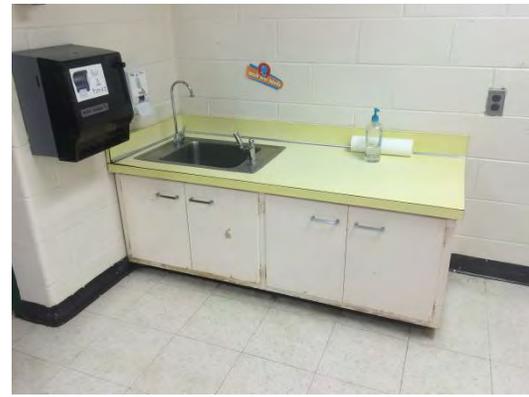
**Worn classroom casework**

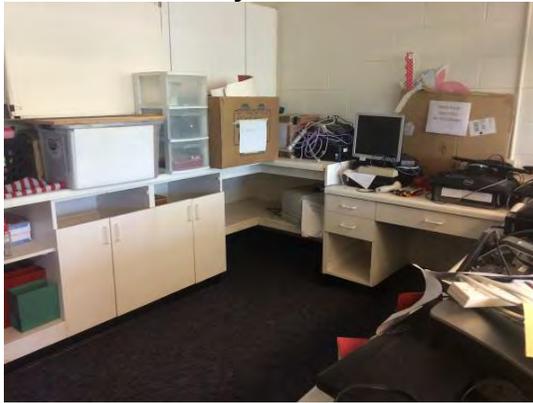
**Library casework**

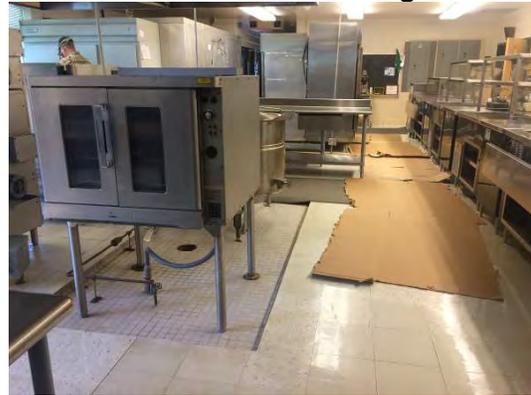
**Kitchen VCT flooring**

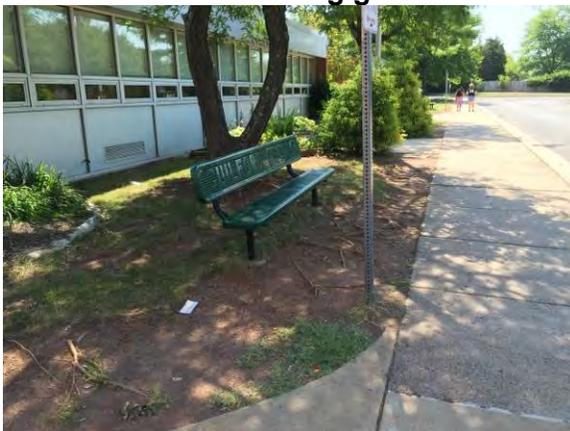
**Main entrance lacking ground cover**

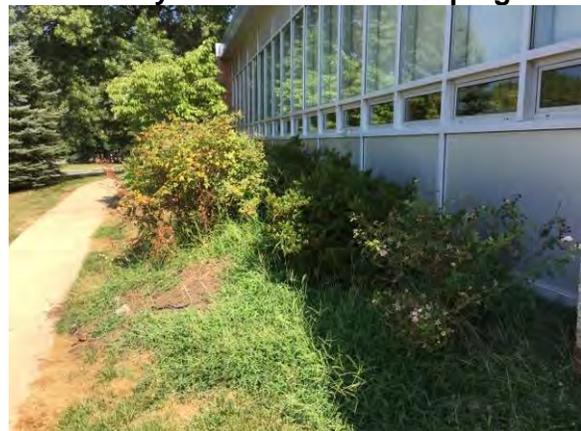
**Poorly maintained landscaping**

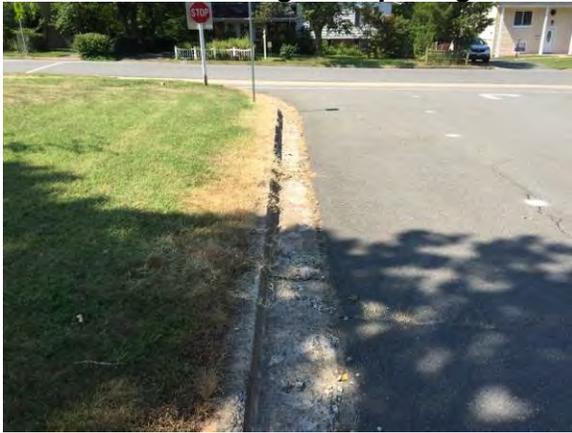
**Poor drainage/stabilization causing erosion near modular learning center**

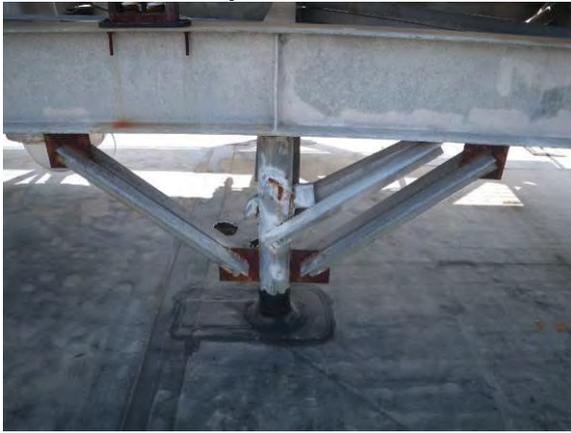
Interior bearing walls are in good condition, but exterior lintels need to be cleaned and painted. There are no control joints in the exterior corner masonry walls at the gymnasium and some hairline cracks are starting to appear.

**Exposed steel**

- Exposed steel lintels and dunnage steel – cleaning and painting
- Cooling tower dunnage – cold galvanizing and painting
- Base isolators on cooling tower – replacement needed due to corrosion and malfunction

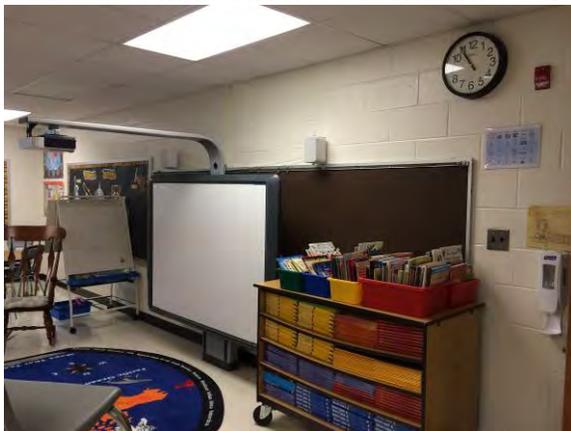
**Chalkboards not converted to marker boards**

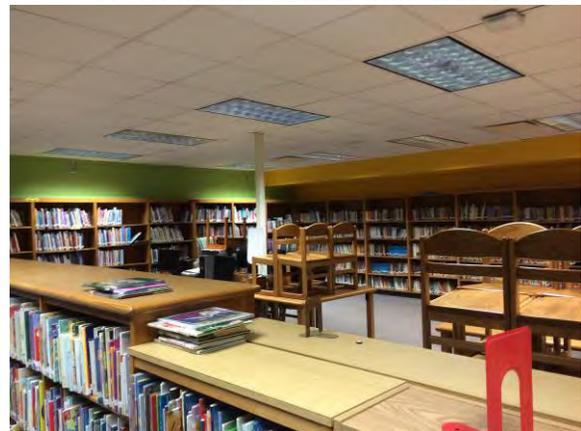
**Worn media center casework**

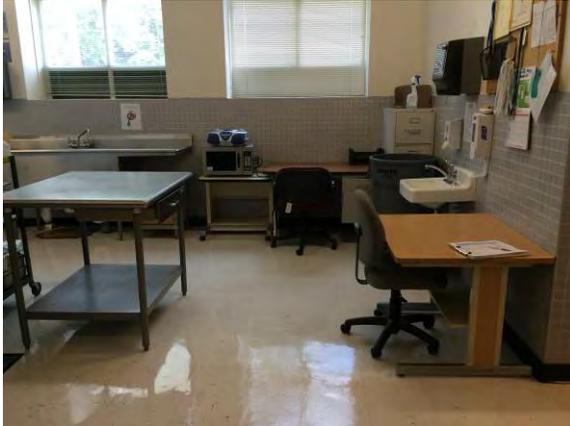
**No kitchen office**

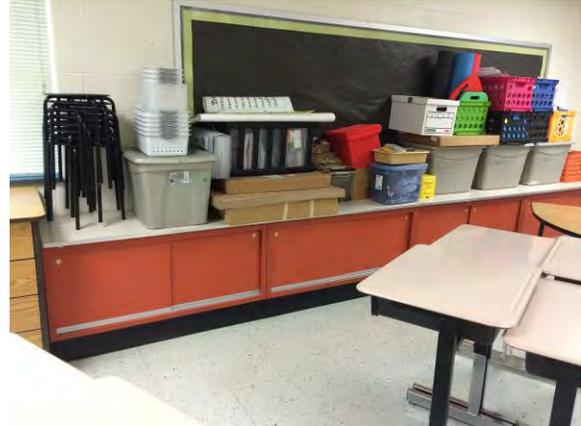
**Worn classroom casework**

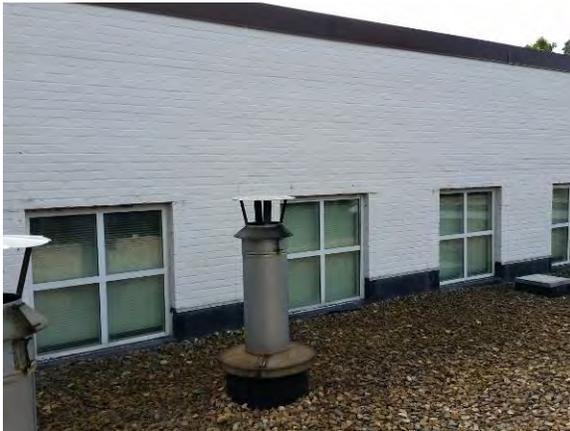
The interior bearing walls are in good condition. Both lintels and dunnage steel were in good condition, but need to be cleaned and painted. The roof screen steel was all galvanized and in good condition.

**Corroded steel lintels**

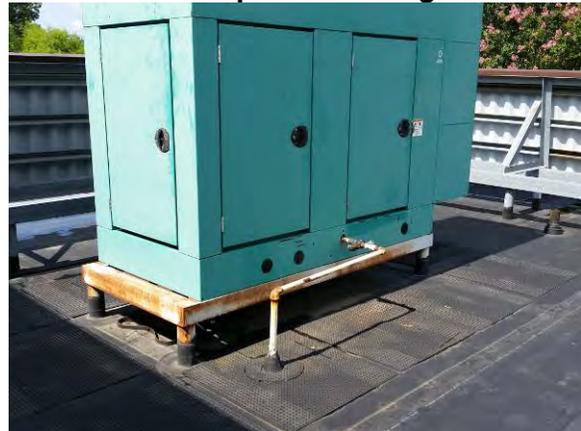
**Corroded exposed dunnage steel**

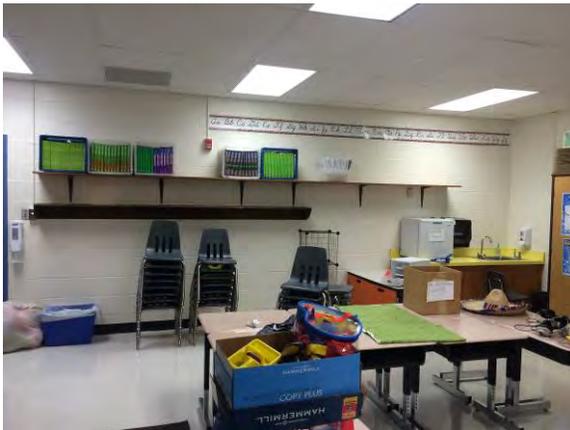
**Worn classroom casework**

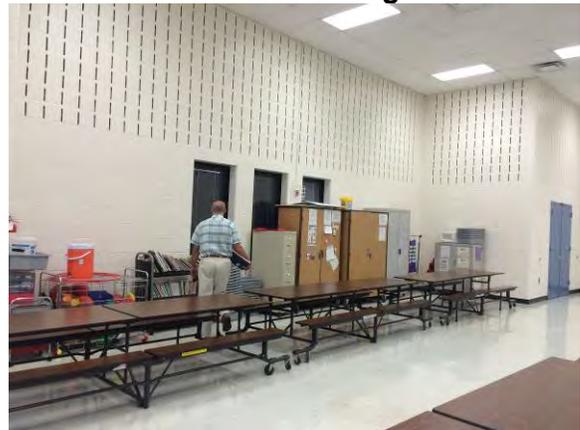
**Before and after care storage in cafeteria**

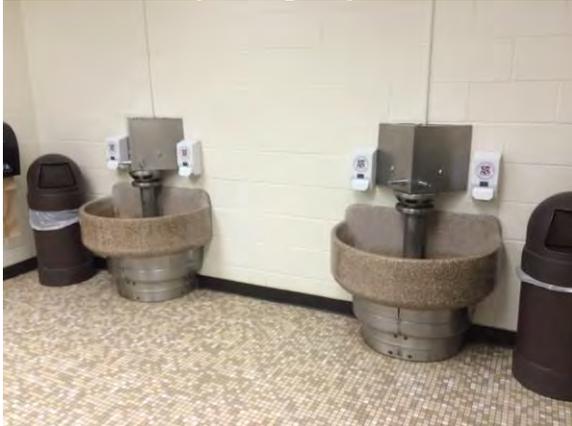
**Non-ADA compliant group restroom sinks**

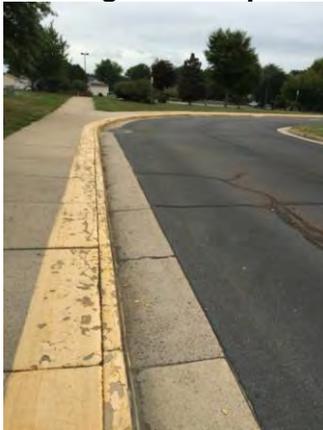
**Peeling fire lane paint**

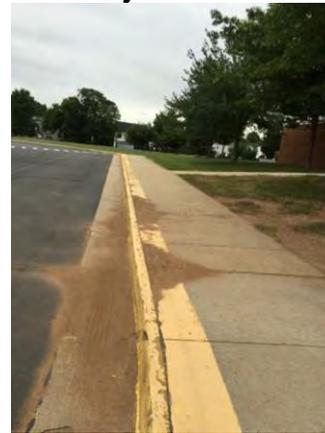
**Erosion adjacent to bus loop**

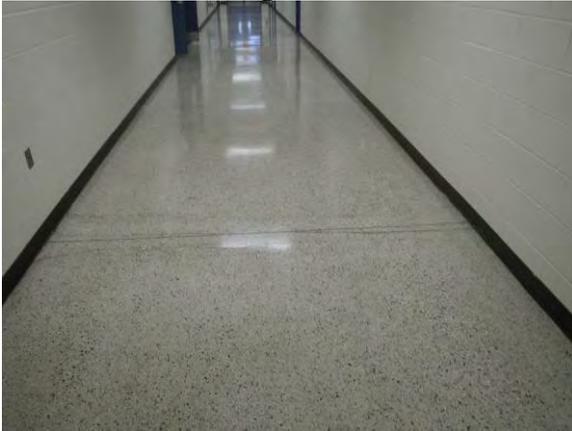
The interior bearing walls are in good condition. There are cracks in a number of floor slabs; however cracks do not appear to be recent, nor are there signs of differential movement. The parapet tile band is showing signs of age. Additionally, cracking mortar joints are in need of repair and all exterior lintels need to be cleaned and painted.

**Flooring – cracked**

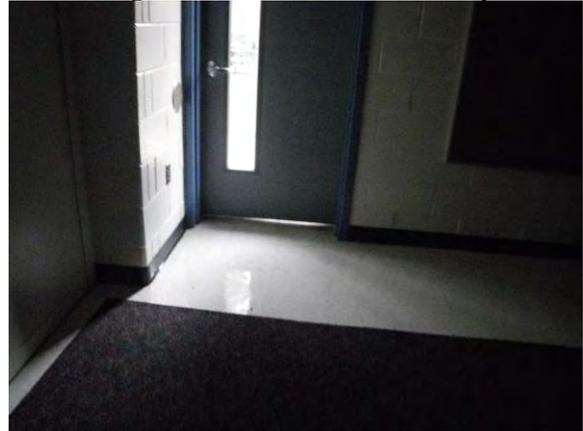
**Kindergarten door- not weather proof**

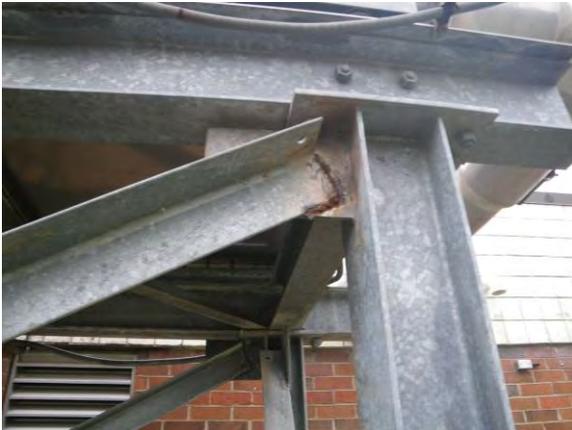
**Cooling tower - welds need to be galvanize painted**

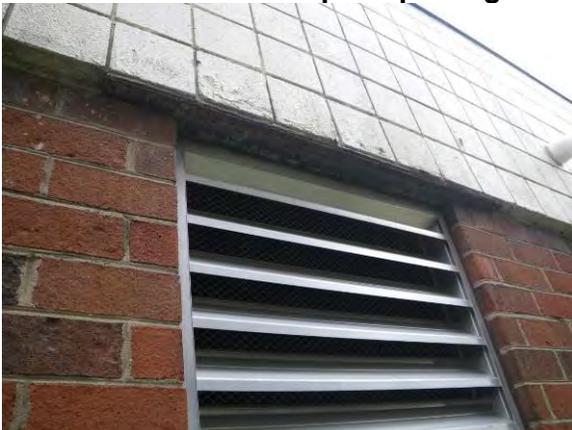
**Lintel rusted and paint peeling**

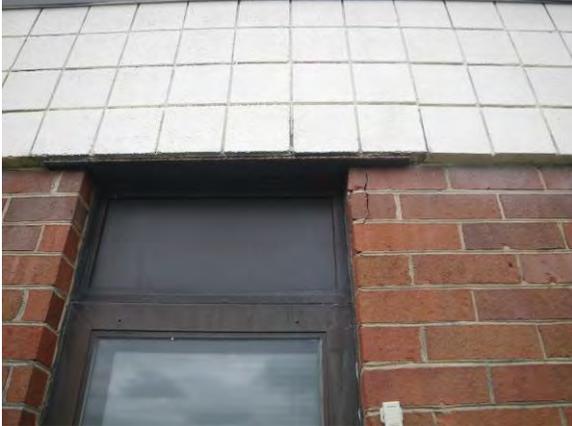
**Façade crack; lintel rusted and paint peeling**

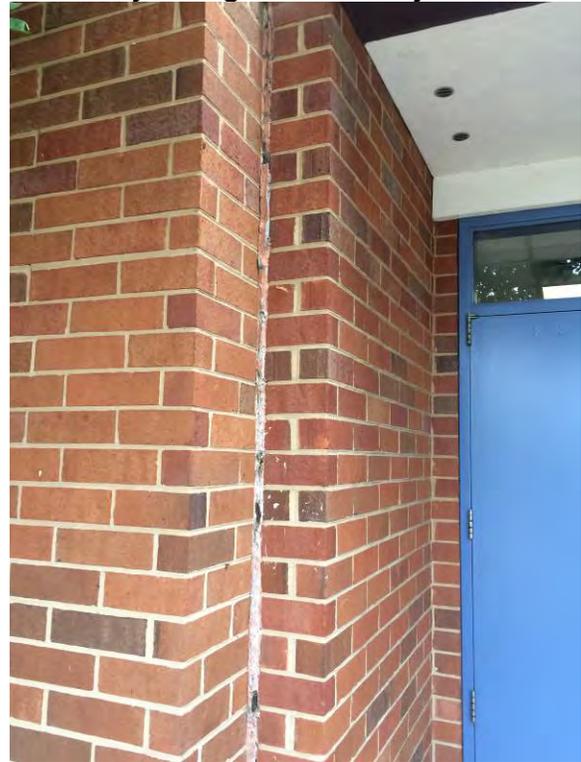
**Dryrotting EJs and CJ joints**

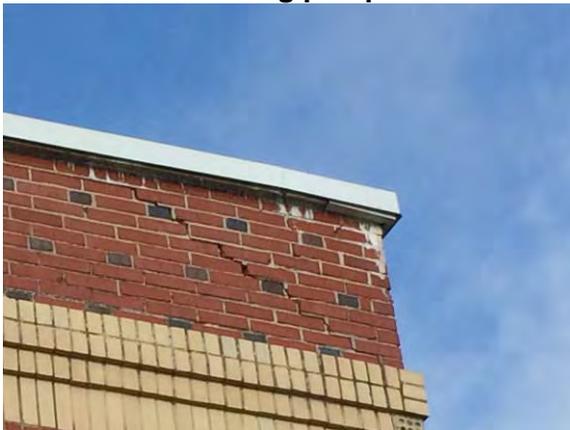
The facility received an overall score of 98 out of a possible 250. The two story structure is showing signs of aging and there are several areas where decay is evident. Specifically, wood rot at roof eaves and masonry mortar deterioration exist around the building. Resource rooms and guidance offices are in the basement and have minimal natural light. The school is currently utilizing two modular building as classrooms. The roof and windows were replaced within the last 10 years; however cracking was noted on the parapet.

**Cracking parapet**

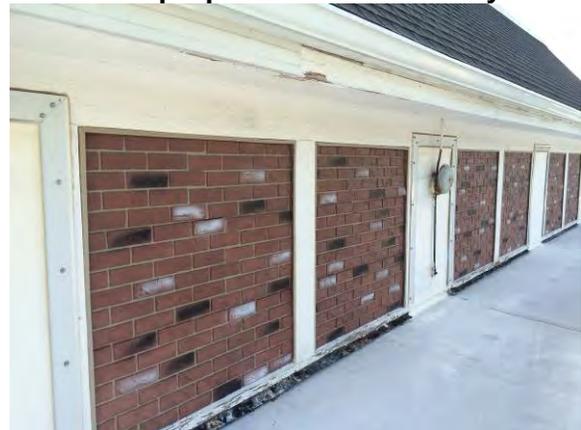
**Faux brick (plastic) and wood rot at multipurpose room clerestory**

- Wood framing – repaired and replaced; especially at roof eaves at the multi-purpose room
  - Further investigation of lally column added in storage room to support basement floor is recommended. The framing in this area was modified to accommodate ongoing MEP system upgrades
- Exterior steel lintels - cleaned and painted
  - East side exterior lintels – repaired/replaced due to significant corrosion
  - Basement door lintel – repaired/replaced due to shear crack
- Brick face – continued shearing could lead to long-term distress in structure

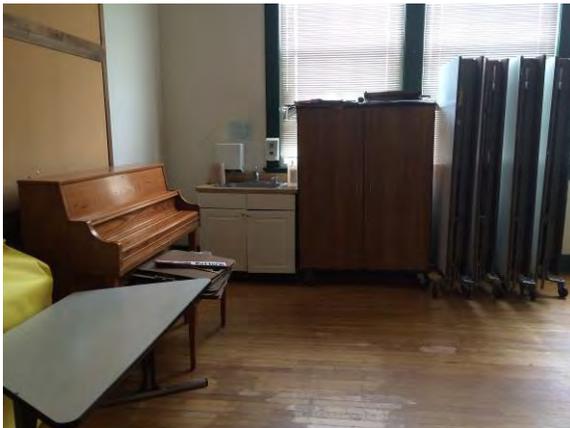
**Old and worn casework**

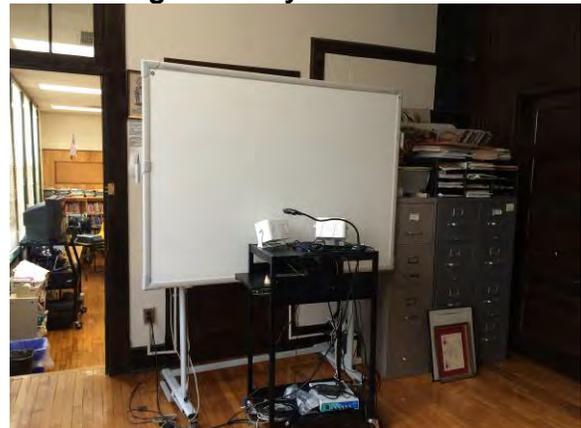
**Stage used by media center**

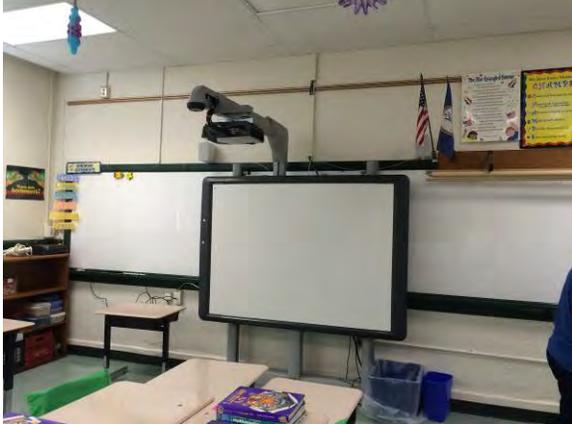
**Chalkboards converted to marker boards**

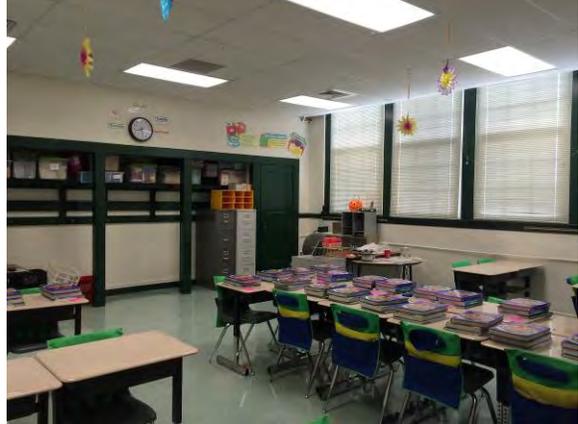
**Classroom storage**

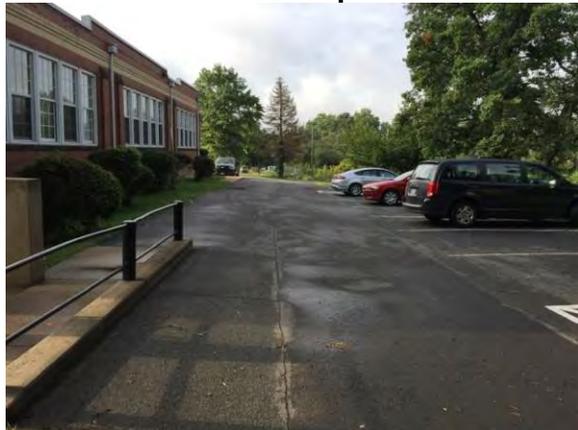
**Bus loop**

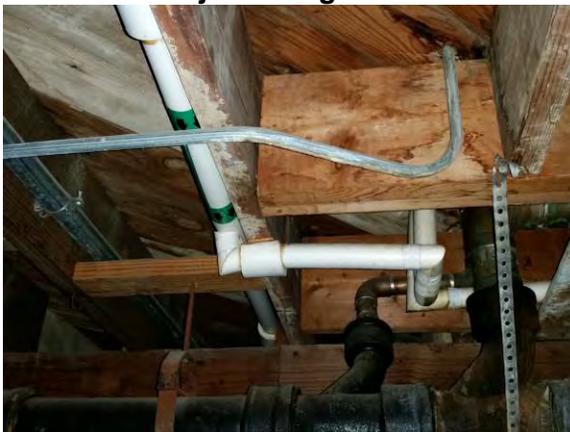
**Toe-nailed wood framing with no joist hangers**

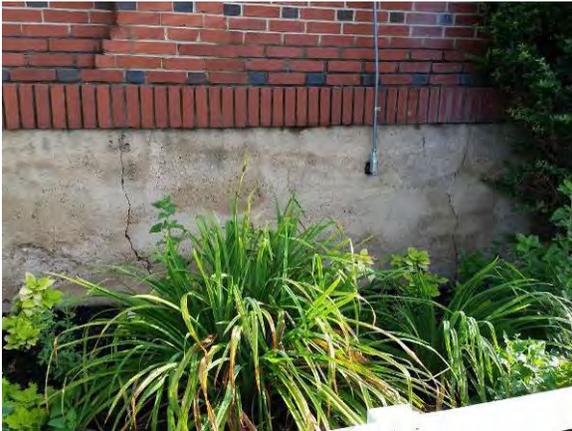
**Foundation settlement cracks**

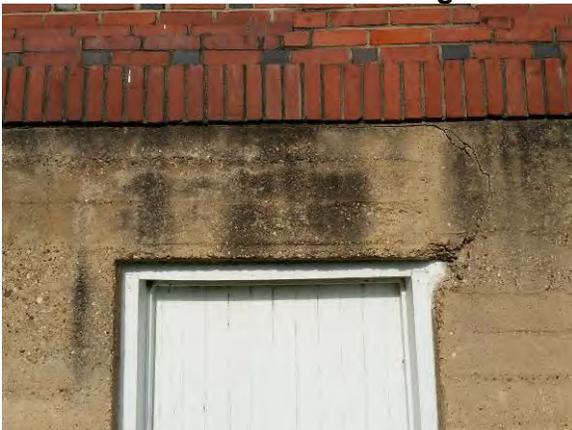
**Shear crack at lintel bearing end**

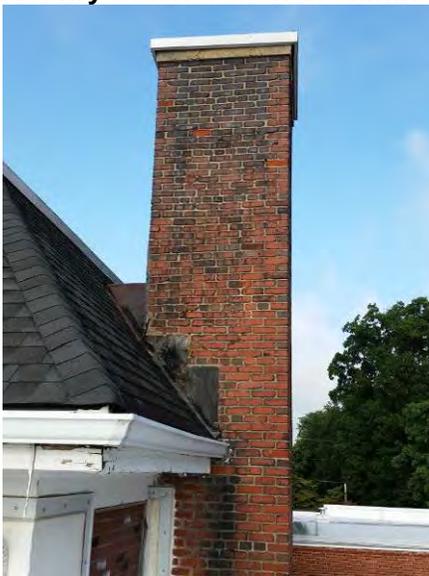
**Masonry deterioration at chimney**

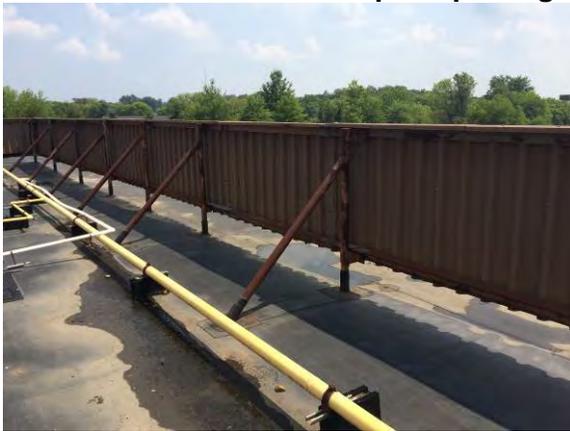
**Roof screens rusted and paint peeling**

- Needed to meet full ADA compliance:
  - 18” vertical grab bar in toilet rooms
  - ADA stalls
  - Administration front counter
- Needed to meet LCPS facility requirements:
  - Dedicated toilet rooms for 1<sup>st</sup>, 2<sup>nd</sup> and special ed classrooms
  - Roof screens – recommend considering replacement when roof system is replaced
