# COUNTY OF LOUDOUN

### **March 2, 2016 BUDGET WORK SESSION SUPPLEMENTAL PACKET**

- Board Questions Response Supplemental Packet #1 – LCPS Questions
- Budget Question Database as of 03/02/2016

Questions from Chair Randall..... 1  
Questions from Supervisor Volpe.....1  
Questions from Supervisor Letourneau.....25  
Questions from Chair Randall.....27  
Questions from Supervisor Higgins.....29  
Attachment to Question 8 (Volpe), *Loudoun County Public Schools Facility Assessment Study*.....46

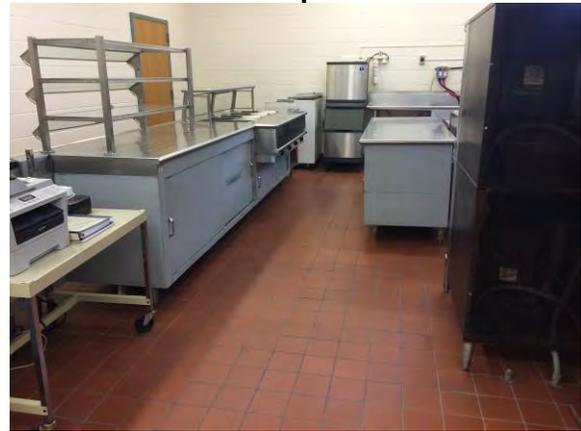
**Kitchen cabinet paint scratched**

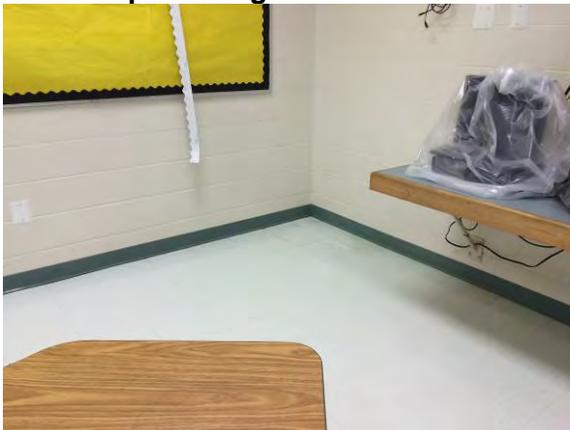
**VCT puckering at corner of room**

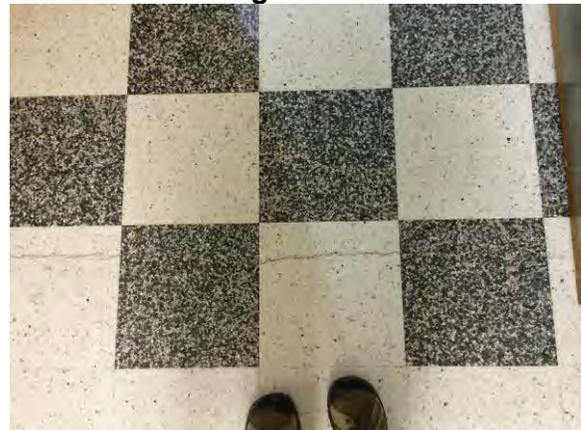
**Cracking terrazo floor**

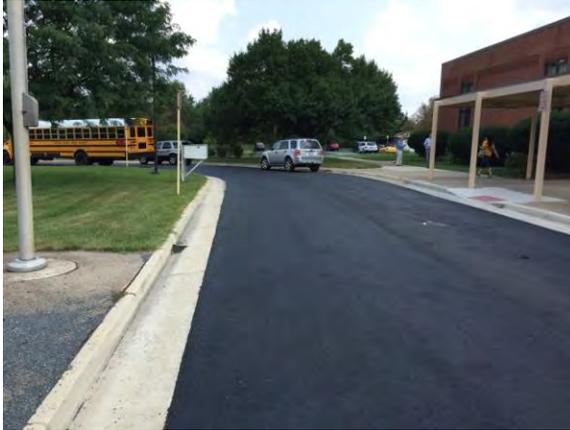
**Bus loop was recently repaved**

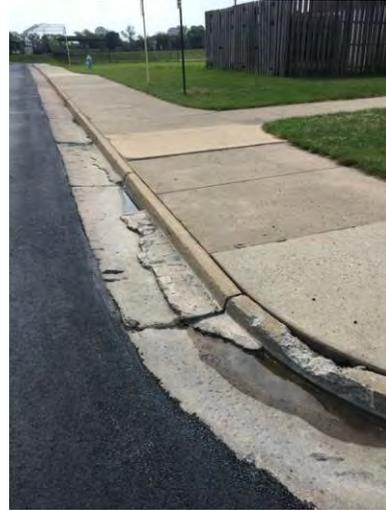
**Curb and gutter deterioration at parent drop-off**

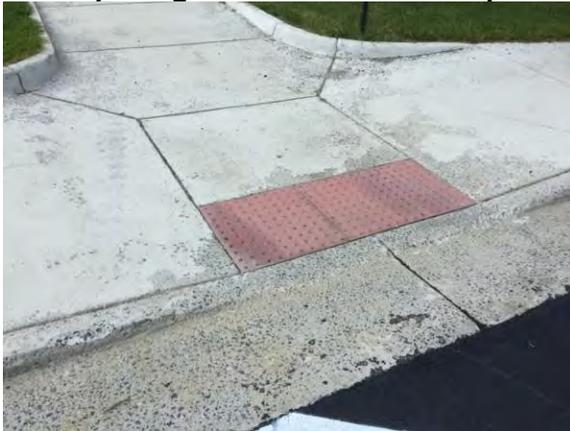
**Spalling concrete at curb ramp**

- Sidewalks/curbs – spalling concrete
- Bus queuing – the principal noted that the buses double-up on the bus loop
- Parking – based on our discussion with the principal, this was the most significant site issue; parking is adequate for faculty but not for volunteers/visitors

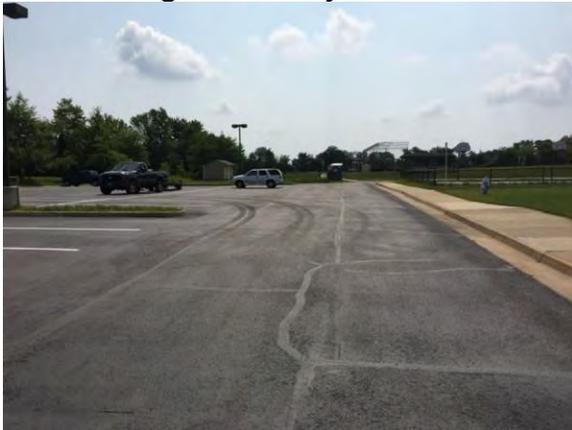
**Parking lot recently seal coated**

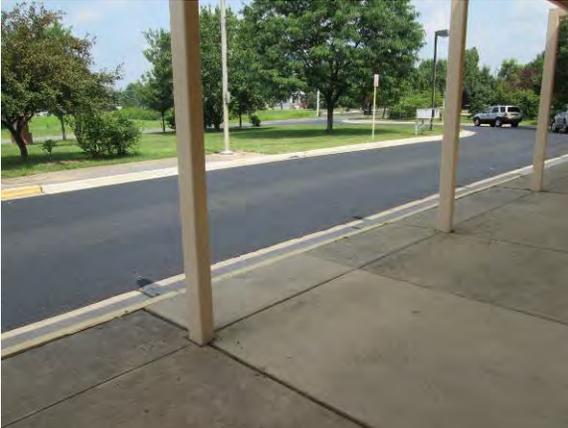
Entrance canopy columns

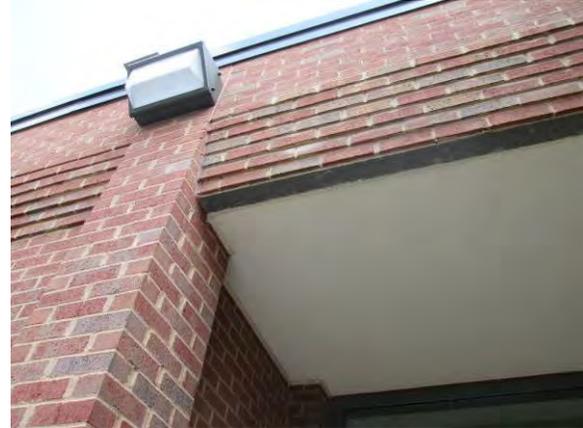
Lintels rusted and peeling paint

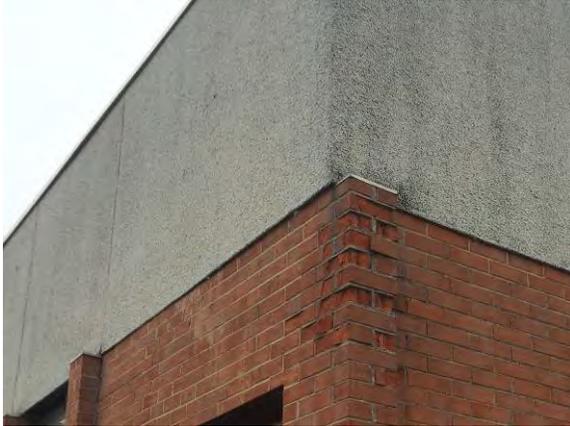
**Brick spalling**

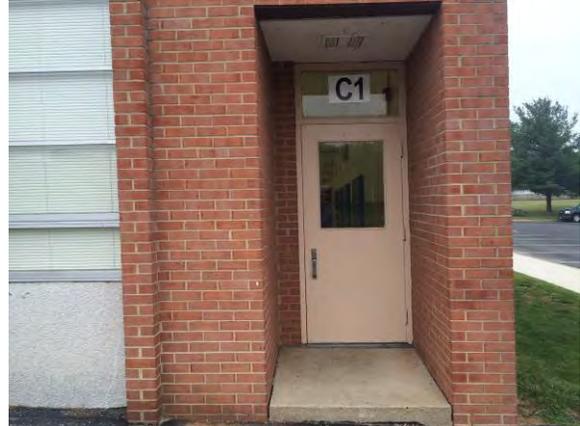
**Non-ADA compliant exit**

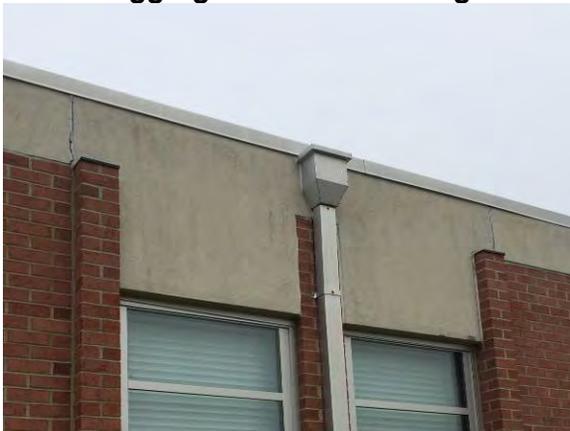
**Aggregate fascia cracking**

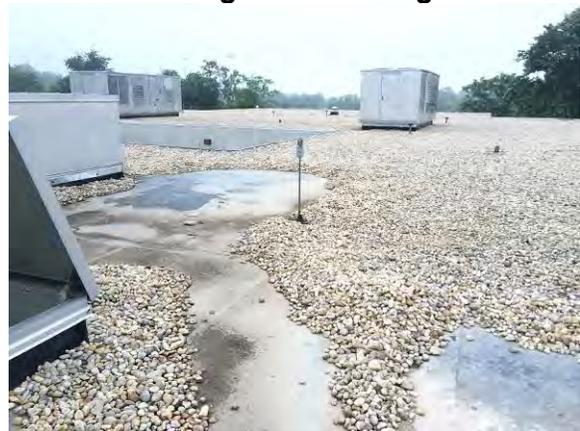
**Roof drainage and flashing issues**

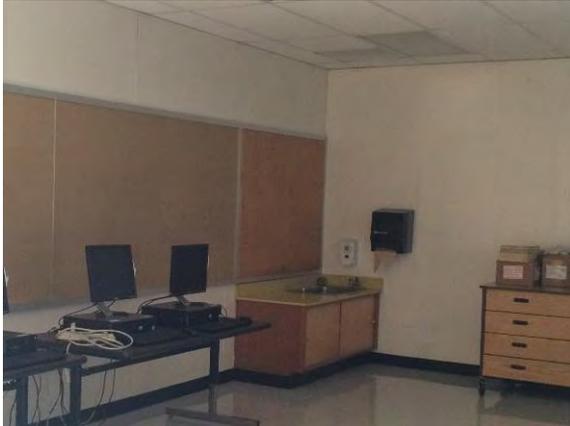
**Worn classroom casework**

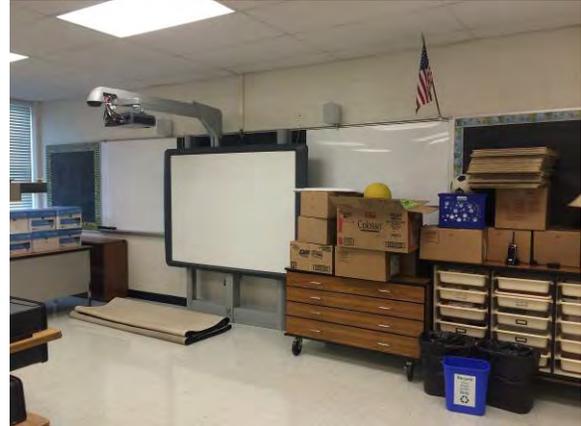
**Chalkboards converted to marker boards**

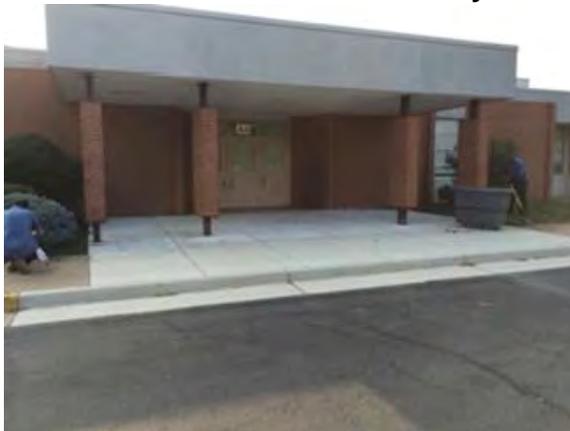
**New sidewalks at main entry**

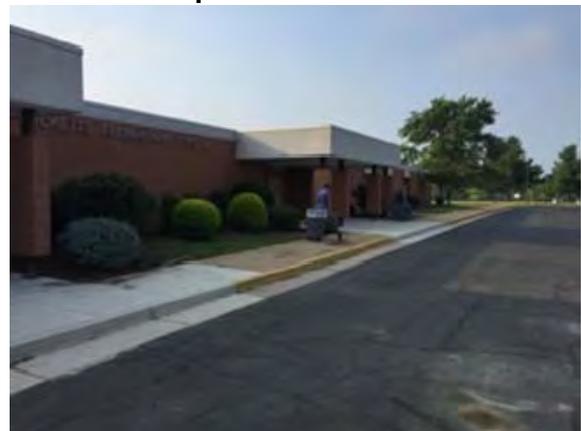
**Bus drop-off at front of school**

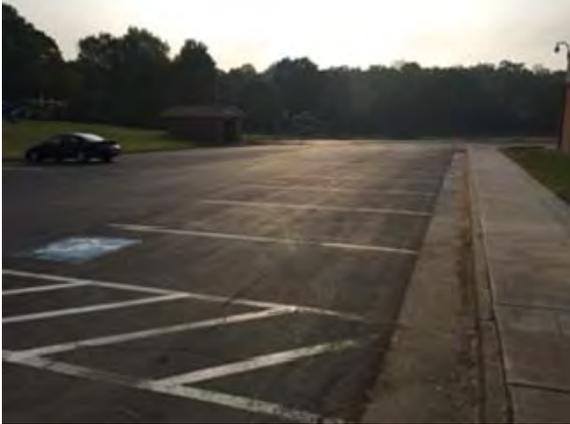
**Parent drop-off on north side of building**

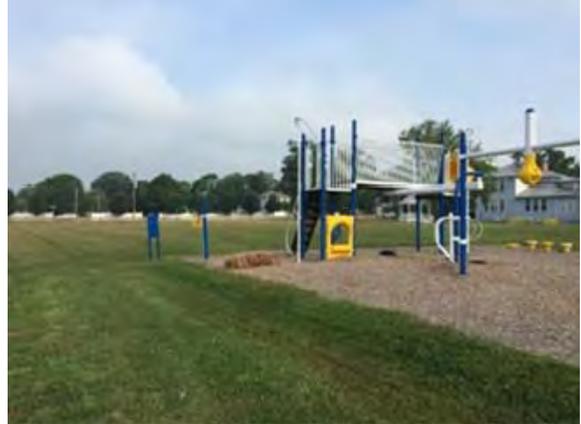
**Playground on north side of building**

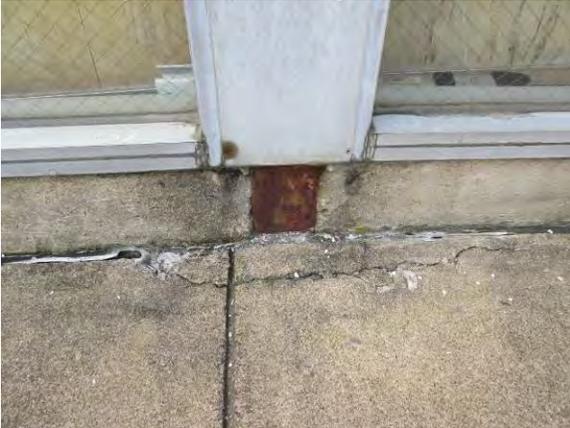
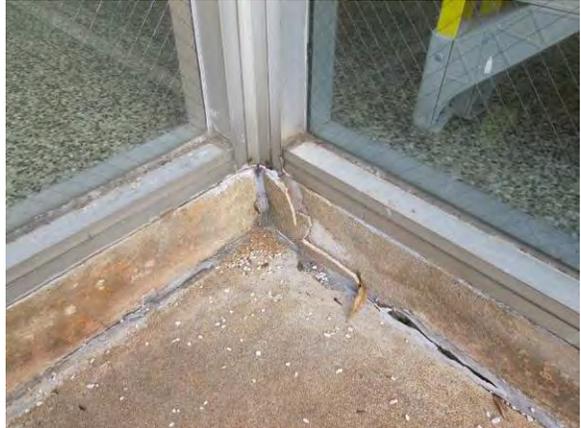
**Courtyard column exposed at base**

- Steel columns
  - At courtyard roof structure - exposed and corroding; continued corrosion can lead to the loss of structural integrity and failure.
  - At main entry roof structure – corroded at base; supporting brick elements are cracked; continued corrosion can lead to the loss of structural integrity and failure.
- Exposed steel should be cleaned and painted

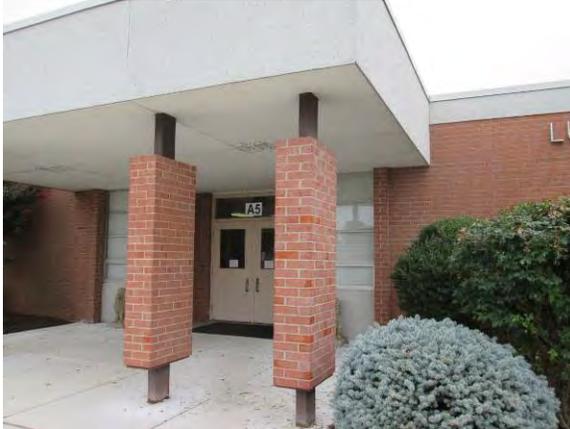
Front entry columns and brick feature

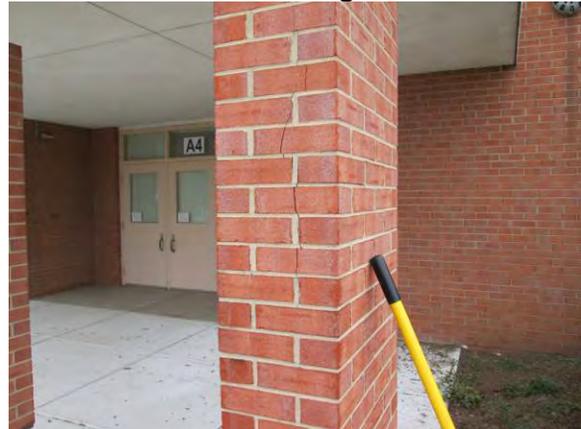
The interior bearing walls are in good condition; however the exterior walls show signs of age and weathering. Specifically, there is cracking at the front entry columns. The exposed steel around various areas of the building is rusting and the paint is peeling off.

Front entry columns and brick feature cracking

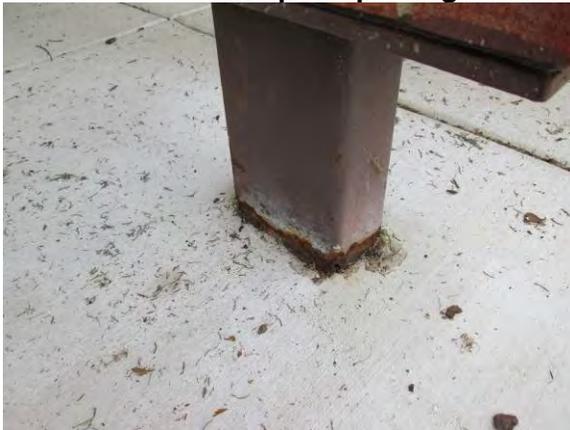
Front entry columns and brick feature rusted and paint peeling

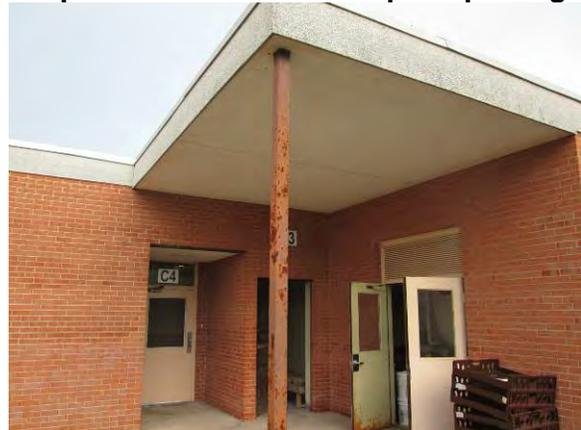
Exposed steel rusted and paint peeling

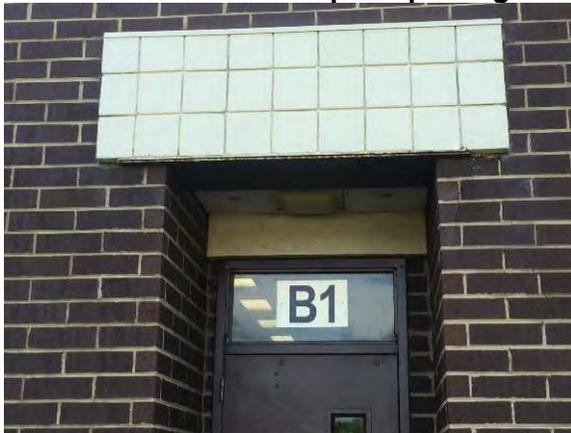
**Lintles rusted and paint peeling**

A number of exterior lintels need to be cleaned and painted. Additionally, there are no control joints in the exterior corner masonry walls some hairline cracks are starting to appear.

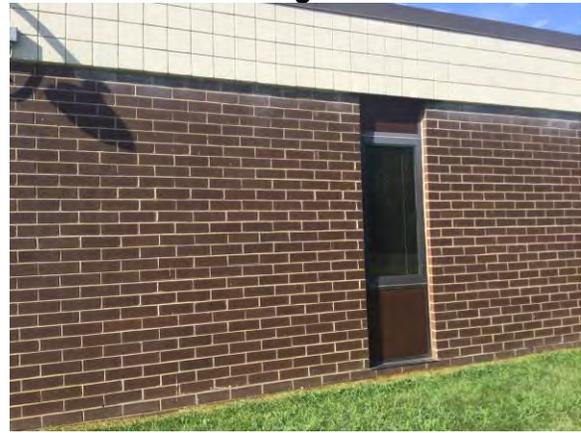
**CMU color leaching onto brick below**

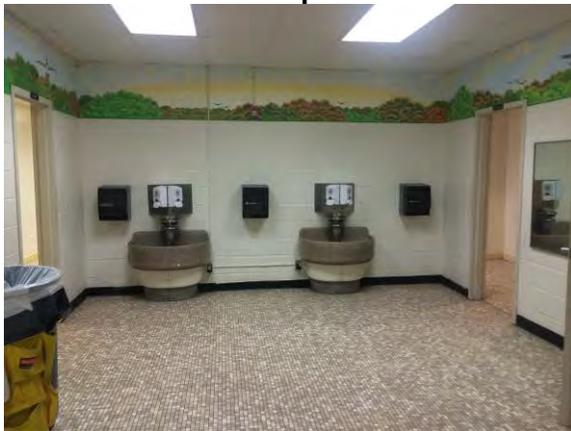
**Inefficient use of space in restroom**

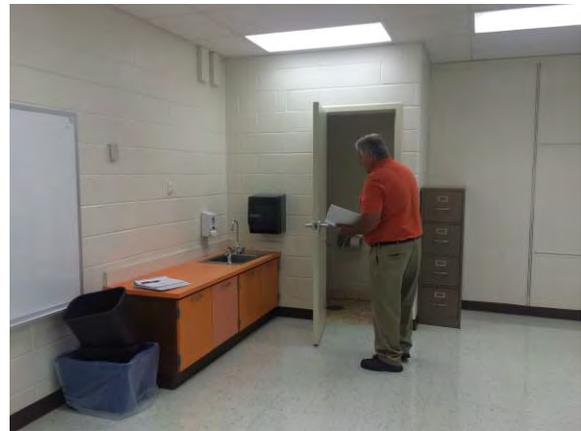
**Old and worn casework**

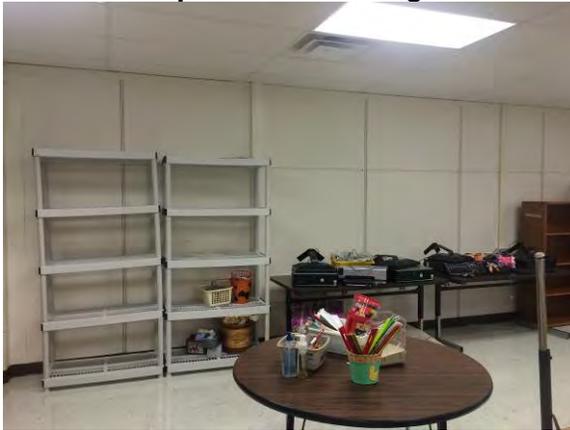
**Movable partitions no longer used**

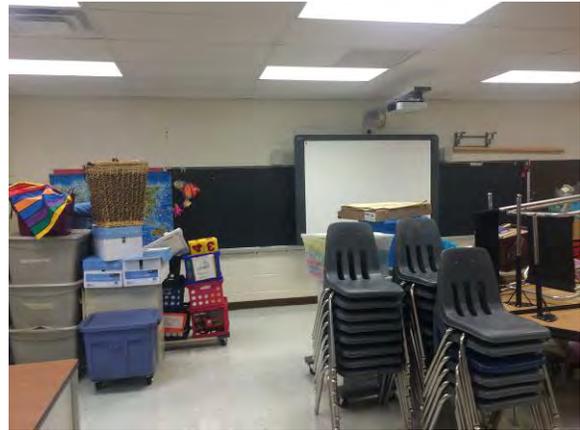
**Chalkboards not converted to markerboards**

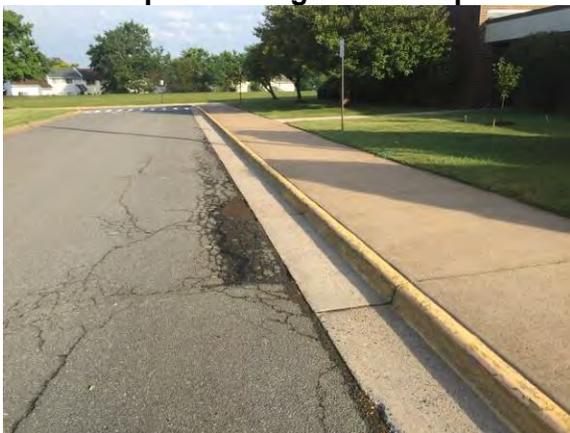
**Asphalt failing at bus loop**

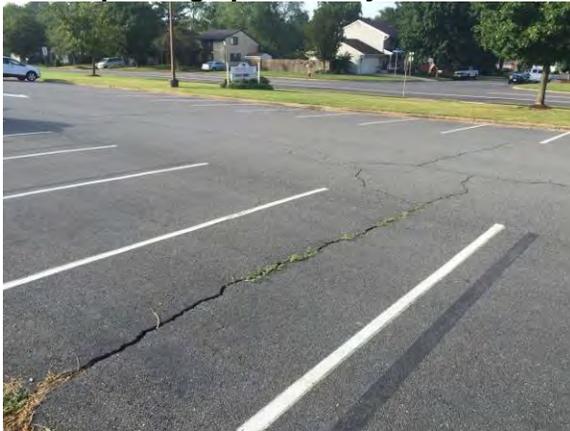
**Parking area asphalt cracking;  
parking spaces only 8' wide**

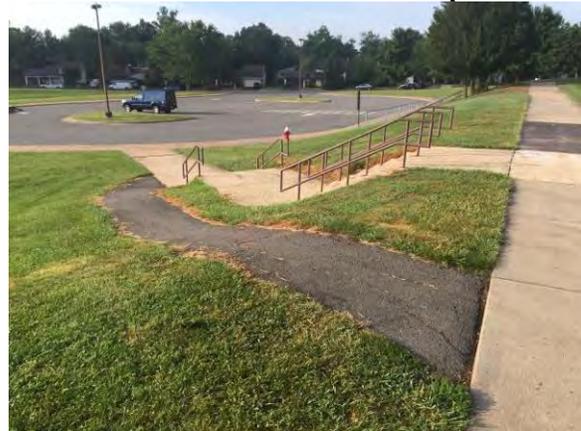
**Grade difference between building and  
kiss-and-ride non-ADA compliant**

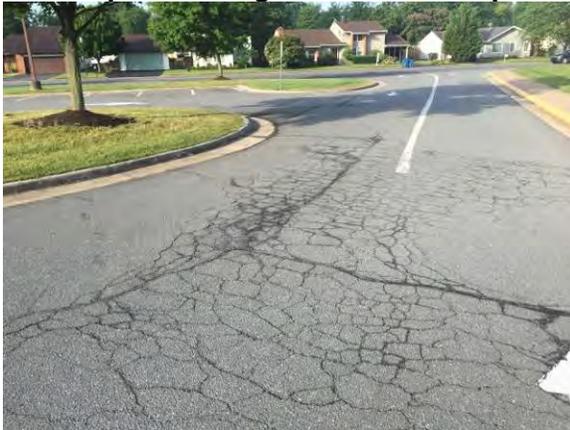
**Asphalt failing at front bus loop**

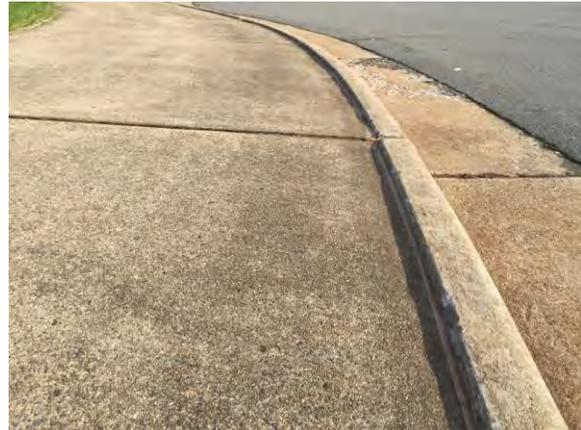
**Concrete settlement at kiss-and-ride area**

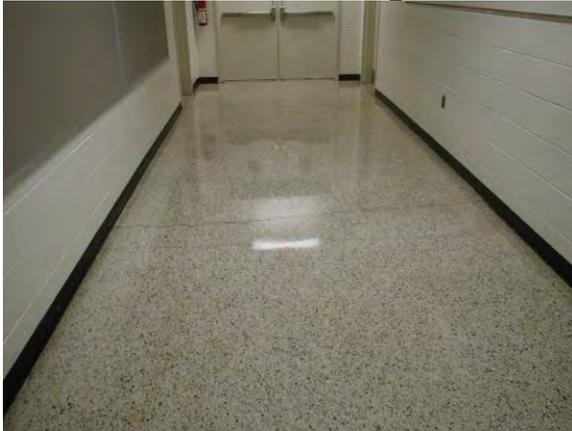
The interior bearing walls are in good condition; however there are a number of cracks in the flooring. The cracks do not appear to be recent and there is no differential settlement.

**Cracked flooring**

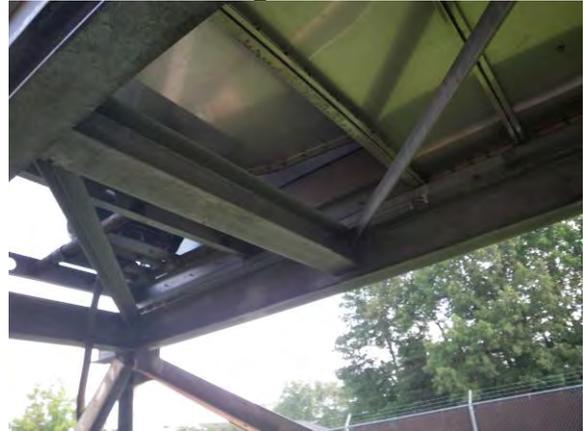
**Cooling tower steel**

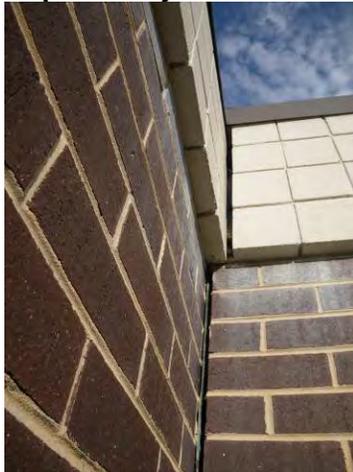
**Courtyard expansion joint lacks caulk**

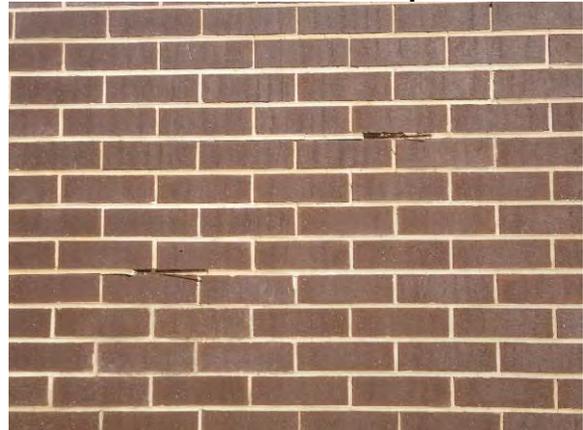
**Mortar deterioration and exposed wire**

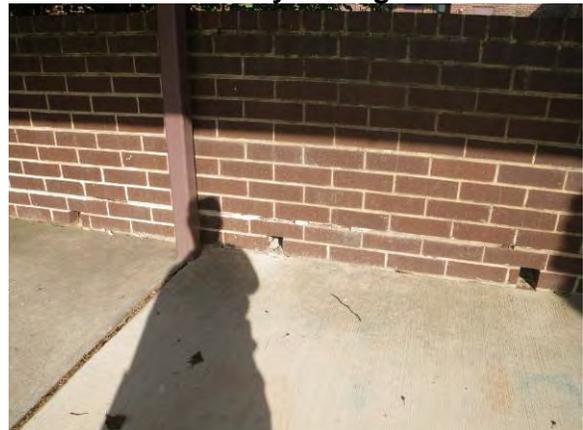
**Breezeway and kindergarten courtyard masonry damaged**

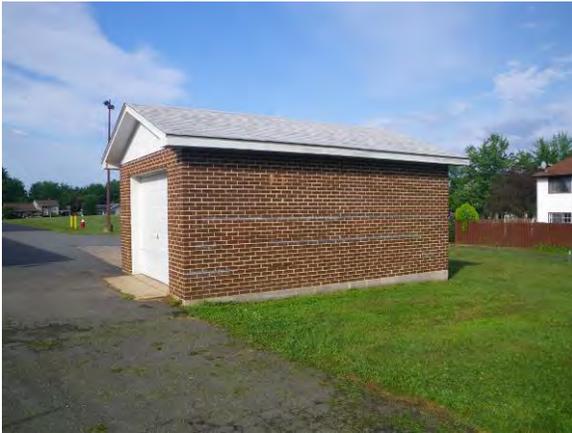
**Shed masonry joint issues repaired with caulk and not mortar**

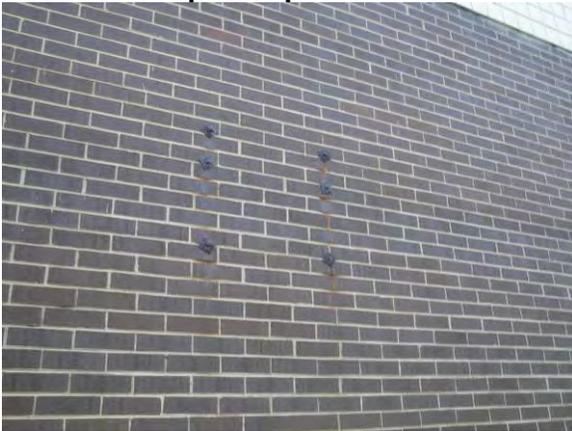
**Corroded bolts at basketball backboards require replacement**

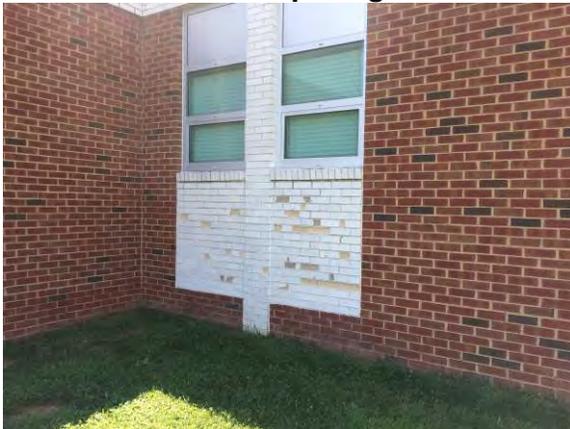
**Brick spalling**

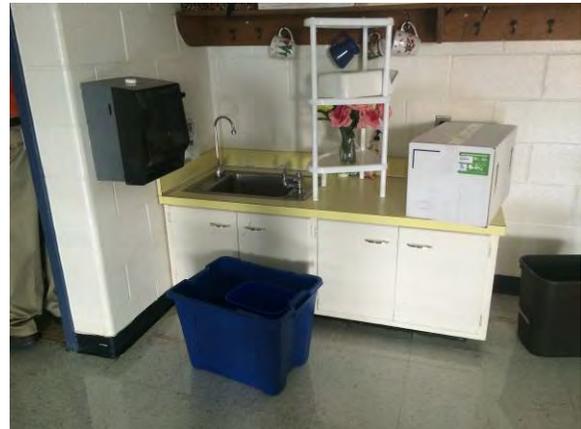
**Worn casework**

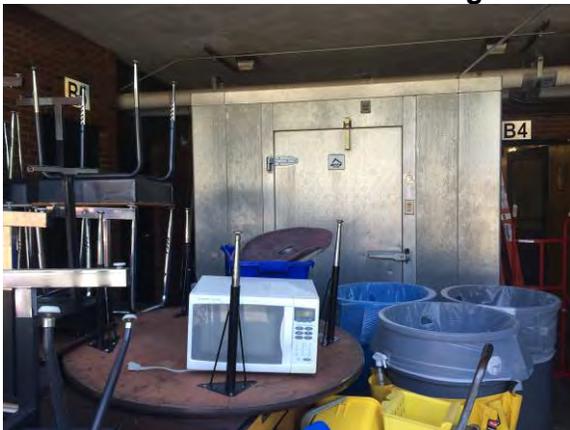
**Walk-in freezer located at loading dock**

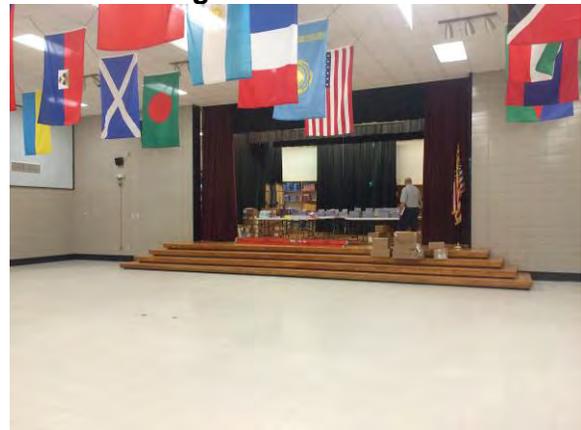
**Stage lacks handrails**

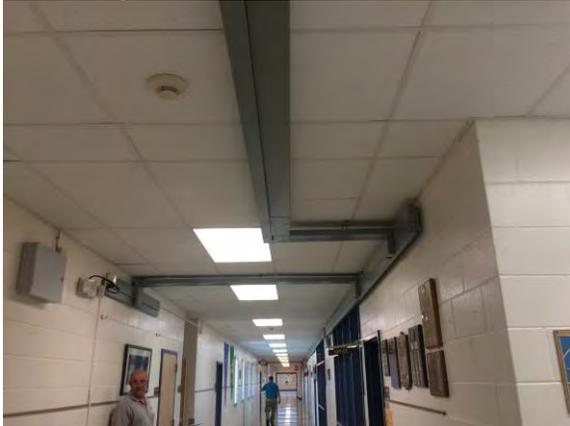
**Exposed wiremold in corridor**

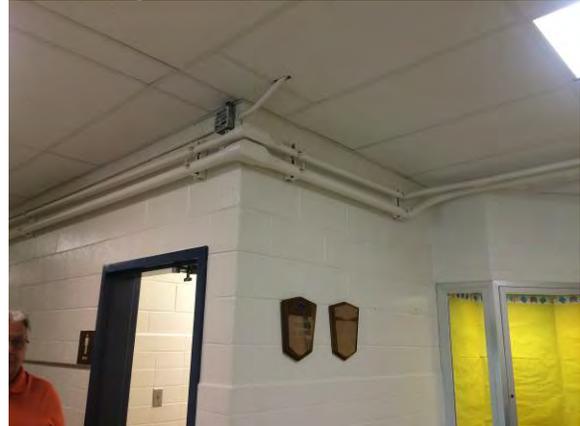
**Exposed conduit in corridor**

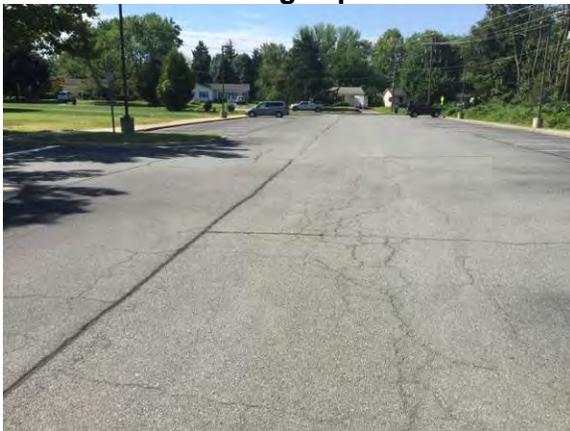
**Cracking asphalt**

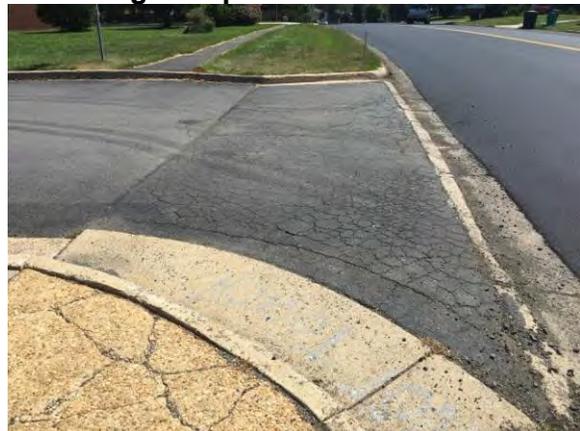
**Damaged asphalt at front of school**

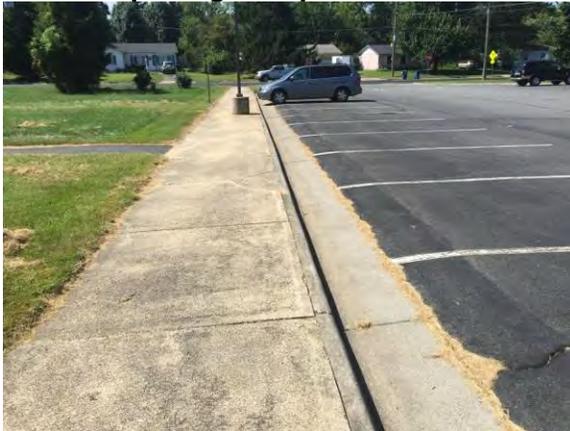
**Open sidewalk seams at asphalt/gutter pan interface**

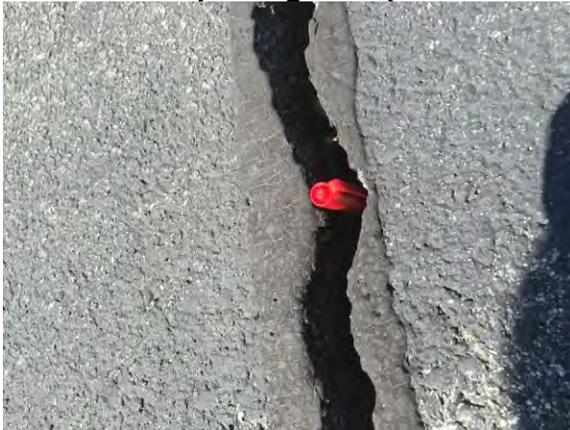
**Significant cracking in front parking lot asphalt**

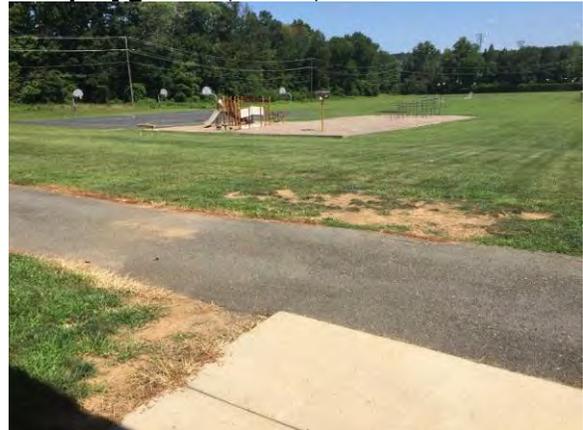
**Plentiful greenspace, but lacking substantial playground, track, small ballfield**

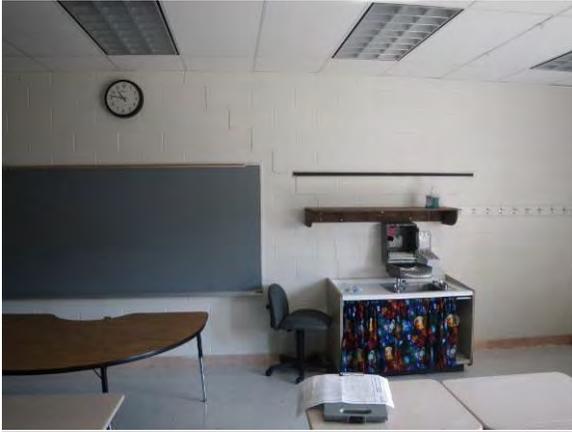
The interior bearing walls are in good condition; however there is one diagonal crack in a classroom which needs further investigation. On the exterior of the building, there are a number of cracks in the façade in the courtyard. There are no control joints in the exterior corner masonry walls, but no additional cracking was visible.

**Cracking bearing wall at rear east-west corridor classroom near courtyard**

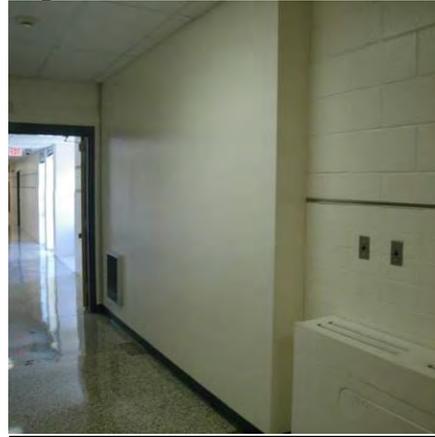
**Bearing wall crack viewed from corridor**

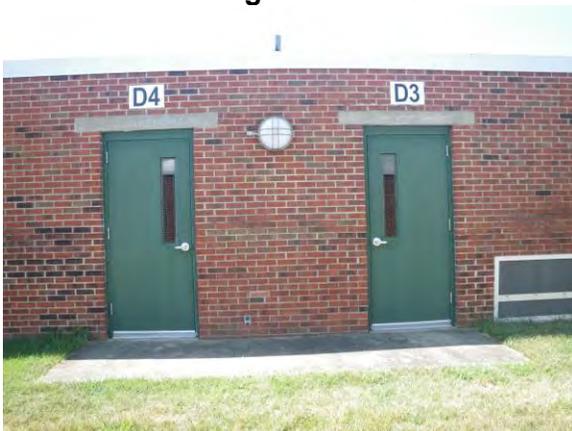
**Precast awnings cutoff at kindergarten doors**

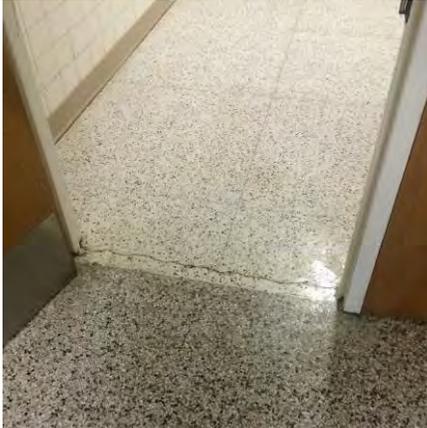
**Cracking terrazzo floor**

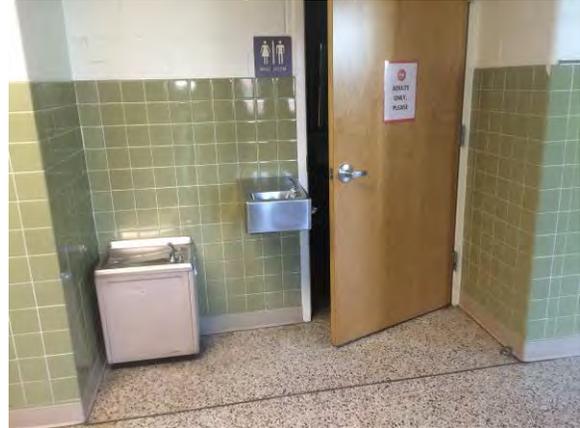
**Non-ADA compliant water fountains**

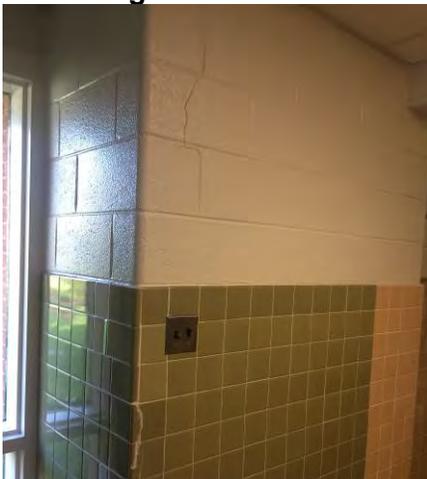
**Cracking wainscot and CMU**

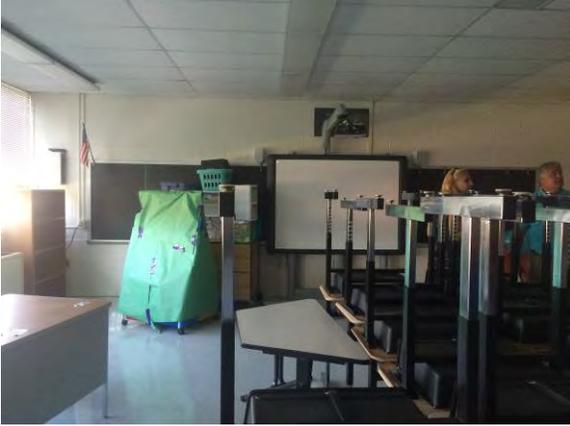
**Chalkboards not converted to marker boards**

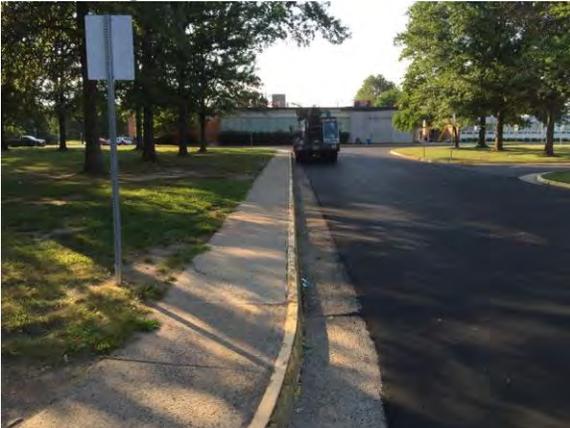
**Recently repaved asphalt at bus loop;  
original curbs and sidewalks**

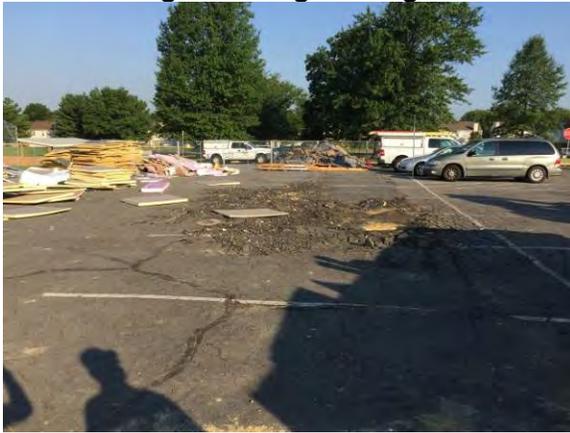
**Asphalt parking area repaired after damaged during roofing work**

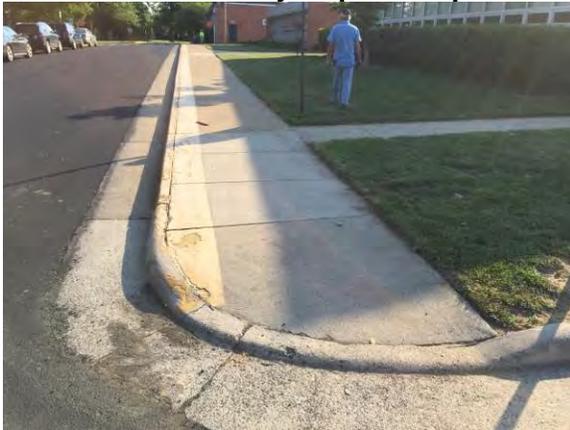
**Site accessibility requires repairs**

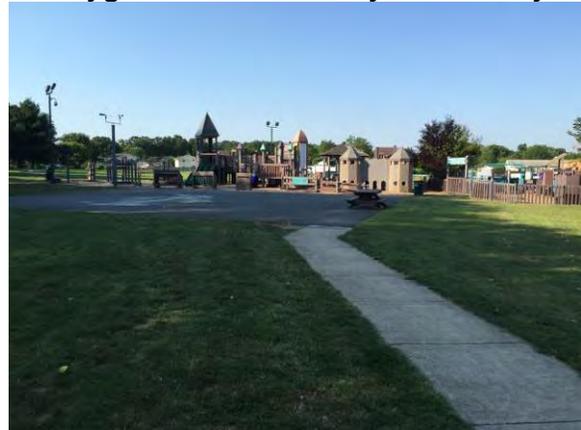
**Playground well used by community**

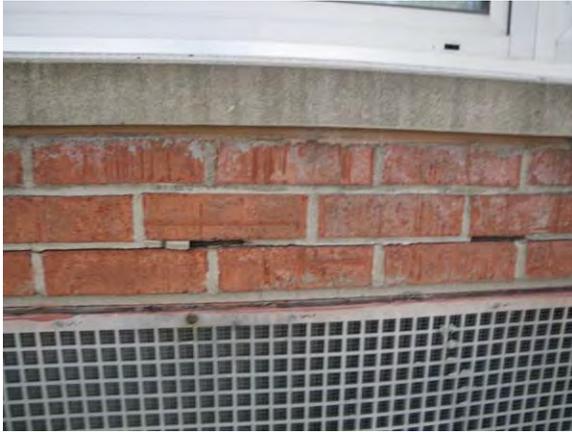
**Mortar deterioration and exposed wire**

- Precast concrete awnings – causing cracking in exterior brick façade; movement of awnings is likely continuous
- Gym corner settlement – appears to have stopped, but should be monitored
  - Mortar joint - repair needed above lintel; no real structural concern at this time
  - Stage door – not functioning properly due to settlement which damaged frame
  - Exterior masonry - may be affected by thermal movement due to lack of control joints in this area
- Through-wall A/C units in the courtyard – protrude beyond brick face; units have been caulked, but decay is evident and risk of water leaking is high
- Lintels – clean and paint

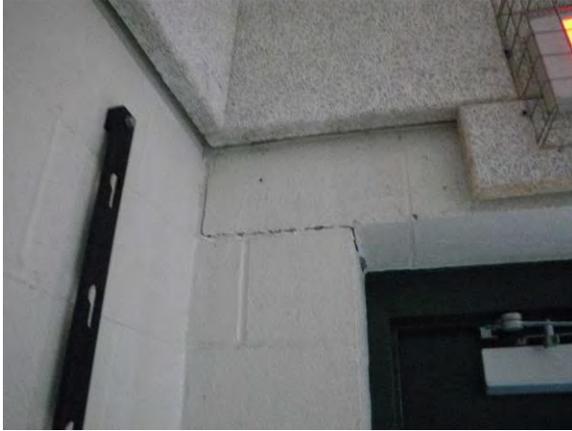
**Crack at end of lintel caused by settlement in corner of gym**

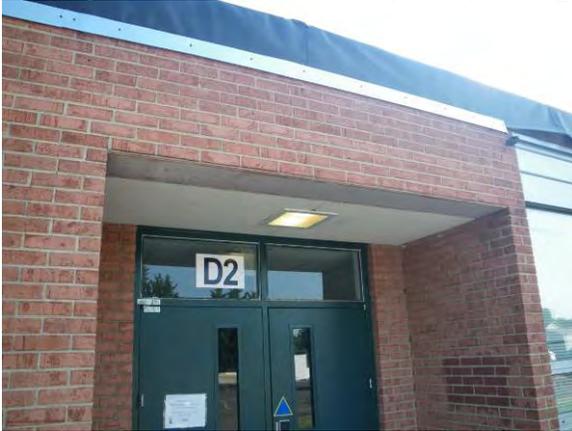
**Courtyard lintel rusted and paint peeling**

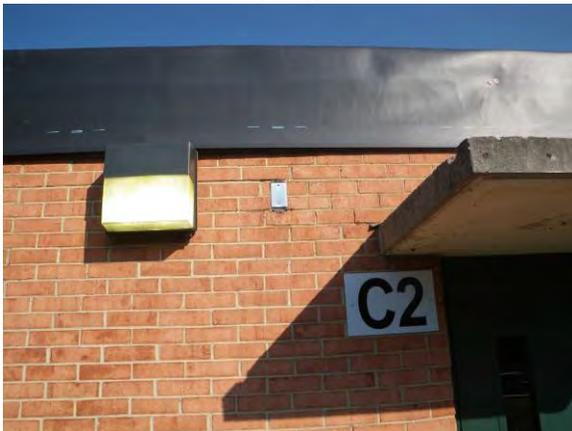
**Precast awning rotation causing façade cracks**

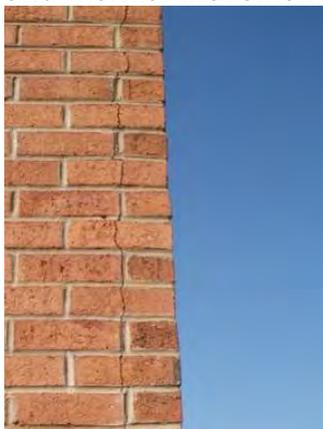
The interior bearing walls are in good condition; however exterior lintels need to be cleaned and painted. There are no control joints in the exterior masonry walls which caused cracking at the corners of the rear classrooms and gym walls due to thermal movement. Additionally, settlement at the corners of the gym was observed. The exterior door at the stage does not function properly and light is visible around the edges due to settlement.

**Façade cracks due to lack of control joints and thermal movement**

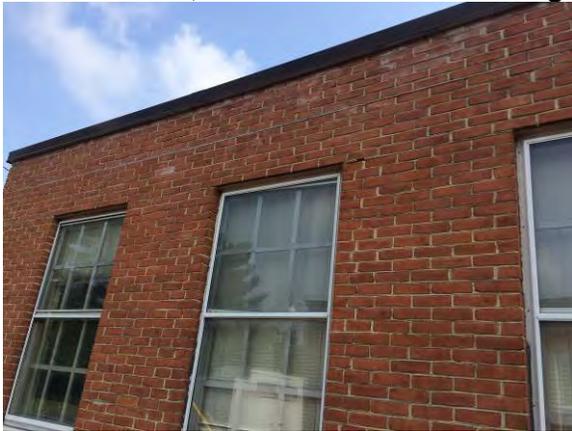
**Lintel rusted; brick mortar deteriorating**

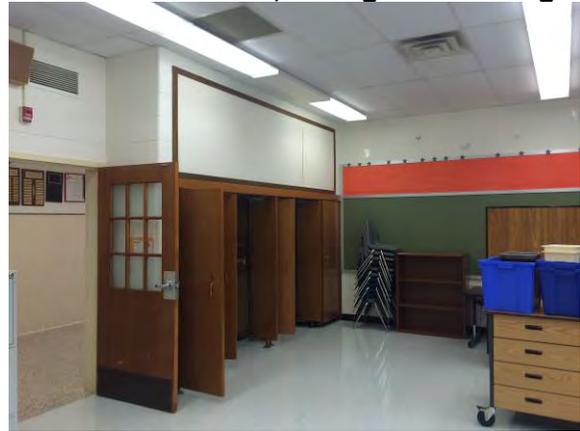
**Classroom doors, storage and ceiling**

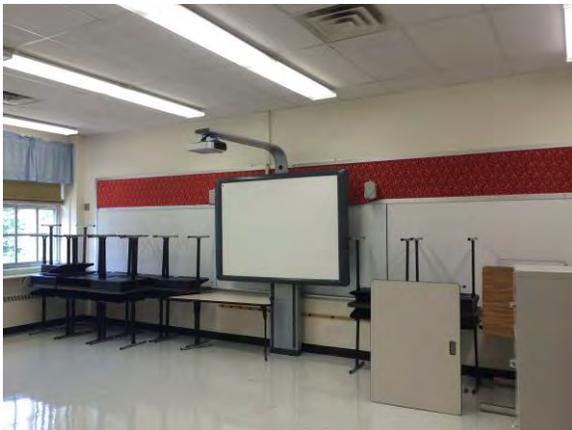
**Chalkboards converted to marker boards**

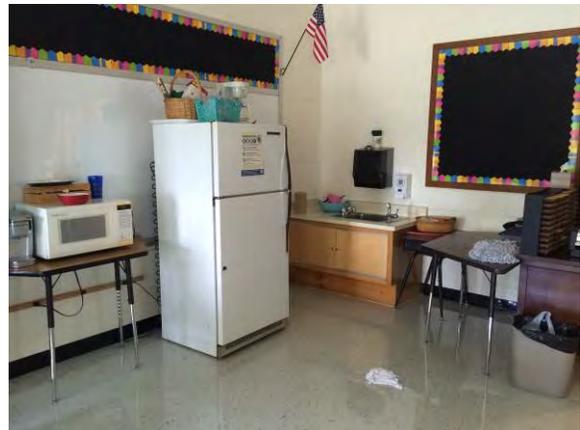
**Old and worn casework**

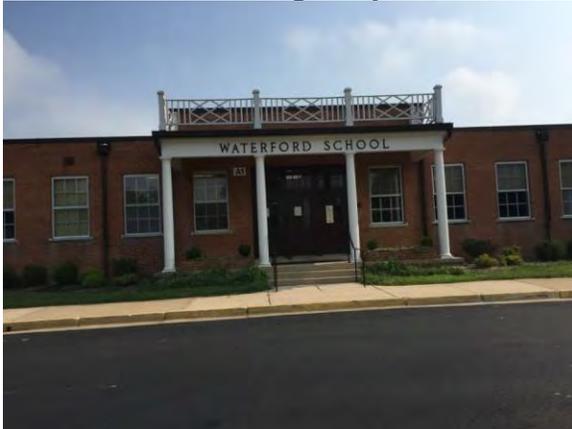
**Building entry**

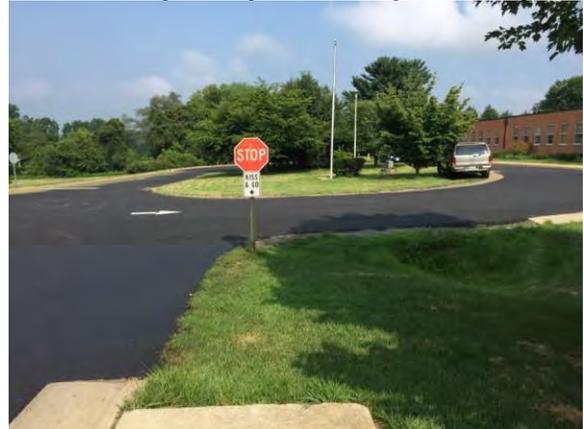
**Bus loop and parent drop-off entry**

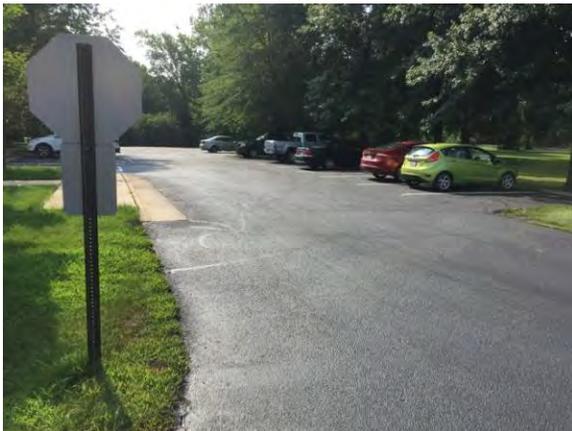
**Parent drop-off end of parking lot turn-around**

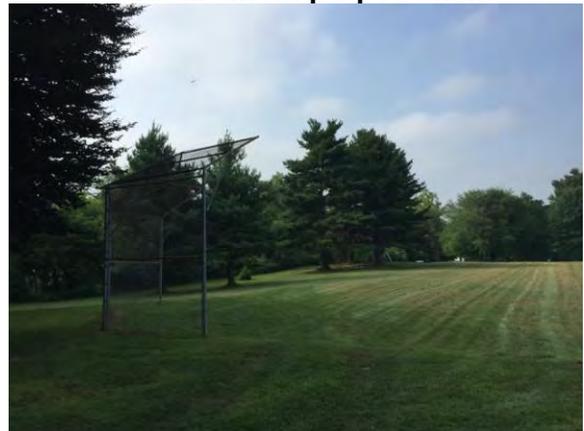
**Softball / multi-purpose field**

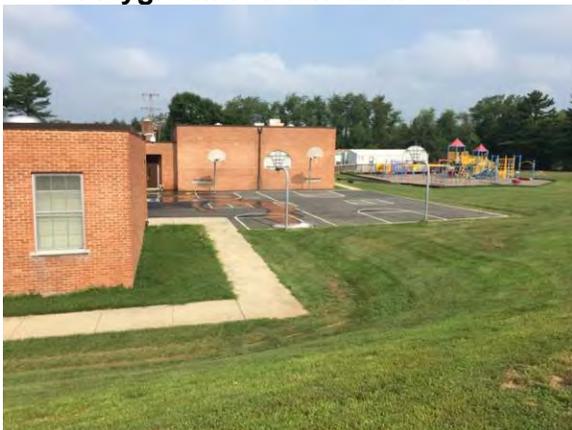
**Playground / basketball courts**

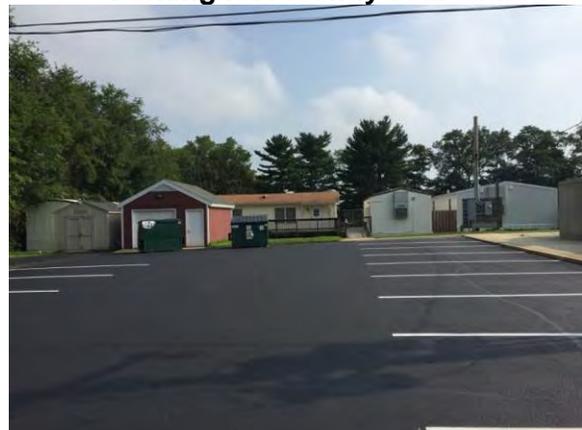
**Parking lot recently seal coated**

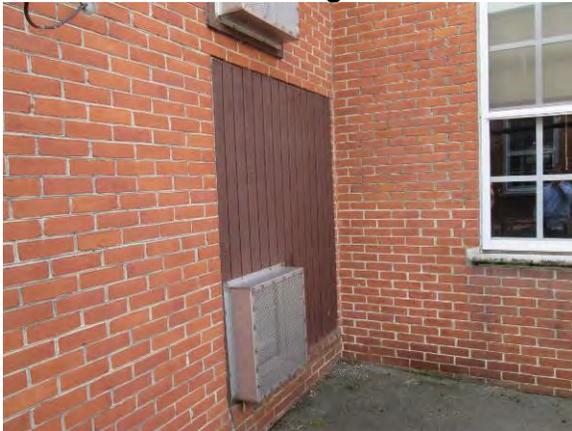
**Mechanical roof opening infilled with wood framing**

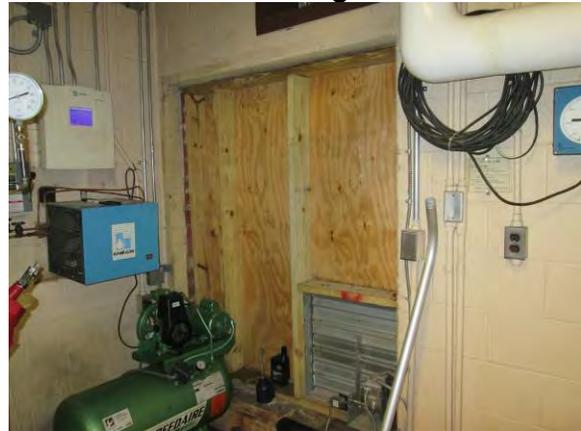
**Electrical room peeling paint**

- Wood framing in in mechanical room – verify with code
- Corroded roof deck in electrical room – clean and repaint exposed lintels

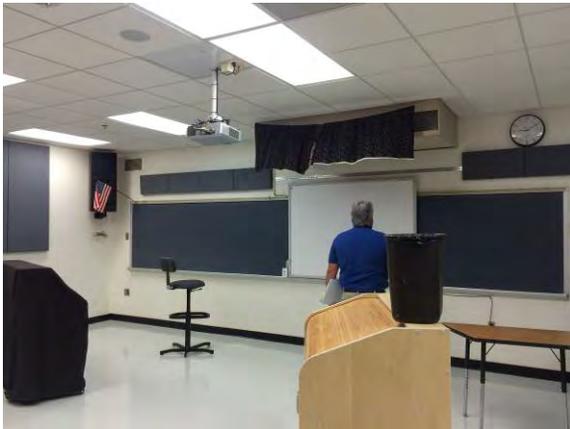
**Chalkboards not converted to marker boards**

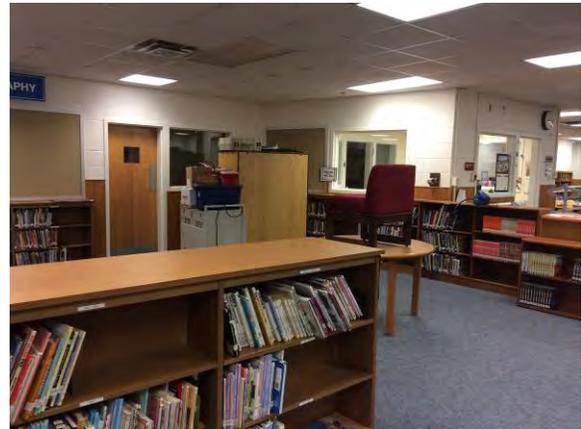
**Old and worn media center casework**

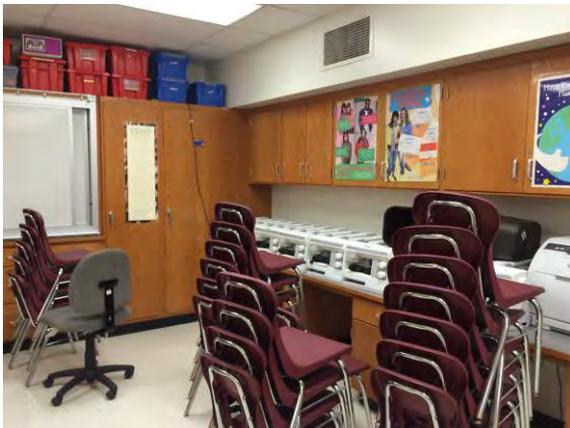
**Outdated Tech Ed casework**

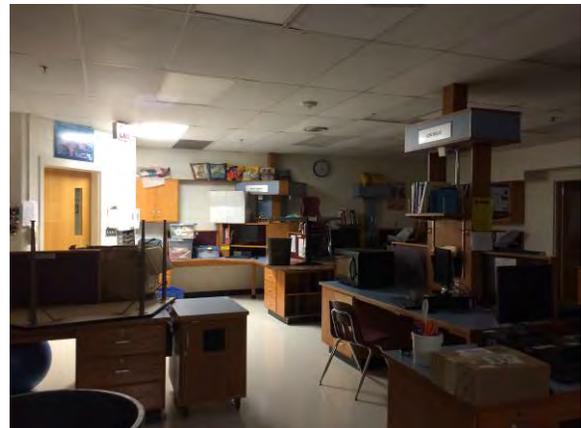
**Outdated Tech Ed casework**

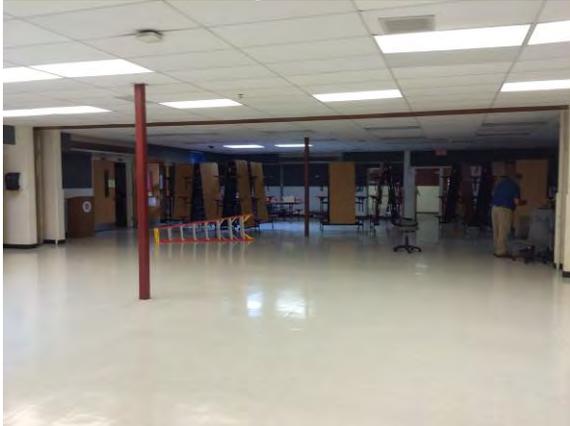
**Work movable partition in cafeteria**
