# COUNTY OF LOUDOUN

### **March 2, 2016 BUDGET WORK SESSION SUPPLEMENTAL PACKET**

- Board Questions Response Supplemental Packet #1 – LCPS Questions
- Budget Question Database as of 03/02/2016

Questions from Chair Randall..... 1  
Questions from Supervisor Volpe.....1  
Questions from Supervisor Letourneau.....25  
Questions from Chair Randall.....27  
Questions from Supervisor Higgins.....29  
Attachment to Question 8 (Volpe), *Loudoun County Public Schools Facility Assessment Study*.....46

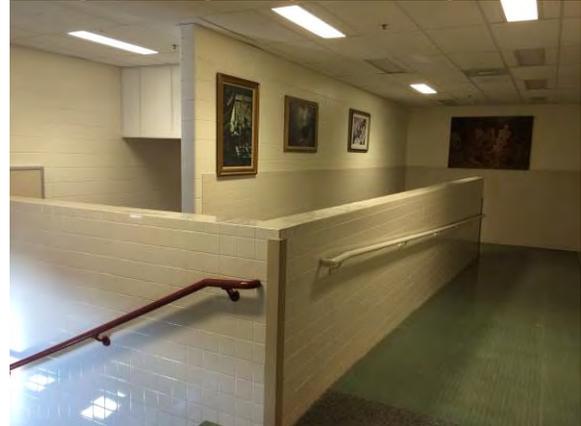
**Hallway visibility compromised by ramp wall**

- Needed to meet full ADA compliance:
  - 18" vertical grab bar in restrooms
- Needed to meet full LCPS facilities standards:
  - Trash enclosure
- Additional recommendations:
  - Roof access ladder safety pole and top rung adjustment
  - Ability for administrative office to have clear visibility around ramp walls

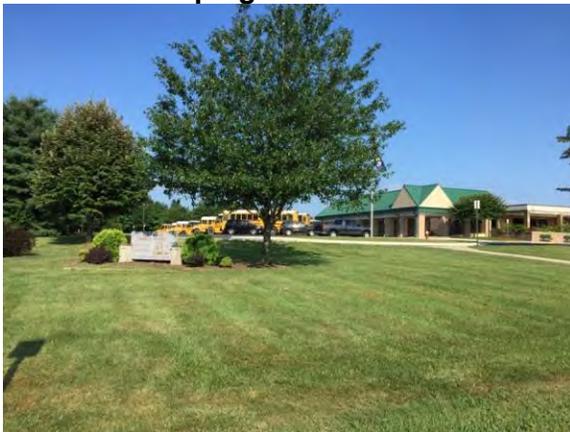
**Landscaping at front of school**

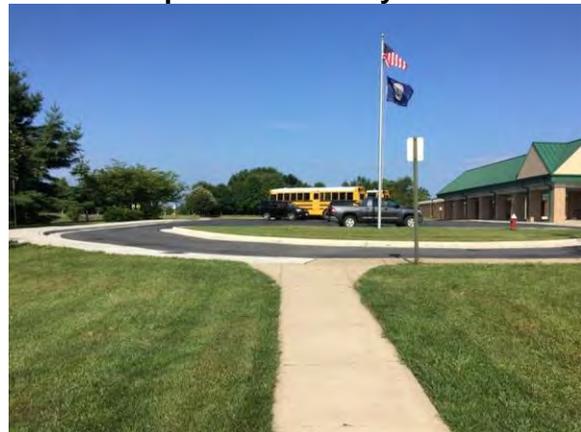
**Bus loop and front entry to school**

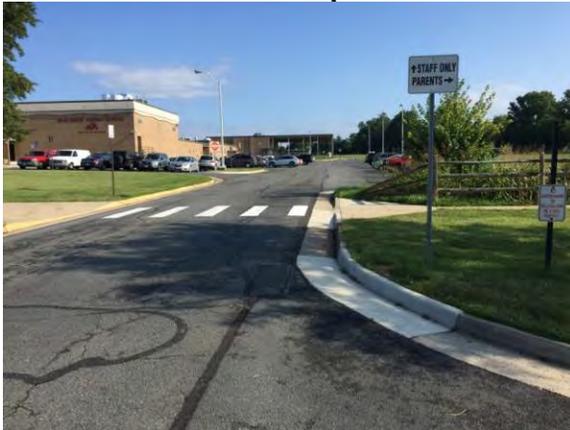
**Parent drop-off**

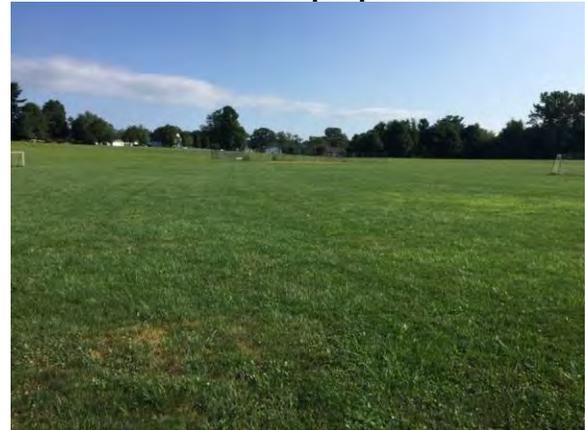
**Softball / multi-purpose field**

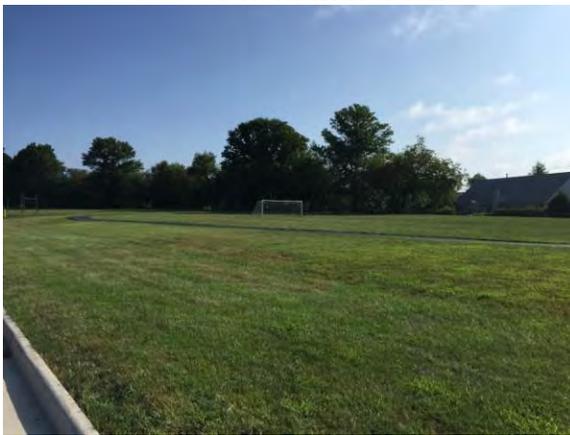
**Soccer field with track**

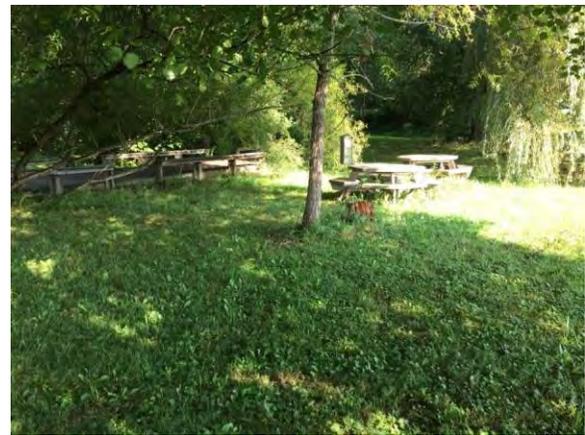
**Outdoor classroom**

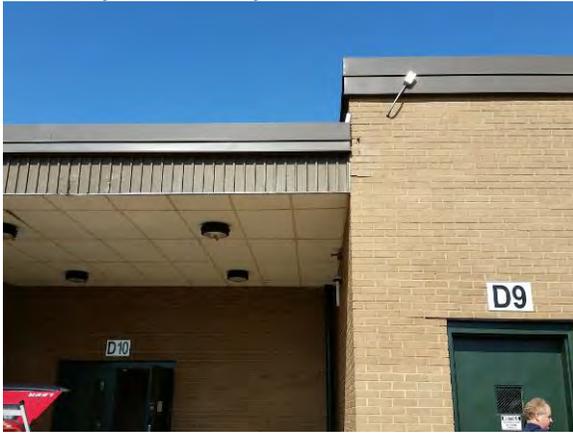
**Façade crack due to canopy connection likely caused by thermal movement**

- Cracked façade at loading dock canopy
- Cracked loading dock column and surrounding concrete -- sealant against moisture needed

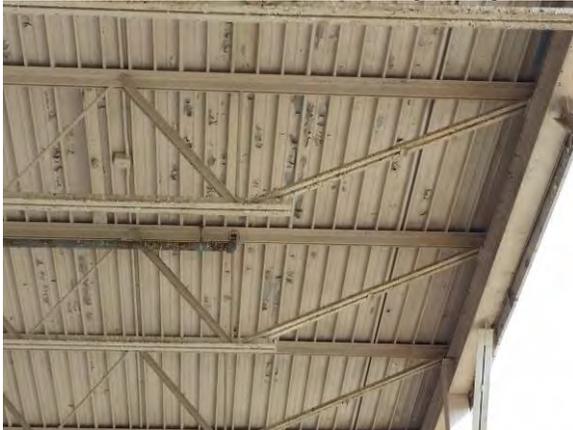
**Exterior basketball court deck paint peeling**

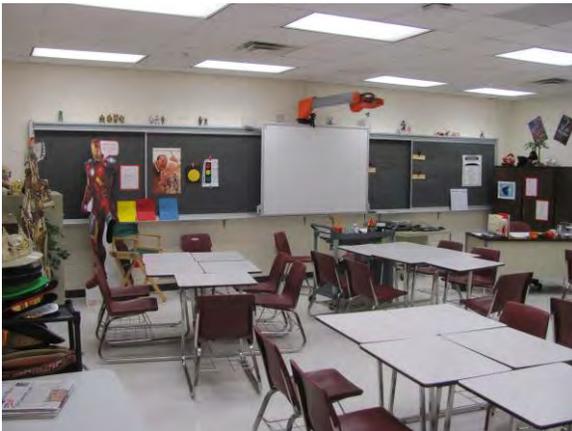
**Chalkboards not converted to marker boards**

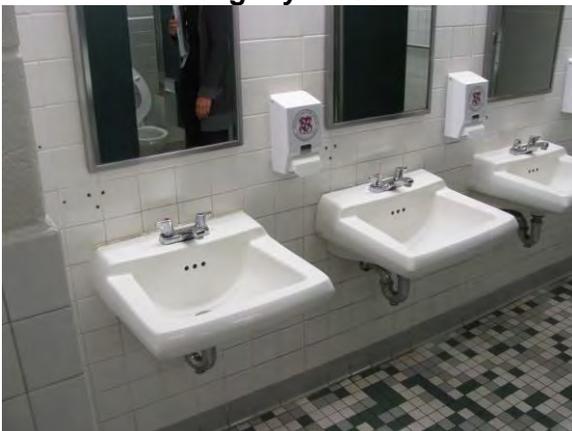
**Wall mountings for sinks in group toilet slightly loose**

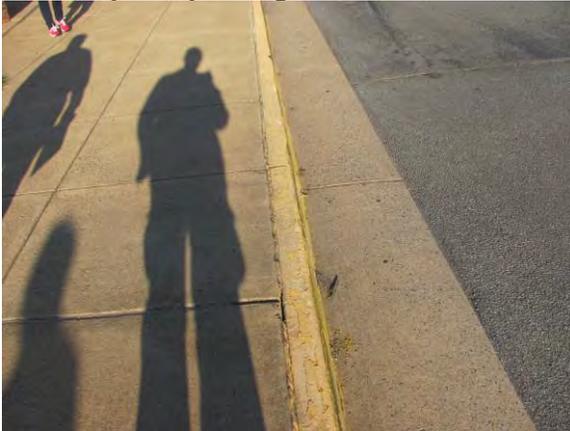
**Curb paint peeling in some locations**

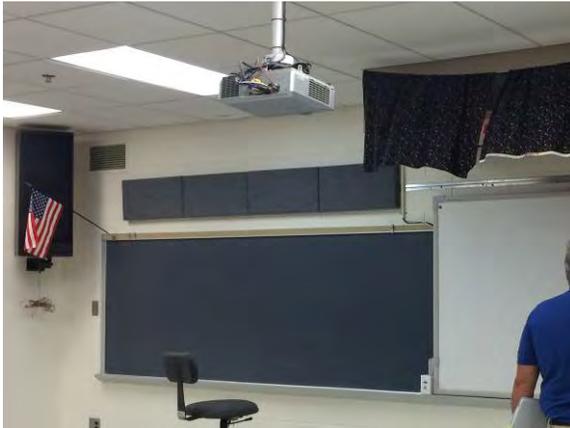
**Chalkboards not converted to marker boards**

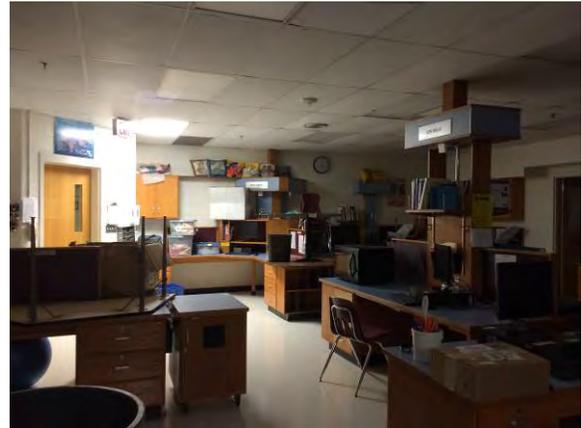
**Outdated Tech Ed casework**

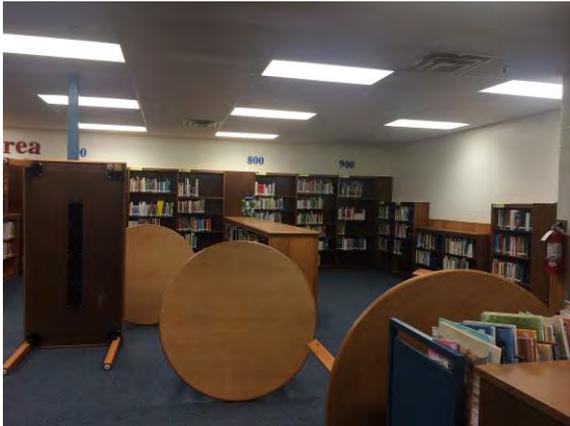
**Old and worn media center casework**

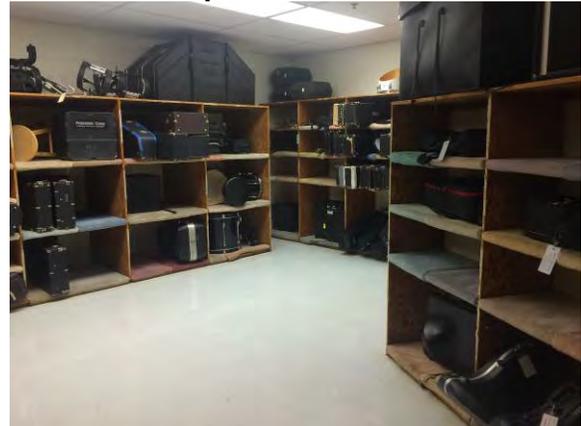
**Inadequate band room storage conflicts with sprinkler heads**

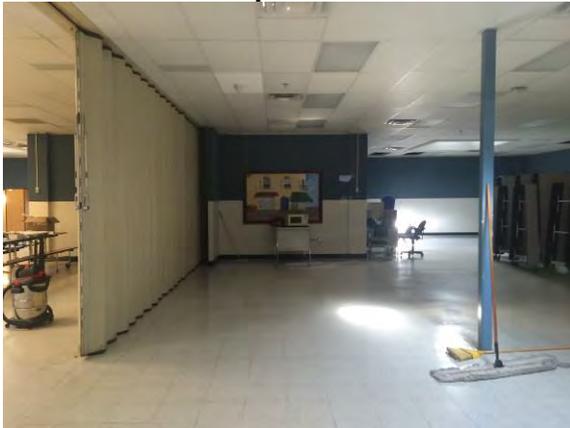
**Worn movable partition in cafeteria**

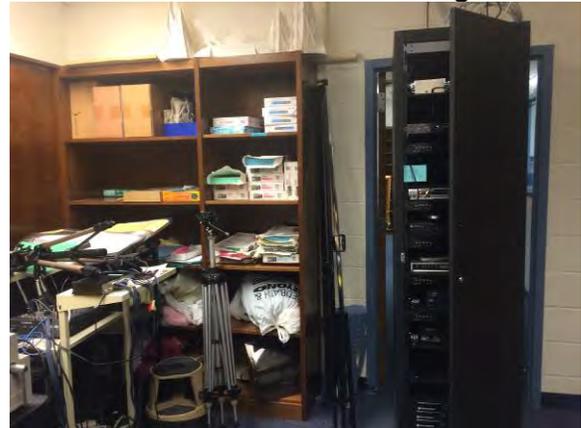
**Media center AV rack blocking door**

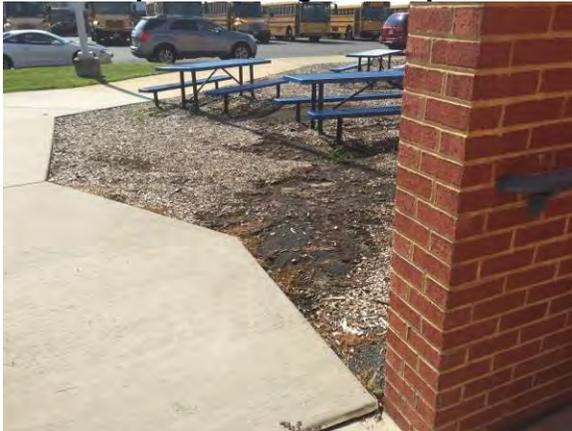
**Mulch washout caused by poor drainage at ramp**

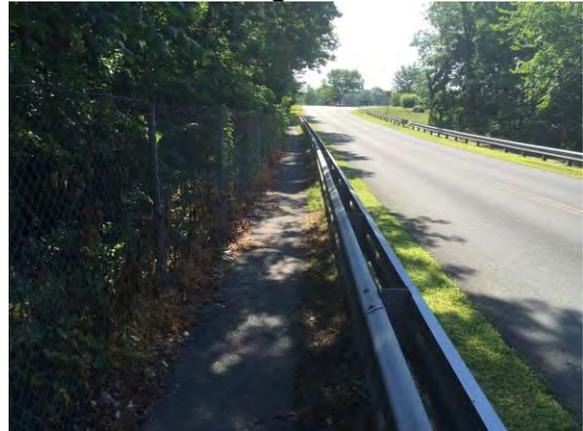
**Narrow trail with vegetation encroachment**

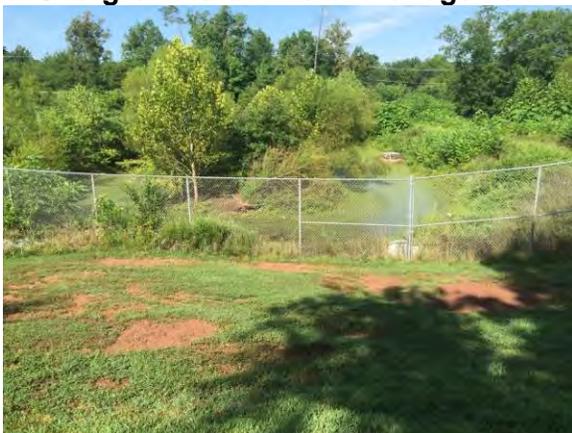
**Overgrown stormwater management**

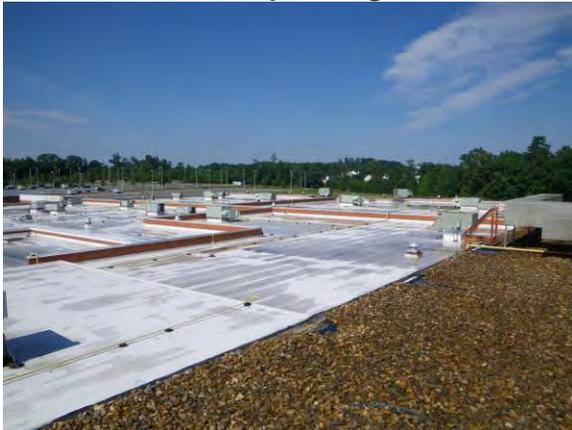
**Roof ponding**

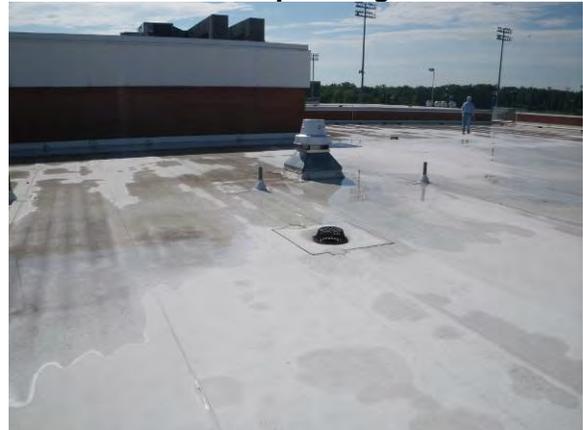
**Roof ponding**

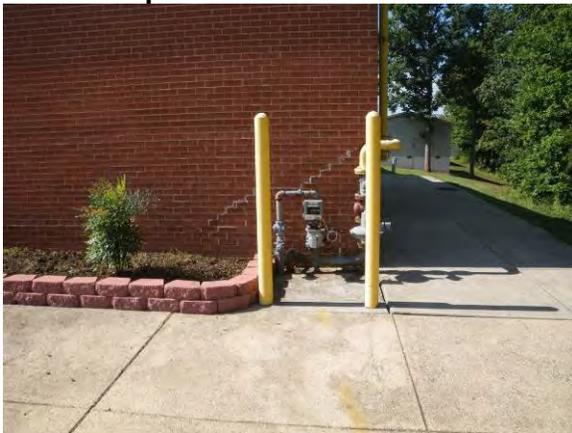
**Repaired settlement crack**

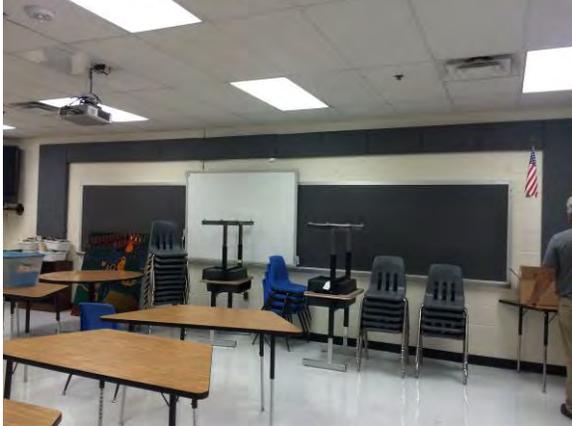
**Chalkboards not converted to marker boards**

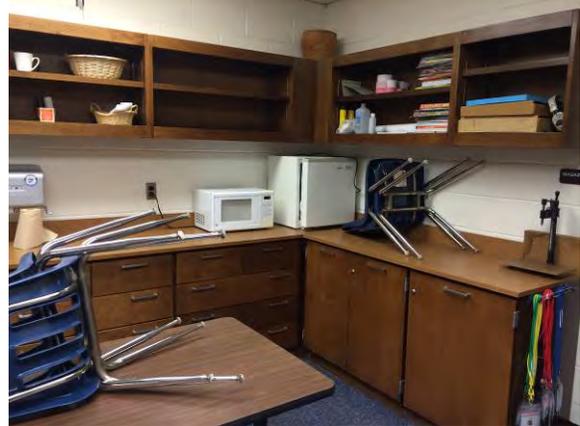
**Old and worn media center casework**

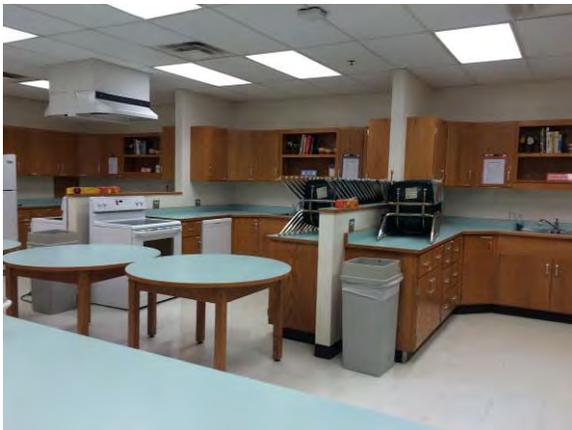
**Outdated family & consumer science casework**

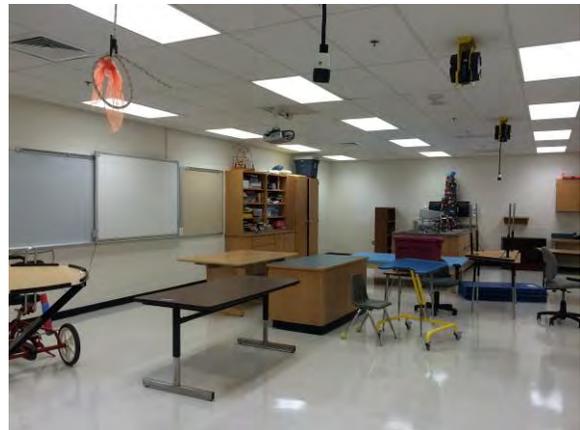
**Art room being used for special ed lacks toilet**

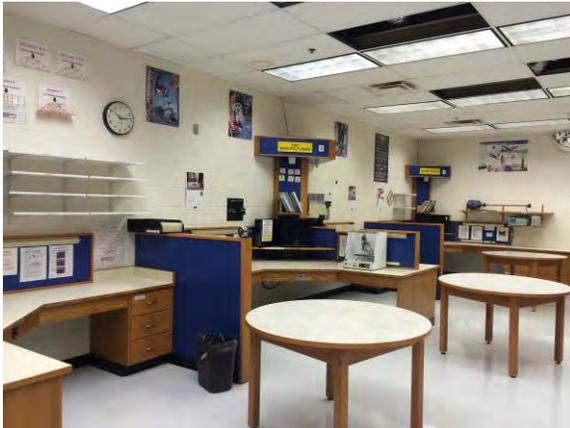
**Outdated tech ed casework**

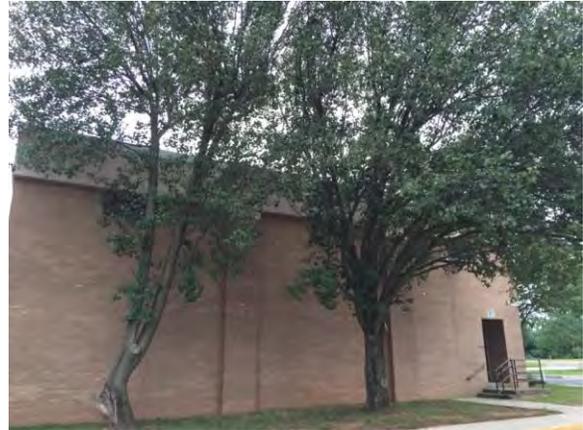
**Overgrown pear trees**

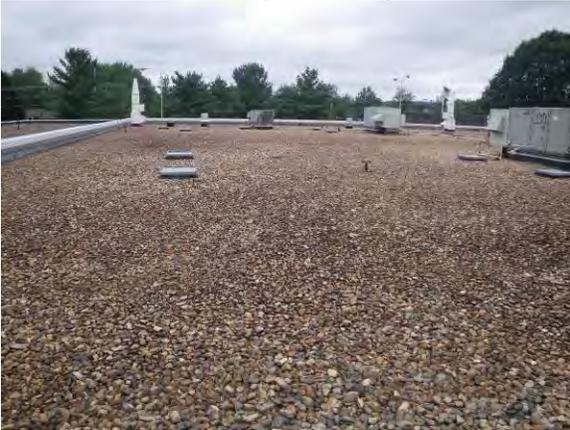
The interior bearing walls are in good condition. Hallway floors have cracking and differential settlement in some areas; although movement appears to have stopped. On the exterior of the building, spalling is occurring on brick faces. While this is not a current structural issue, continued deterioration could lead to concern. Also of note are the apparent ponding and drainage issues on the ballasted roof. Further investigation is required.

**Dark stones indicate inadequate flow to drains causing ponding on roof**

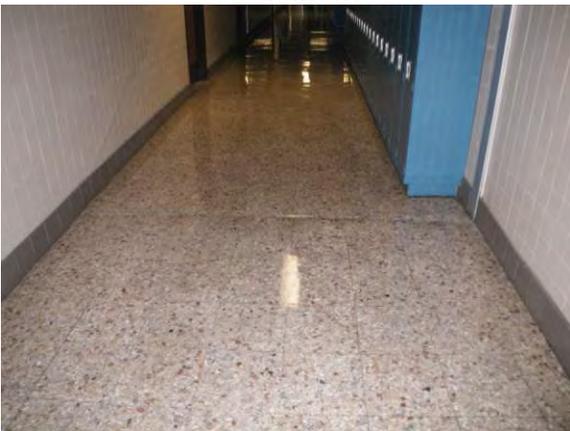
**Classroom corridor flooring between addition and original building displays differential settlement**

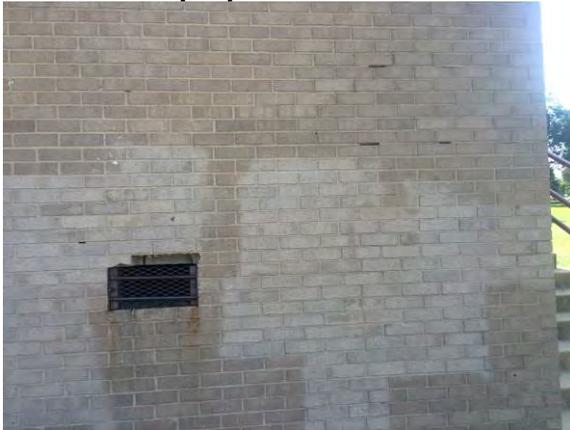
**Mortar deterioration and exposed wire; improper ventilation**

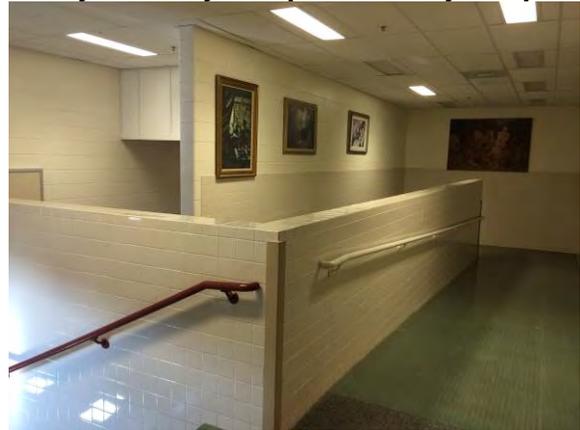
**Hallway visibility compromised by ramp wall**

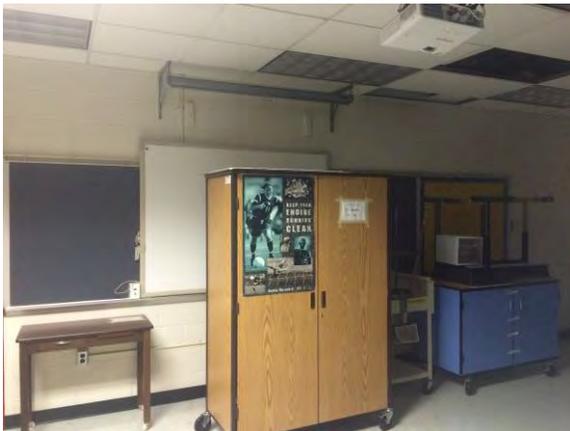
**Chalkboards not converted to marker boards**

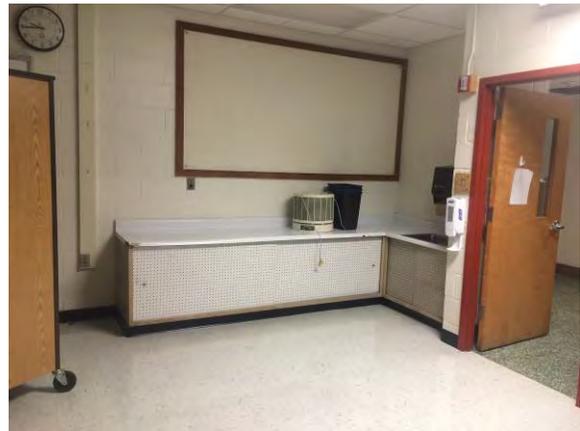
**Old and worn casework**

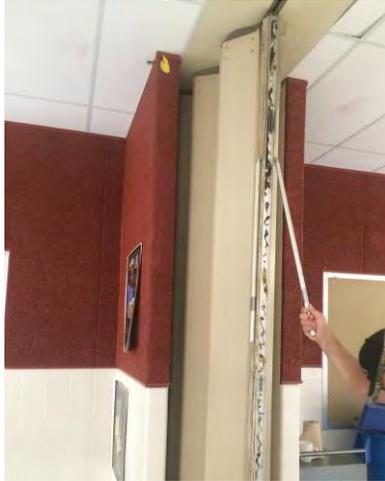
**Worn movable partition in cafeteria**

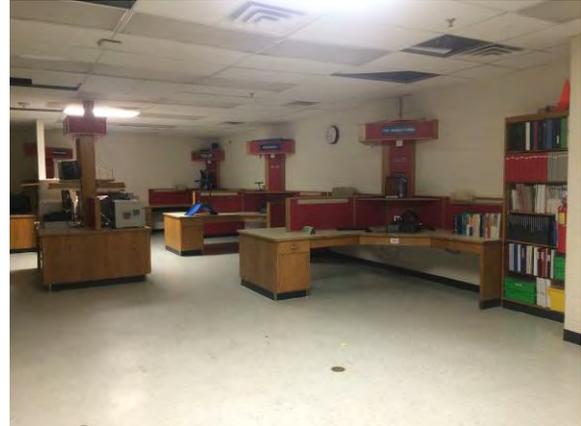
**Outdated tech ed casework**

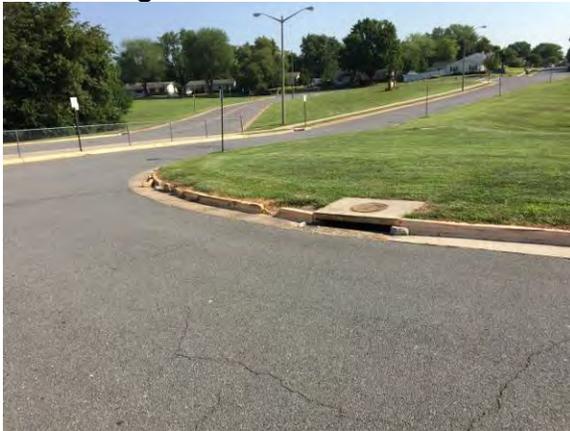
**Damaged curbs in front of school**

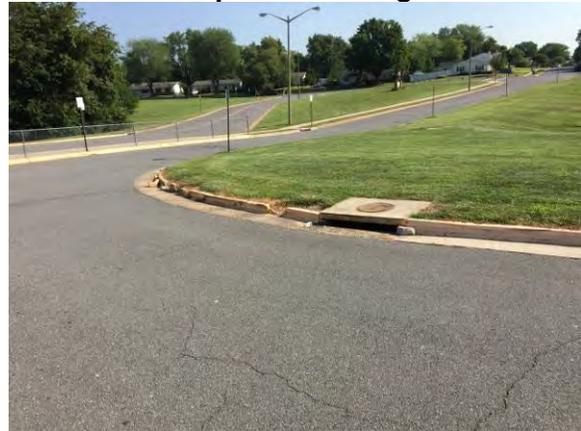
**Asphalt cracking**

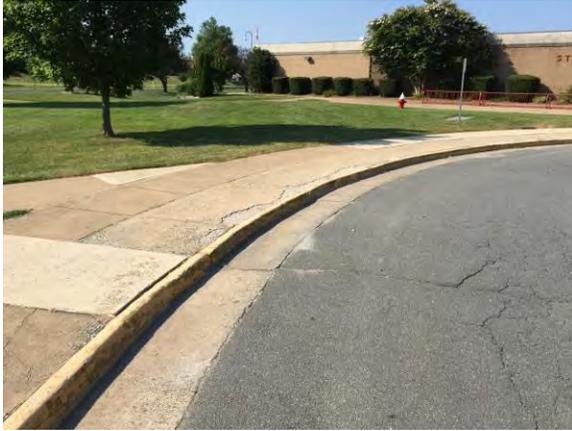
**Concrete sidewalks in front of school deteriorating from snow loading and high salt concentrations**

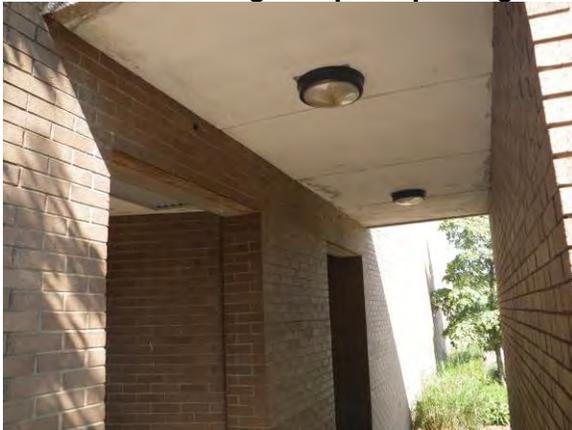
**Lintels rusting and paint peeling**

- Lintels – clean and paint to protect from corrosion
- Loading dock ramp – monitor for settlement
- Exterior basketball court framing – reassess recent painting methods; re-sealing maybe necessary

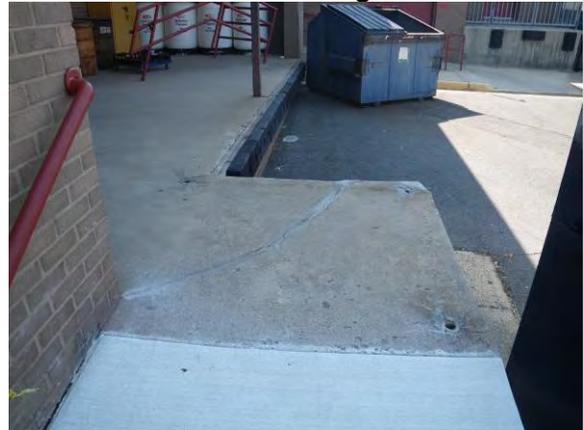
**Settlement at loading dock slab**

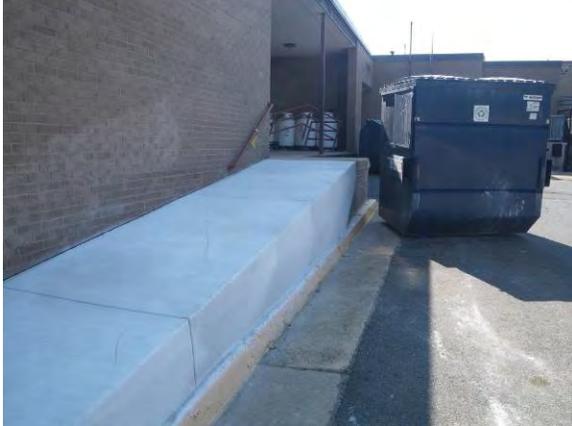
**New loading dock appears to be built on existing sidewalk – monitor for settlement**

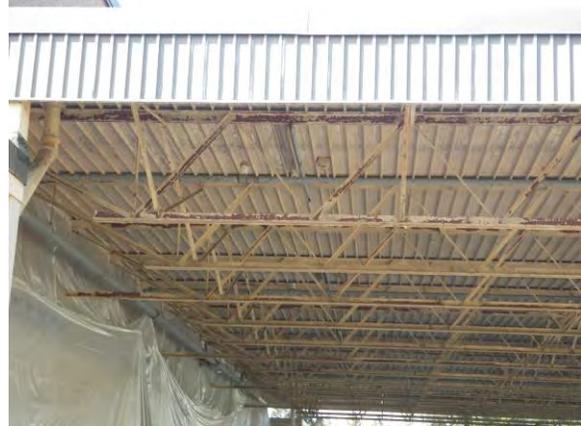
**Basketball court roof corroded and paint peeling**

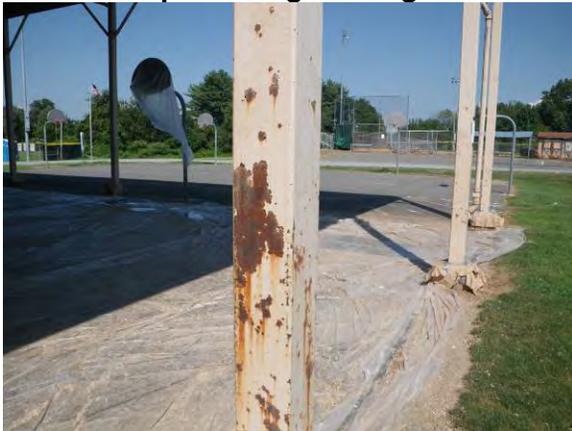
**Court area being painted without cleaning rust and old paint; ineffective method for protecting framing**

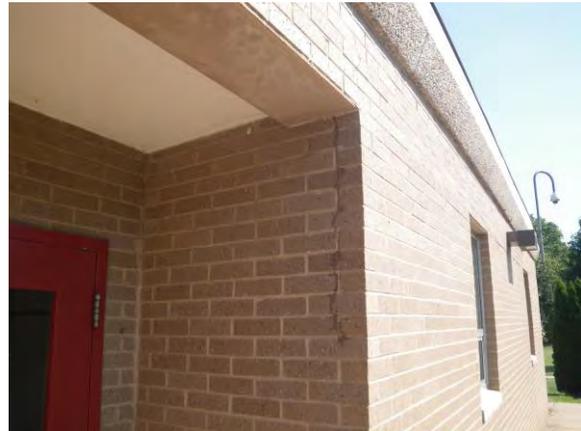
**Façade crack due to lack of control joints and thermal movement**

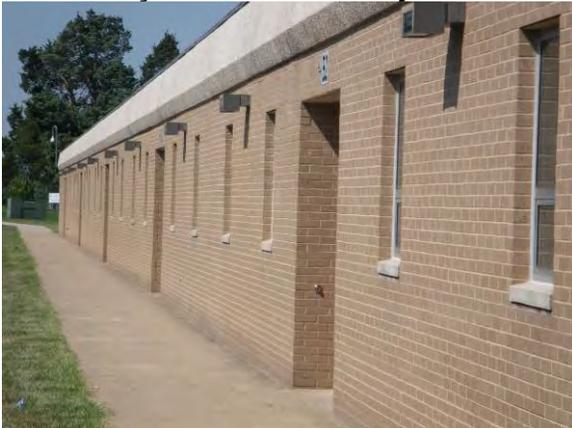
**Façade lacks control joints**

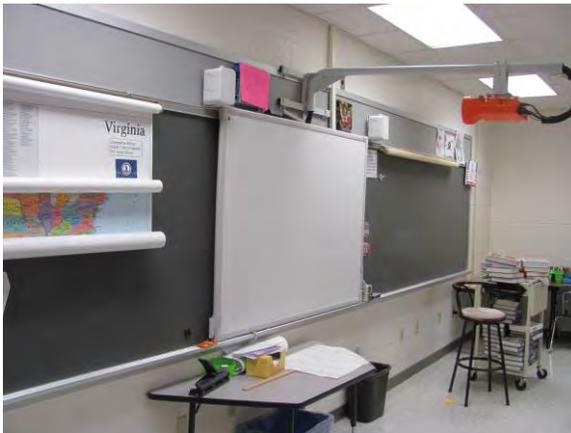
**Chalkboards not converted to marker boards**
